Appendix 3

Photographs of the Site

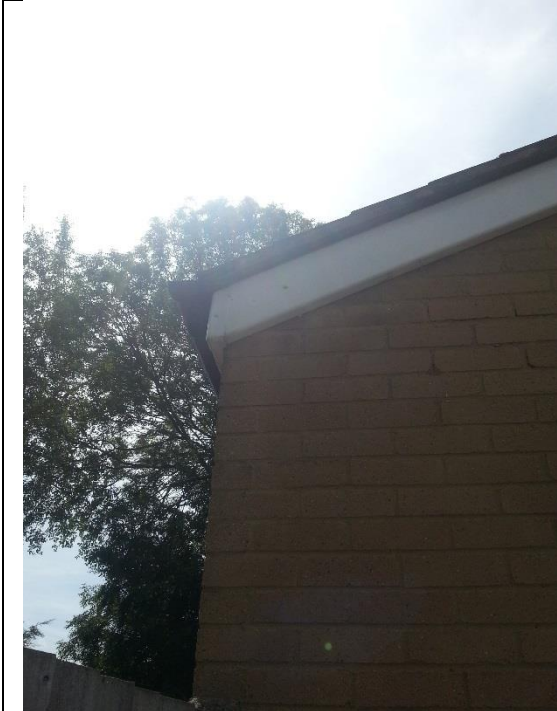
Photograph 11. TN1- Hole in cement underneath tile next to drain pipe.

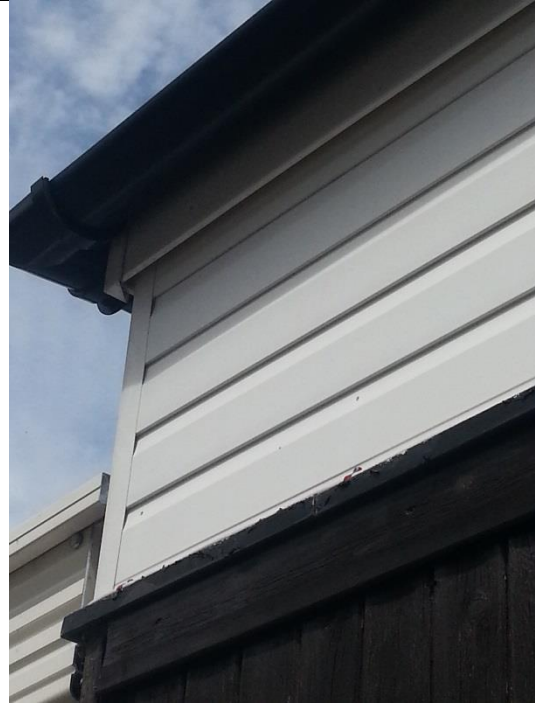
Photograph 12. TN2- Example of gaps underneath soffits.

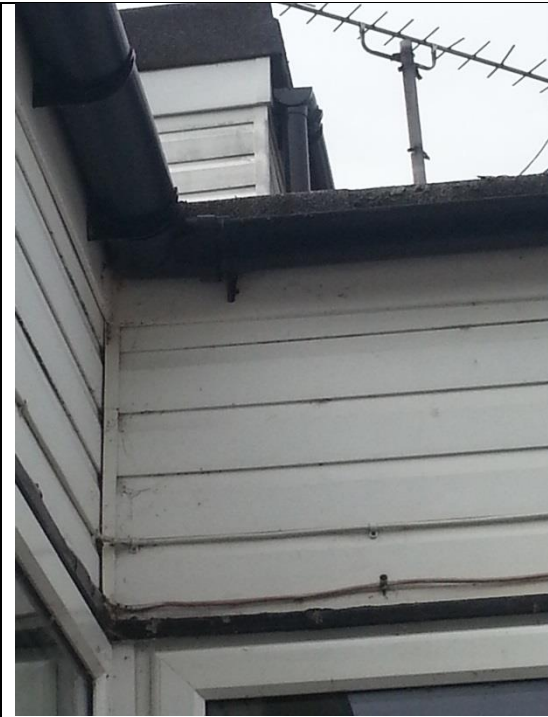
Photograph 13. TN3- gaps beneath bitumen felt on roof.

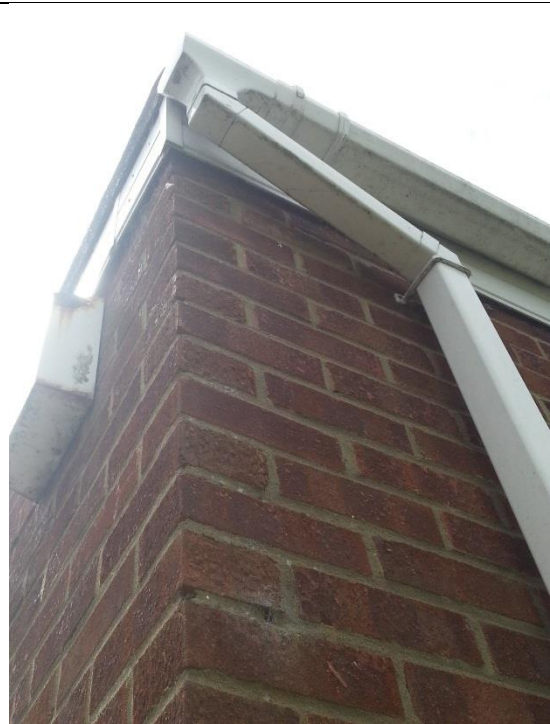
Photograph 14. TN4- slight gapping between soffit box and wall.

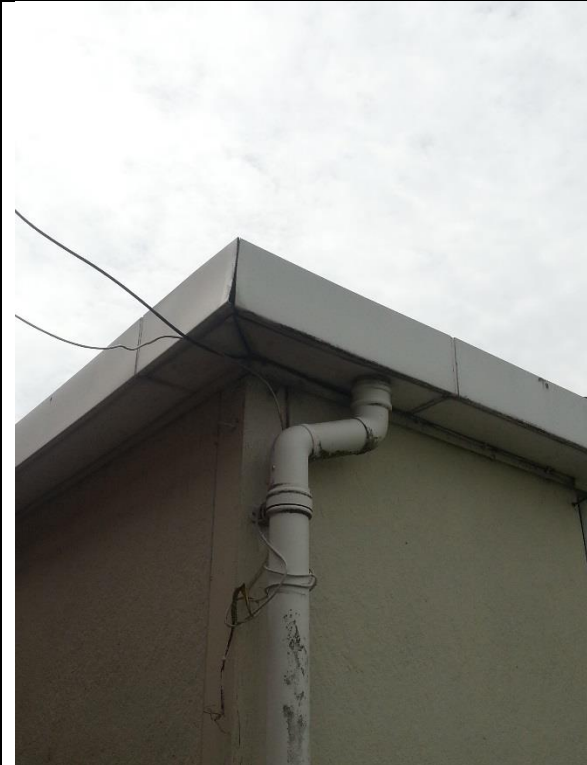
Photograph 15. TN5- Gap providing access to metal soffits..
