# BS5837 Arboricultural Impact Assessment & Method Statement

15 The Avenue, Ickenham, Uxbridge, UB10 8NR

Client: Multi Creation

March 2025

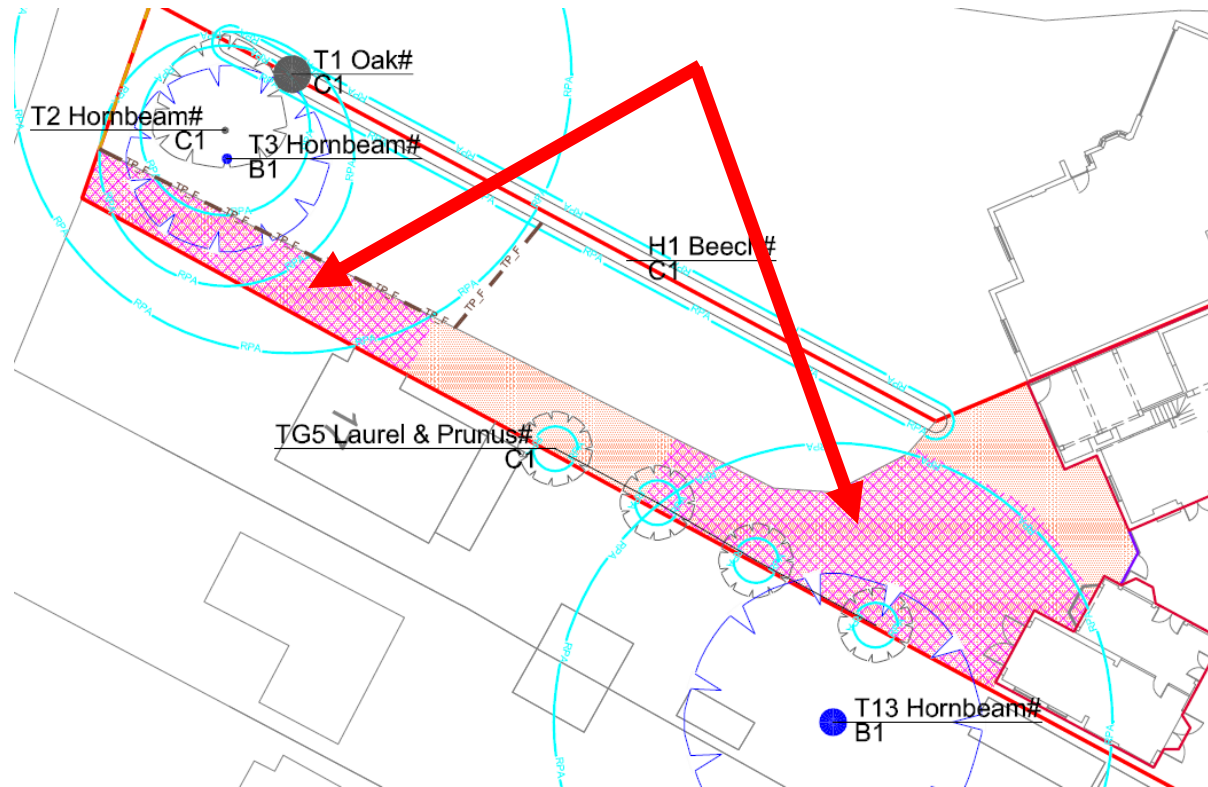
**Fig 8 – 2 areas of no dig driveway will be installed prior to any on site activity.**

- 5.4.4 A no dig surface is required to allow the new driveway and construction access through the RPA's of retained trees. This is because the existing driveway is inadequate to the front and new relative to its extent for the 3<sup>rd</sup> party tree referenced as T13. **It is indicated within this section of the report because its installation prior to any on site activity forms an integral part of the tree protection process.**

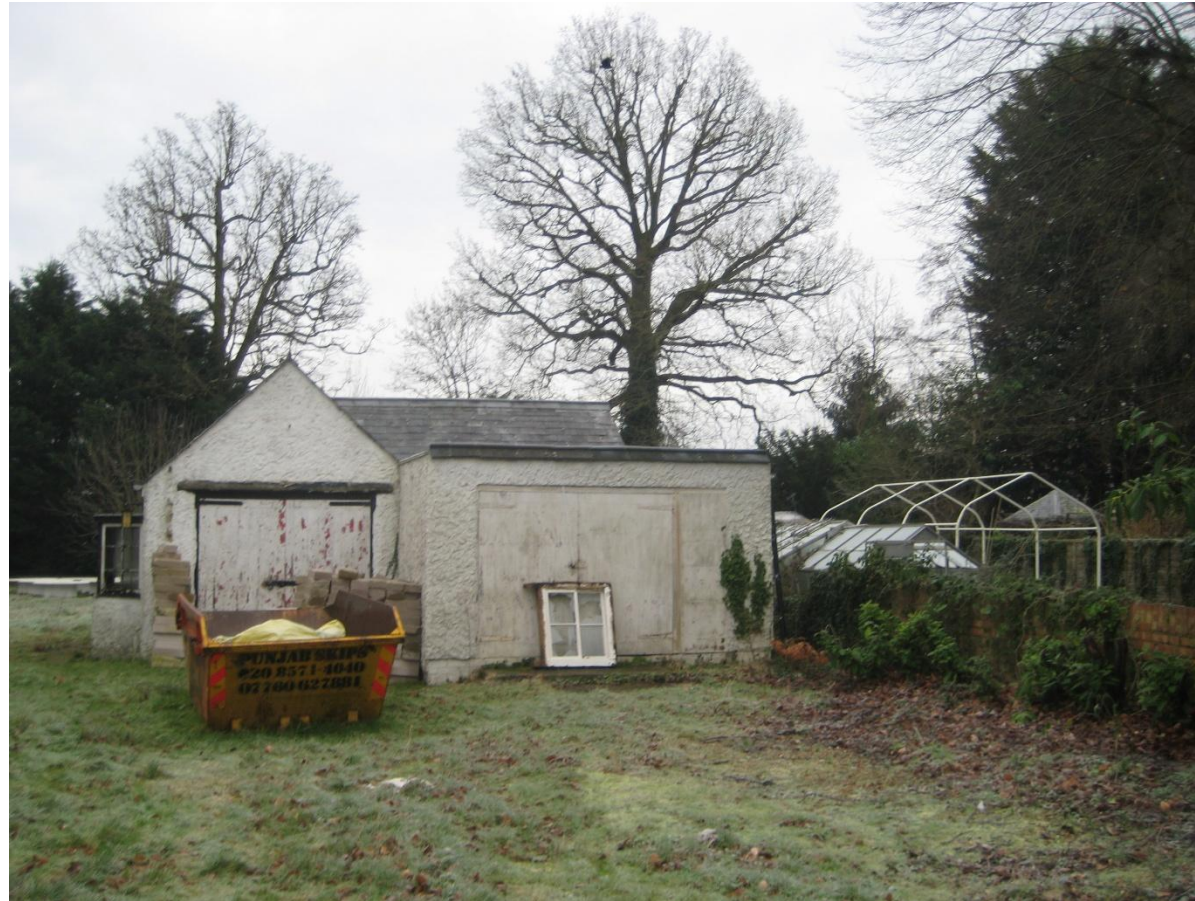
**Image 1** – Existing garage/ outbuilding and grass area to be converted to no dig surface.

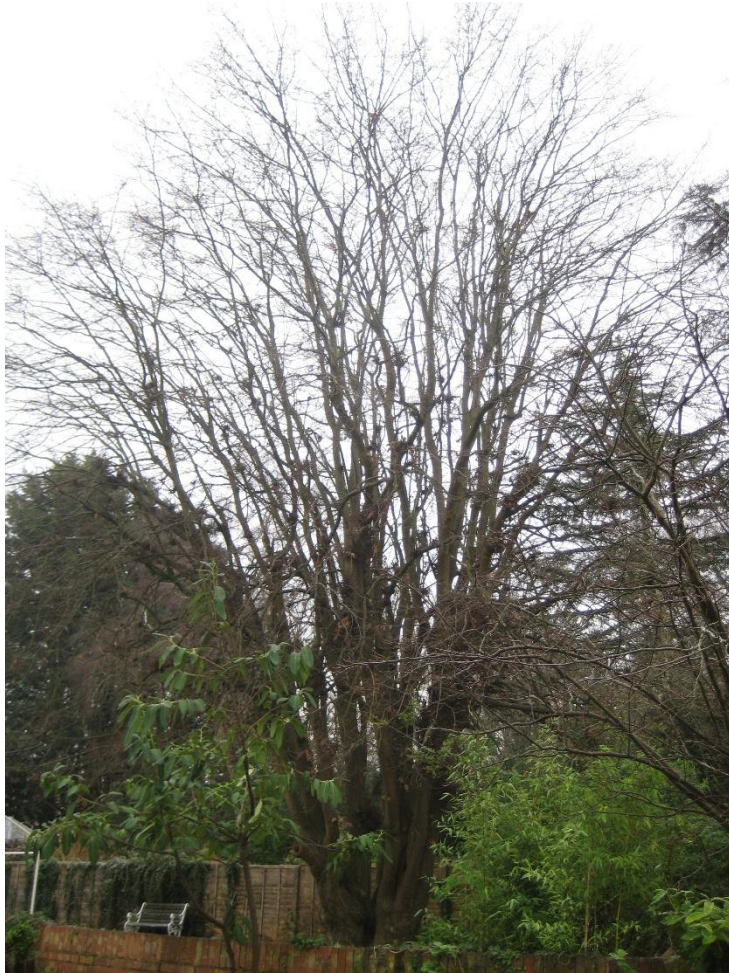
**Image 2 – T13 Hornbeam**

- 1.3 The main constraint trees T1 (Oak), T2 & T3 (Hornbeam) close to the main site access point and T13 (Hornbeam) a large 3<sup>rd</sup> party tree with Root Protection Area which extends into the site. There are no development excavation/ footprint incursions into the Root Protection Area (RPA) of surveyed trees as works to the existing garage building to integrate it to the separate dwelling are modifications rather than removal and replacement.

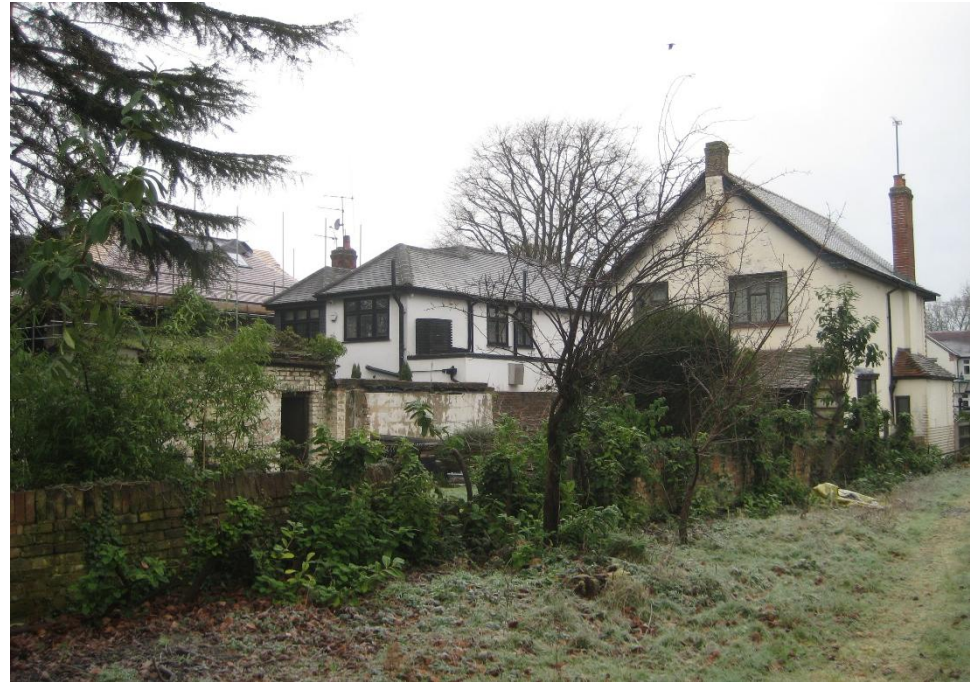
**Image 3 –TG5 and access (part) to become no dig surface/ driveway.**
