**Arbor Cultural Ltd. Providing Expertise on Your Trees®**

**BS5837 Arboricultural Report and  
 Arboricultural Impact Assessment**

<b>OUR REFERENCE</b>	AC.2026.0534
<b>CLIENT</b>	Mr Faluk Patel
<b>SITE</b>	29 Thornhill Road, Ickenham, Uxbridge UB10 8SG
<b>REPORT BY</b>	I S Thompson (known as Tom) M. Arbor. A., BSc. (Hons) Arb, MSc. eFor
<b>DATE</b>	7 <sup>th</sup> April 2026
<b>DATE OF SITE VISIT</b>	2 <sup>nd</sup> April 2026

**Application Ref No 1080/APP/2023/2475    Erection of a two storey front extension, part single storey, part double storey rear extension with amendments to fenestration. New roof with altered pitch and raised ridge line.**

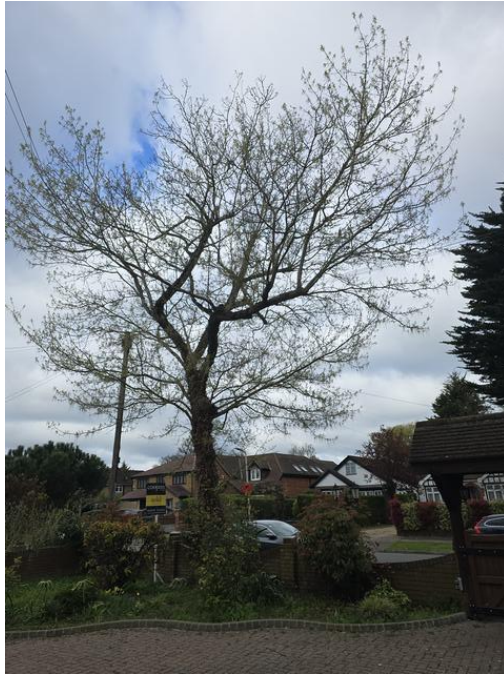
- 2.2.4** There were a total of 9 individual trees and two groups of trees surveyed. T01 was a C1/2 category box elder with torsional fibre buckling and in conflict with the service lines, see Images 1 and 2 in Appendix III. T02 is a C1 category multi-stemmed plum tree, see Image 3. T03 and T08 are both multi-stemmed C1 category laburnum trees in the adjacent garden, see Image 3. T04 and T05 are both C1 category multi-stemmed cabbage palms in the front garden, see Image 4.

**Image 1** T01 a box elder in the front garden, viewed from the house.

Ref	Species	Measurements	Spread	General Observations	Retention Category	RPA	Recommendations	Condition	Reinspect
T01	Box elder maple ( <i>Acer negundo</i> )	Height (m): 8 Stem Diam(mm): 410 Spread (m): 6N, 6E, 5S, 4.5W Crown Clearance (m): 3 Lowest Branch (m): 4(NE) Life Stage: Early Mature Rem. Contrib.: 10+ Years	N:6 E:6 S:5 W:4.5	Basal growth. Torsional fibre buckling on the trunk. Ivy severed and falling away. Conflict with the phone lines.	C1,2	Radius: 4.9m. Area: 75 sq. m.	No Action Recommended at this time, (NAR). Install temporary tree protection fencing during the construction work.	Physiological Cond: Good Structural Cond: Fair Bat Habitat: Low	<b>3 Yrs.</b>
T02	Cherry plum ( <i>Prunus cerasifera</i> )	Height (m): 6 7 stems, avg.(mm): 90 Spread (m): 1.5N, 3E, 3S, 3W Crown Clearance (m): 2 Life Stage: Early Mature Rem. Contrib.: 10+ Years	N:1.5 E:3 S:3 W:3	In adjacent property. Multi stemmed from the ground. Tight unions and included bark.	C1	Radius: 2.9m. Area: 26 sq. m.	NAR Install temporary tree protection fencing during the construction work.	Physiological Cond: Good Structural Cond: Fair Bat Habitat: None	<b>3 Yrs.</b>

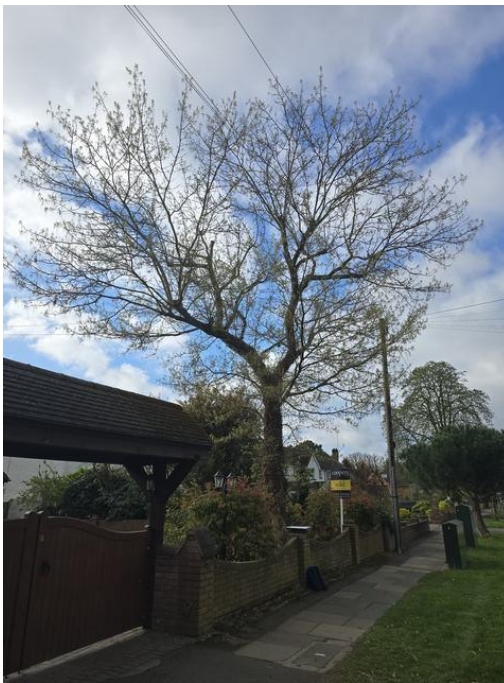
**Image 2** T01 a box elder in the front garden, viewed from the road.

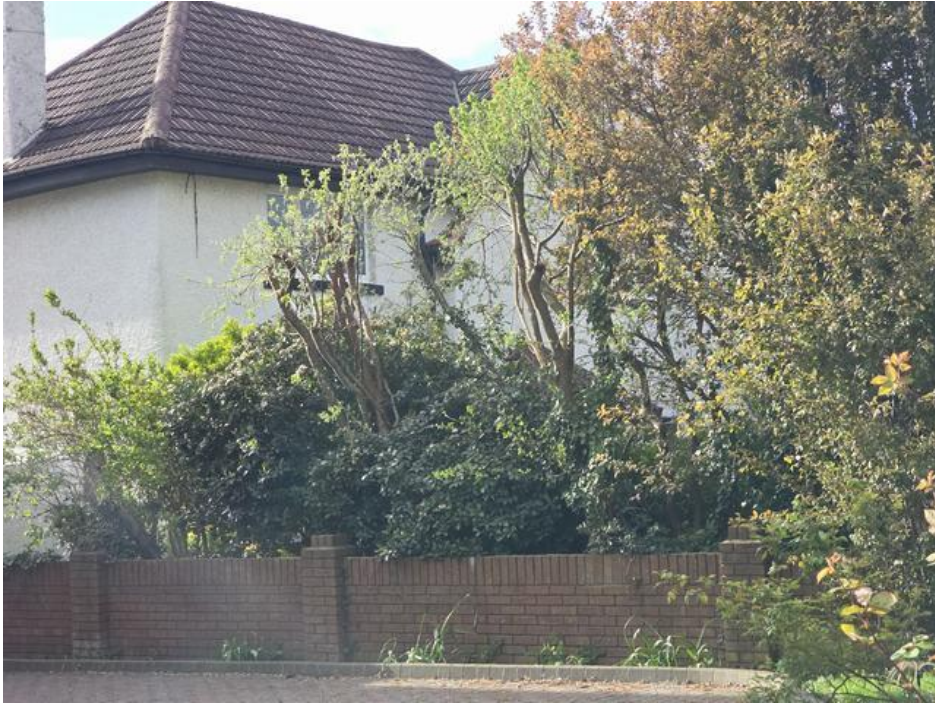
**Image 3** T02 a plum, and T03 and T08 both laburnum in the adjacent garden.

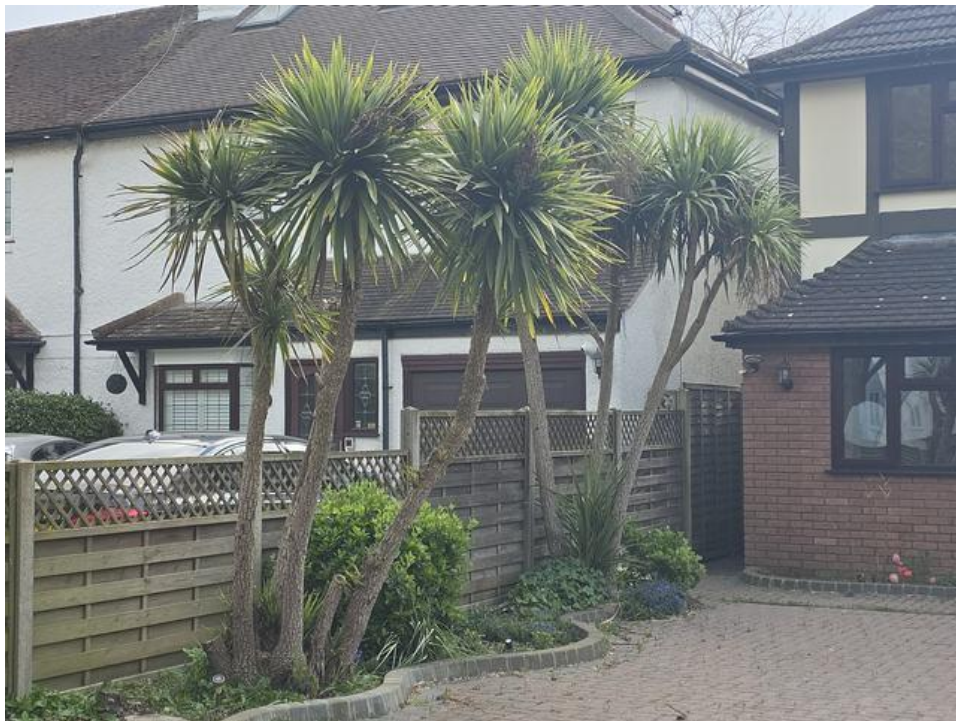
**Image 4** T04 and T05 both multis stemmed cabbage palms in the front garden.

Ref	Species	Measurements	Spread	General Observations	Retention Category	RPA	Recommendations	Condition	Reinspect
T04	Cabbage tree ( <i>Cordyline australis</i> )	Height (m): 2 4 stems (mm): 90, 100, 80, 80 Spread (m): 1N, 1E, 1.5S, 1.5W Crown Clearance (m): 1.5 Life Stage: Semi Mature Rem. Contrib.: 10+ Years	N:1 E:1 S:1.5 W:1.5	Multi stemmed from the ground. In flower bed. Necrotic bark on stems.	C1	Radius: 2.1m. Area: 14 sq. m.	NAR Install temporary tree protection fencing during the construction work.	Physiological Cond: Good Structural Cond: Fair Bat Habitat: None	<b>3 Yrs.</b>
T05	Cabbage tree ( <i>Cordyline australis</i> )	Height (m): 4 3 stems (mm): 120, 100, 100 Spread (m): 2N, 2E, 2S, 1W Crown Clearance (m): 2 Life Stage: Early Mature Rem. Contrib.: 10+ Years	N:2 E:2 S:2 W:1	Multi stemmed from the ground. In flower bed. Necrotic bark on one stem.	C1	Radius: 2.2m. Area: 15 sq. m.	NAR Install temporary tree protection fencing during the construction work.	Physiological Cond: Good Structural Cond: Fair Bat Habitat: None	<b>3 Yrs.</b>

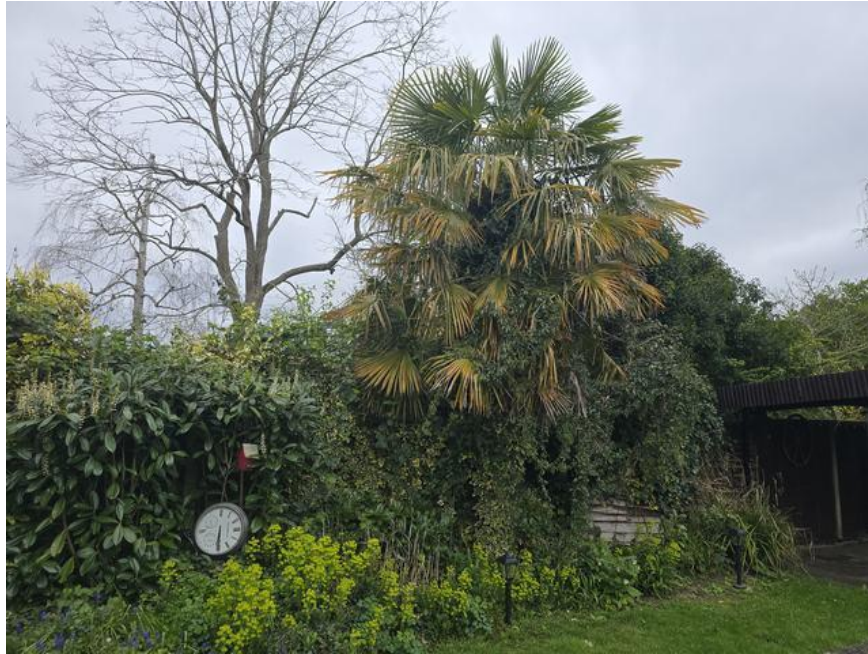
**Image 5** T06 a Chusan palm tree in the back garden.

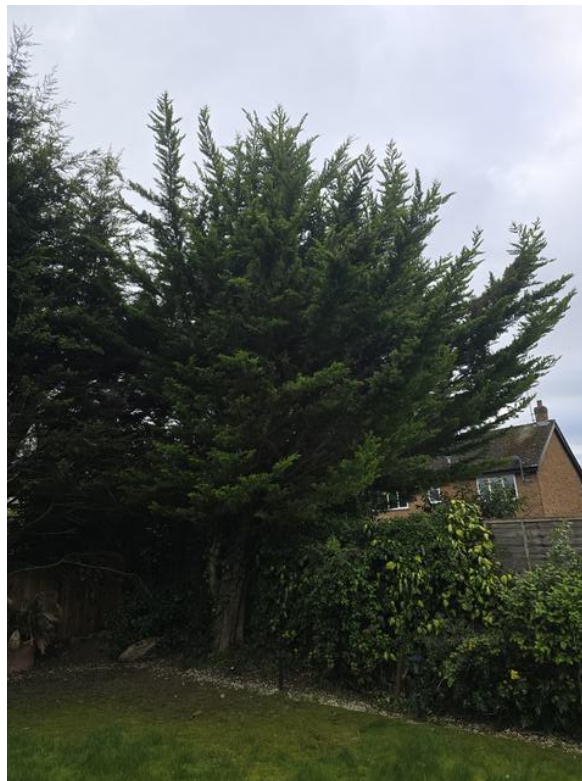
**Image 6** T07 a Leyland cypress at the end of the back garden.

Ref	Species	Measurements	Spread	General Observations	Retention Category	RPA	Recommendations	Condition	Reinspect
T07	Leyland cypress ( <i>X Cuprocyparis leylandii</i> )	Height (m): 10 Stem Diam(mm): 530 Spread (m): 4.5N, 2E, 5S, 5.5W Crown Clearance (m): 2 Life Stage: Early Mature Rem. Contrib.: 10+ Years	N:4.5 E:2 S:5 W:5.5	Asymmetrical crown.	C1	Radius: 6.4m. Area: 129 sq. m.	NAR Install temporary tree protection fencing during the construction work.	Physiological Cond: Good Structural Cond: Fair Bat Habitat: Low	<b>3 Yrs.</b>
T08	Common laburnum ( <i>Laburnum anagyroides</i> )	Height (m): 4 2 stems (mm): 130, 60 Spread (m): 1N, 2E, 2S, 2W Crown Clearance (m): 1 Life Stage: Semi Mature Rem. Contrib.: 10+ Years	N:1 E:2 S:2 W:2	In adjacent property. Cut back to the boundary. Recently topped at around 3 m.	C1	Radius: 1.7m. Area: 9 sq. m.	NAR Install temporary tree protection fencing during the construction work.	Physiological Cond: Good Structural Cond: Fair Bat Habitat: None	<b>3 Yrs.</b>

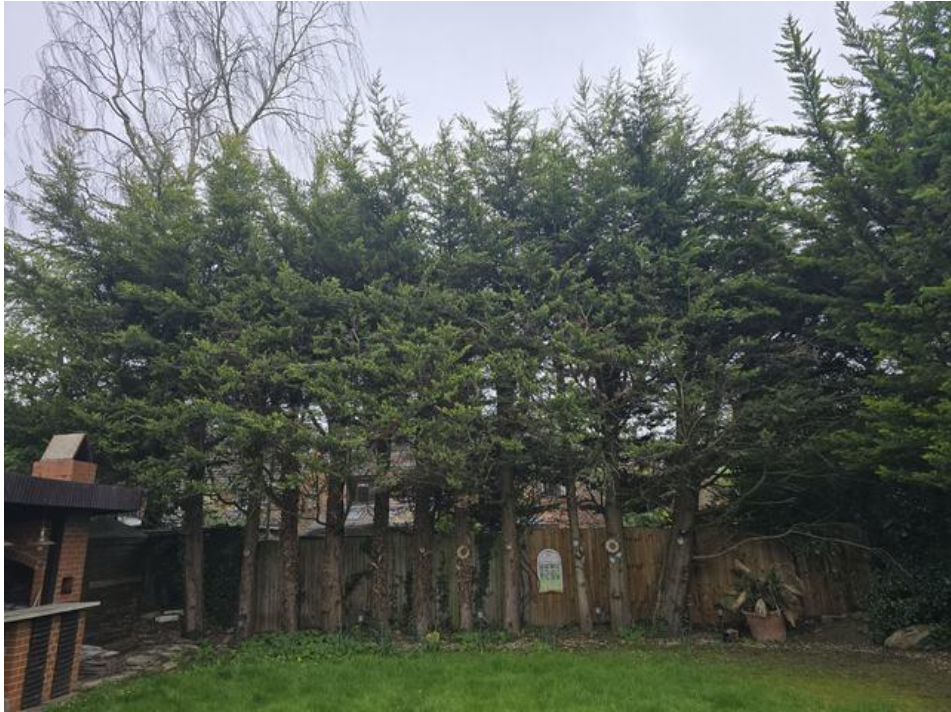
**Image 7** G01 a row of 11 Leyland cypress trees, with a silver birch tree, T09 at rear.

T09	Silver birch ( <i>Betula pendula</i> )	Height (m): 17 Stem Diam(mm): 320 Spread (m): 4N, 4E, 6S, 4W Crown Clearance (m): 10 Life Stage: Early Mature Rem. Contrib.: 20+ Years	N:4 E:4 S:6 W:4	On adjacent property. Limited access and visibility. No obvious defects.	B1	Radius: 3.8m. Area: 45 sq. m.	NAR Install temporary tree protection fencing during the construction work.	Physiological Cond: Good Structural Cond: Fair Bat Habitat: Low	<b>3 Yrs.</b>

Ref	Species	Measurements	Spread	General Observations	Retention Category	RPA	Recommendations	Condition	Reinspect
G01	Leyland cypress x10 ( <i>Cuprocyparis leylandii</i> )	Height (m): 10 10 stems, avg.(mm): 300# Spread (m): 5N, 5E, 5S, 5W Crown Clearance (m): 2 Life Stage: Semi Mature Rem. Contrib.: 10+ Years	N:5 E:5 S:5 W:5	Row of 10 trees as a boundary hedge. Previously topped.	C2	Area: 86 sq. m.	NAR Install temporary tree protection fencing during the construction work.	Physiological Cond: Good Structural Cond: Fair Bat Habitat: Low	<b>3 Yrs.</b>
G02	Mixed species ( <i>Mixed species</i> )	Height (m): 2 Stem Diam(mm): 50 Spread (m): 2N, 2E, 2S, 2W Crown Clearance (m): 1 Life Stage: Semi Mature Rem. Contrib.: 10+ Years	N:2 E:2 S:2 W:2	Two very small trees. Japanese maple and cabbage palm.	C2	Area: 17 sq. m.	Remove these two tree for site access.	Physiological Cond: Good Structural Cond: Fair Bat Habitat: None	<b>N/A</b>

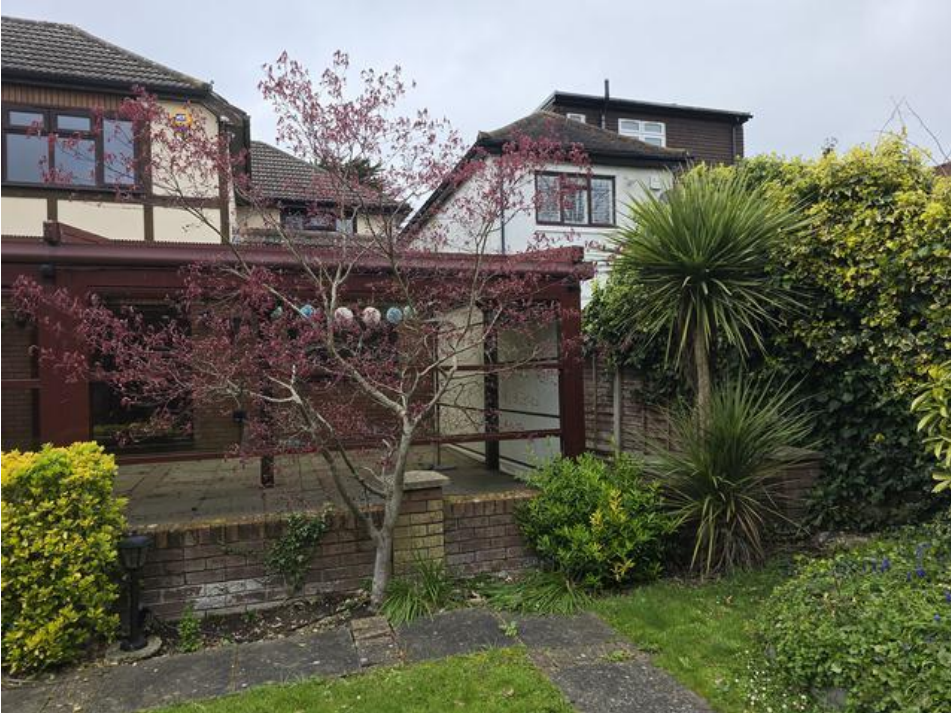
**3.2.1** There is only one group of two small saplings (G02) that is proposed for removal as part of this application. Consequently, there will be a minimal effect to the amenity value of the area.

**Image 8** Two small saplings making up G02.
