2.3 Hayes Park North

Existing elevation treatment

2.4 Building appraisal

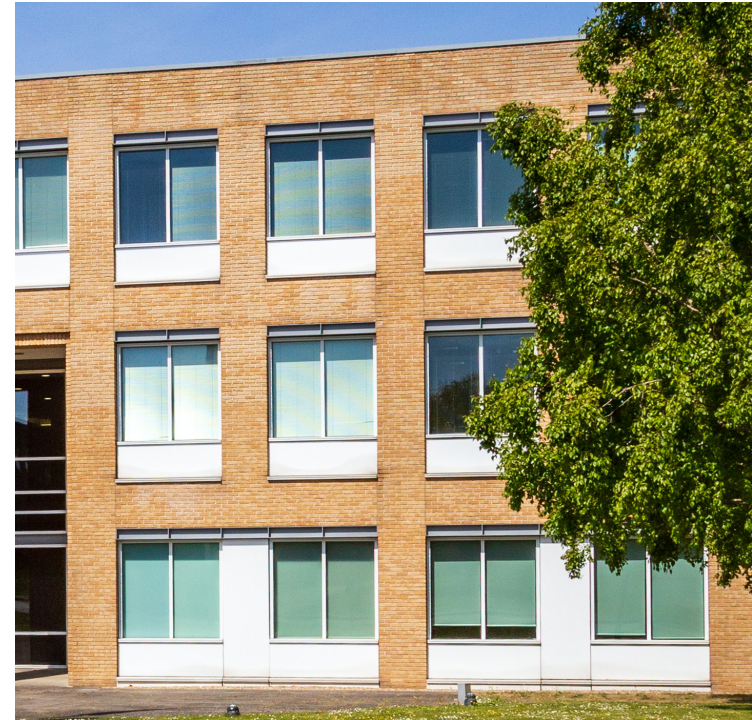
Accent materials include the white metal cladding panel which sits below the window openings, and the grey lintel which sits above.

Grey plastic lintels and white plastic panels

Improve quality of materials used in these locations.

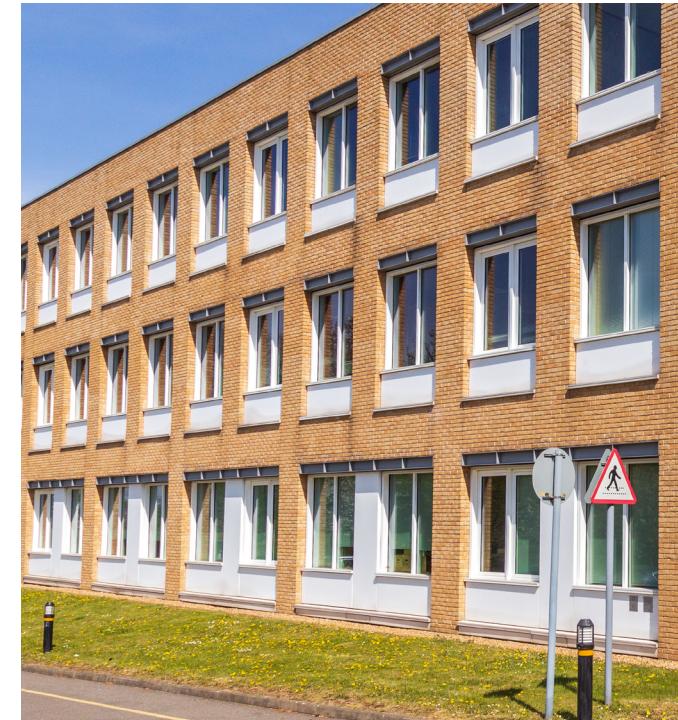
At ground floor the grid is broken down by white panels which take the place of the brick pier at every other bay.

Contrast piers at ground floor

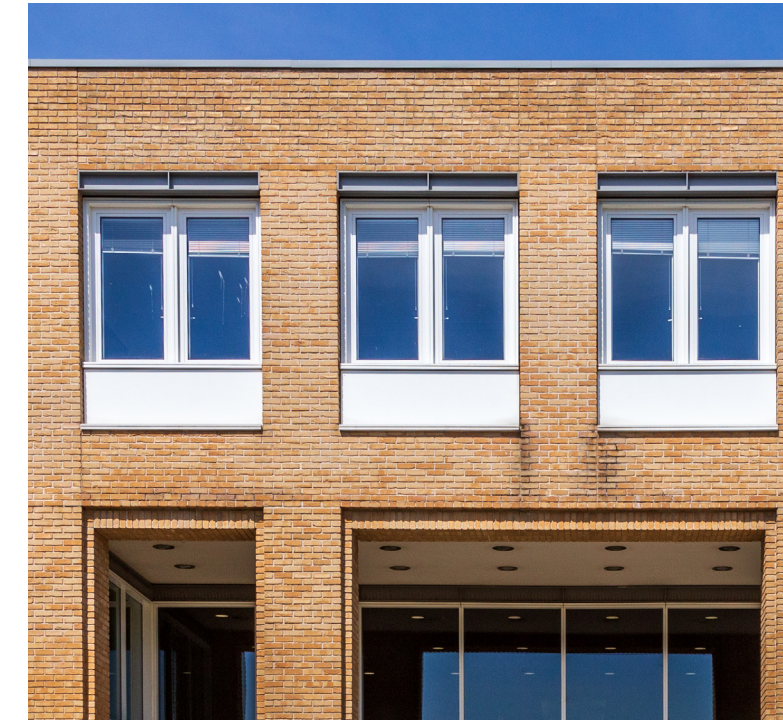
There is some detailing around the recessed main entrance in the form of a soldier course brick.

Soldier course above entrance

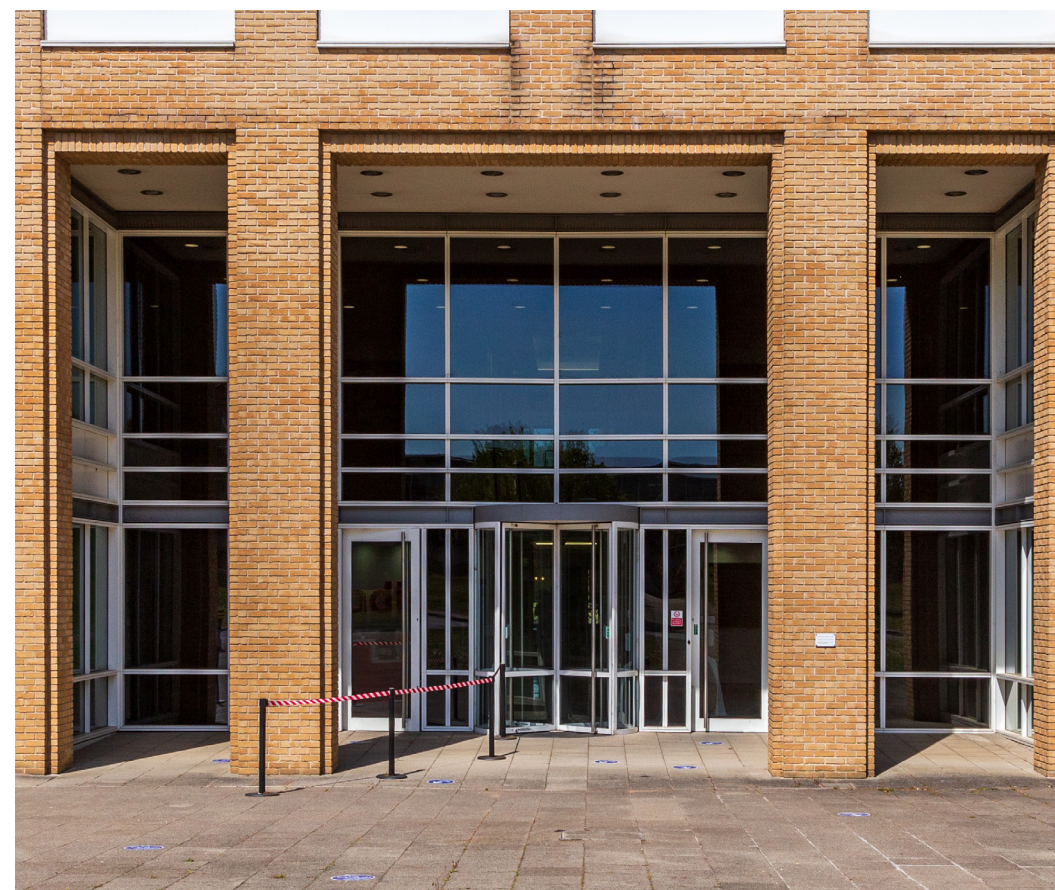
The main entrance sits in a double height undercroft space, which is clad on all sides in curtain wall glazing with tall rotating doors.

Entrance doors in undercroft

Re configuration to improve residential arrival experience.

Removal of curtain walling and use of materials appropriate for dwellings.

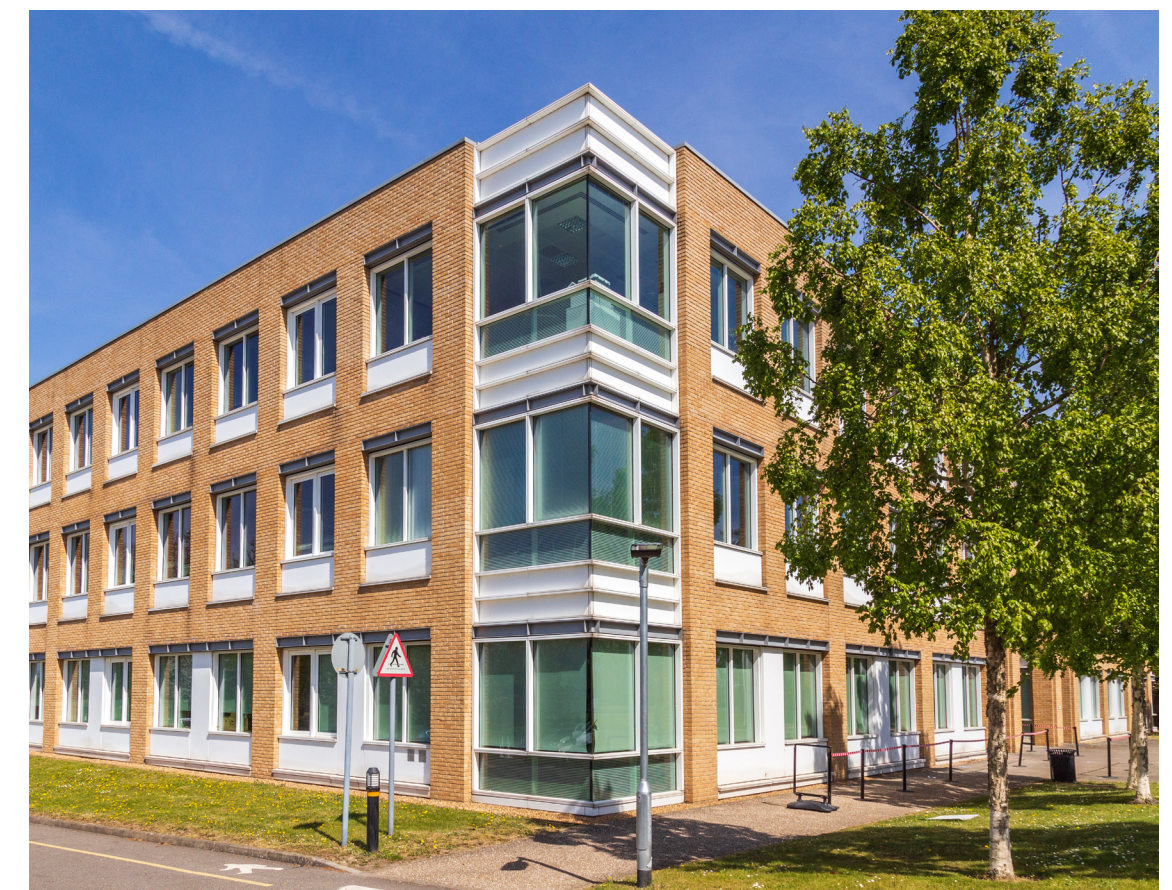
The building corners are clad floor to ceiling curtain wall glazing, with same white metal panel to hide the slab and soffit.

Glazed and recessed corners

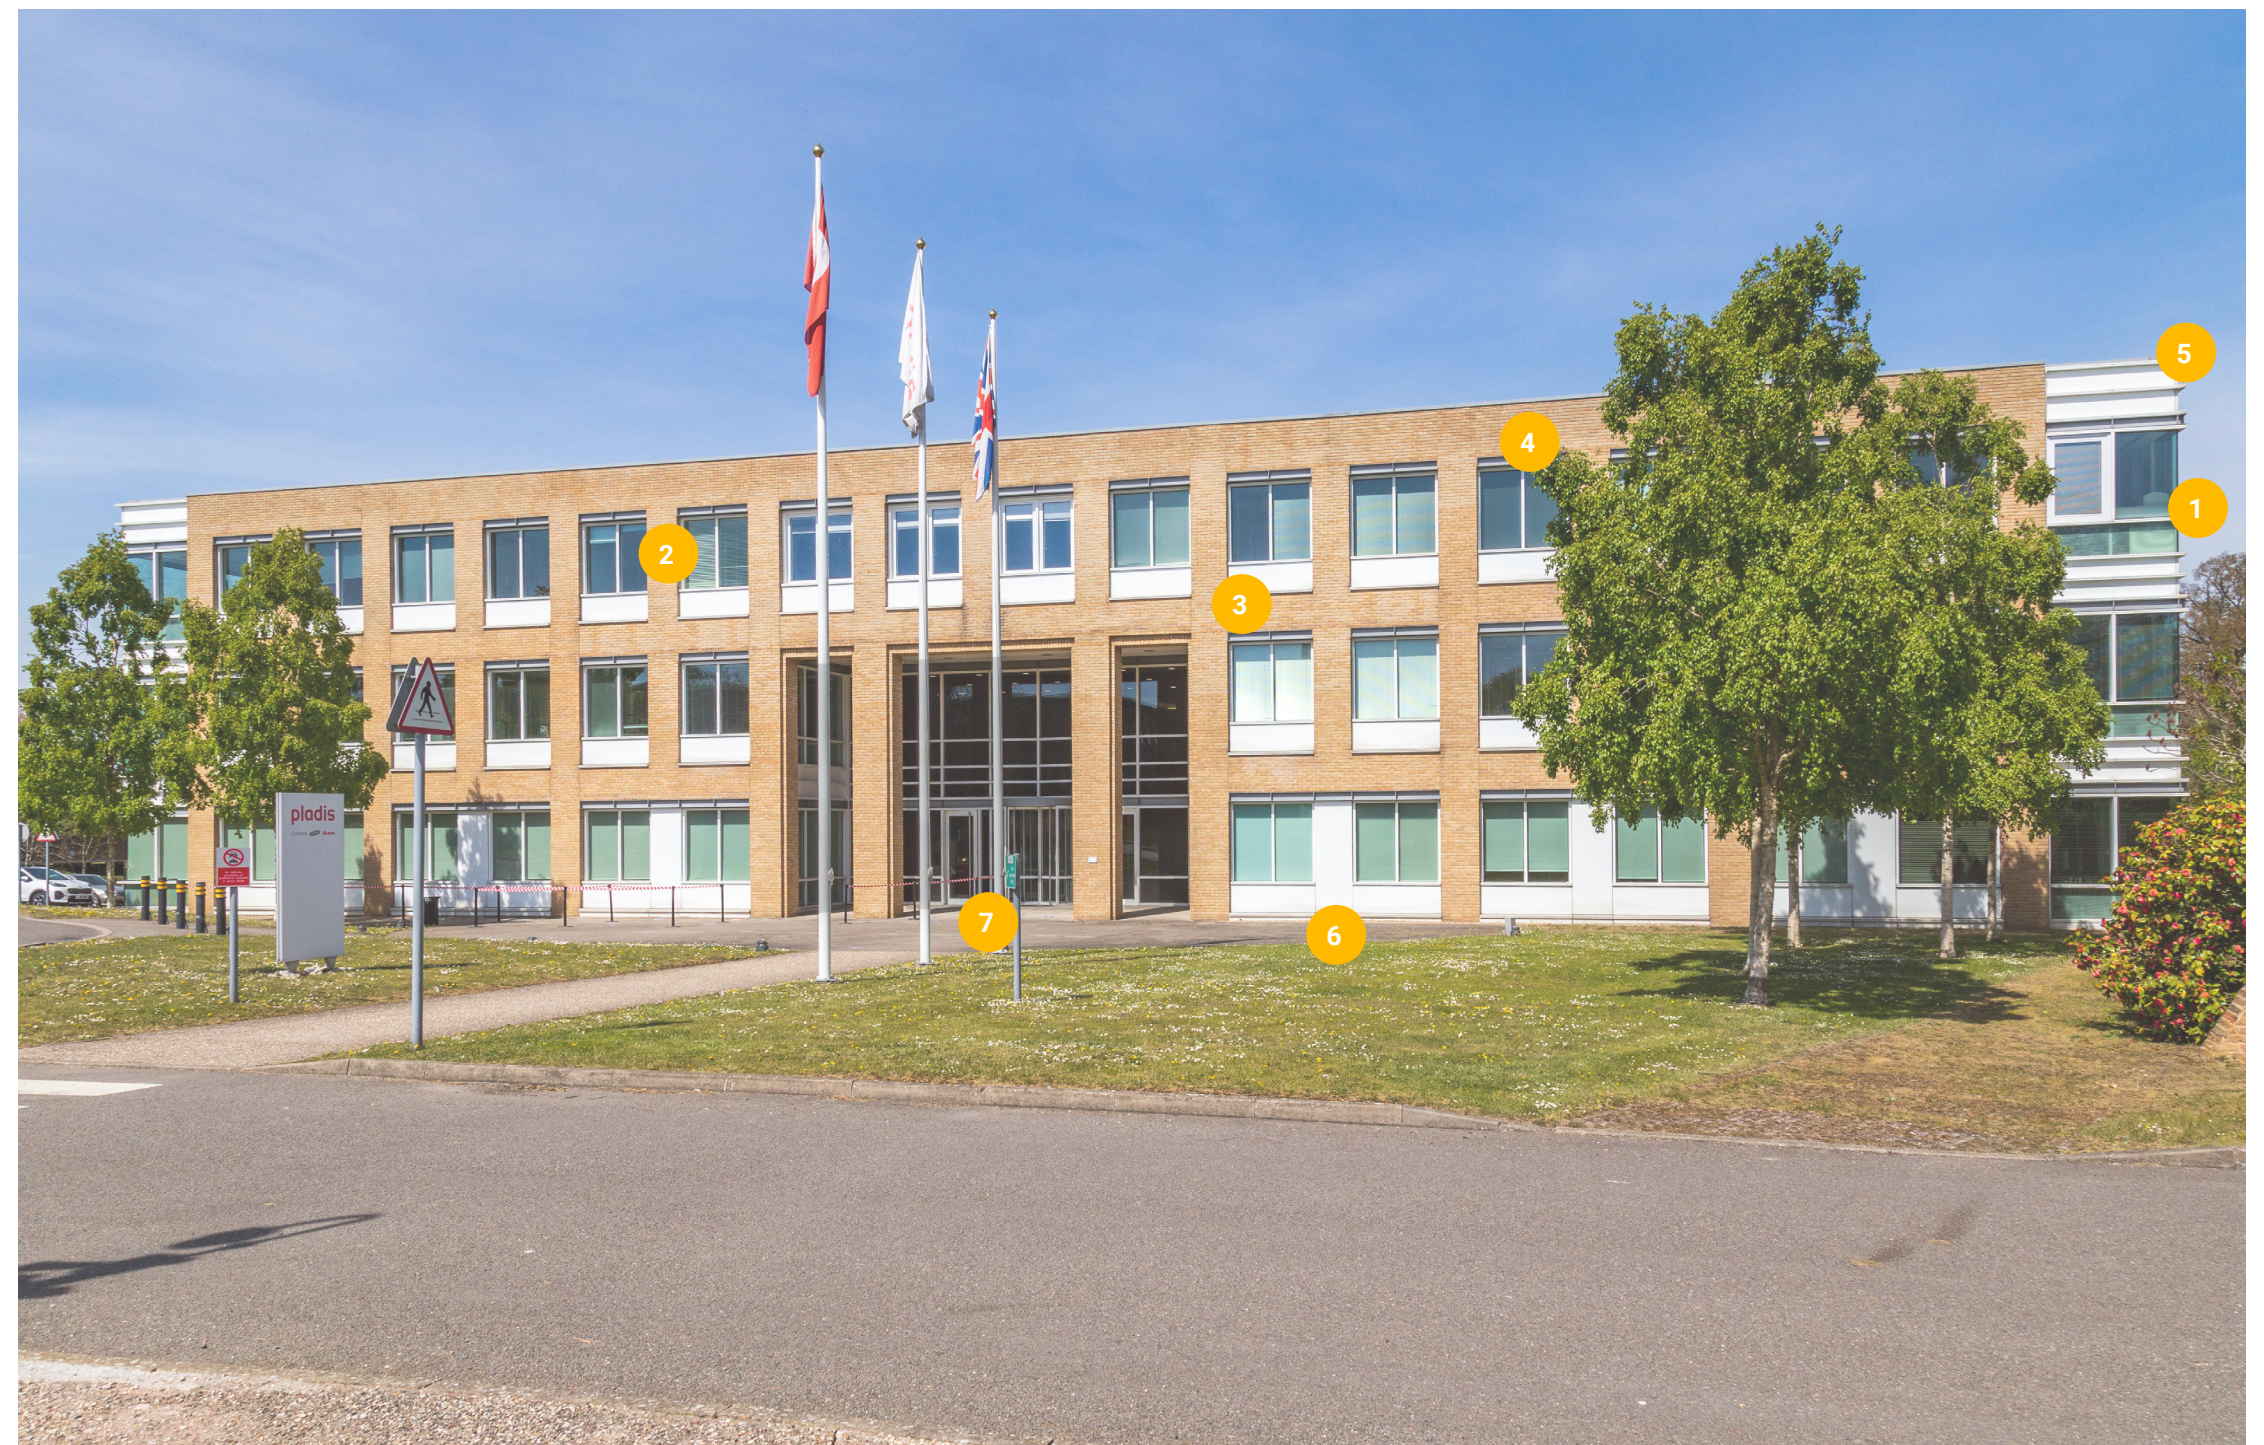
Hayes Park North existing facade

Overall the current facade feels tired and dated, and is more suitable for office use than residential dwellings.

The existing facade is suited to the previous use as an office, however some changes are required to make it appropriate for residential dwellings.

1. Corner glazing.

2. Window format.

Update fenestration to allow residential use, including safe opening of windows and Juliet balconies to living rooms.

3. Base panel material.

4. Lintel material.

5. Corner panel material.

6. Ground floor piers.

7. Review of recessed entrance.
