Reeves Arboricultural Services

Arboricultural Survey, Impact Assessment and Method statement

130 Field End Road,
HA5 1RJ

File Ref: ASIAMS202.1

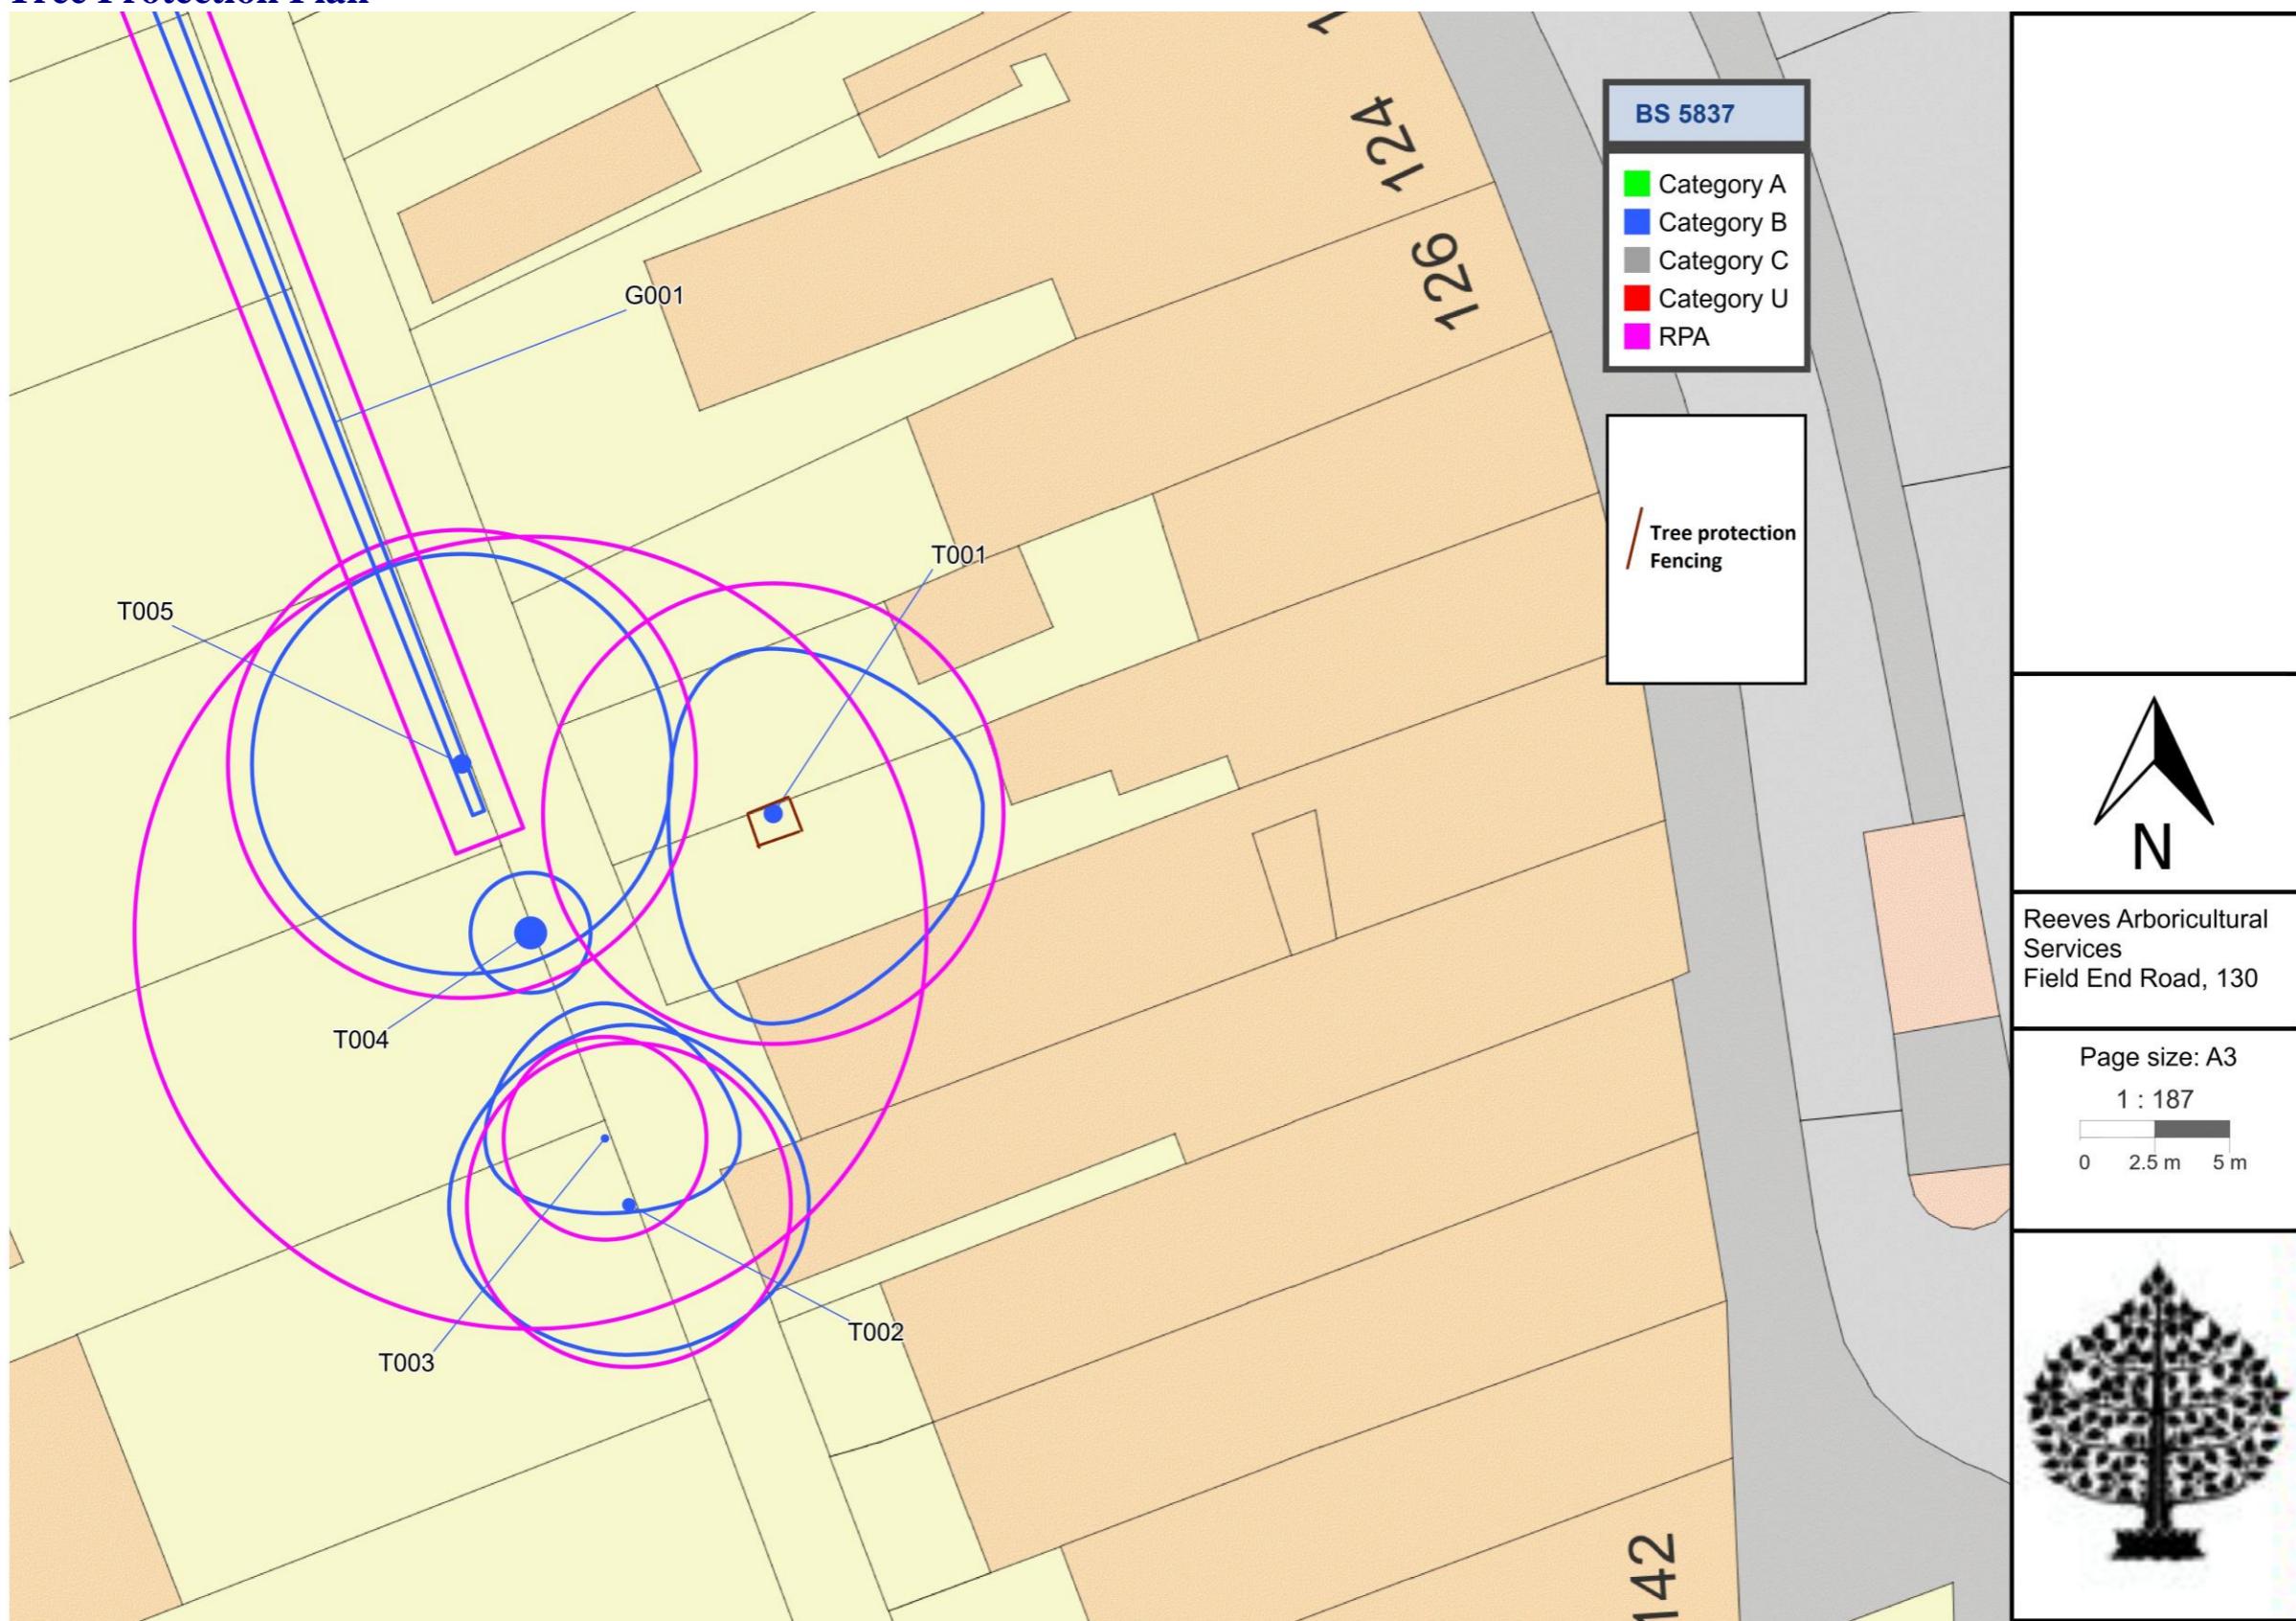
Tree protection plan- ASIAM202- M03

4.4.2.1 There is some risk of root disturbance to retained trees caused by demolition, excavation and construction. These risks will be controlled through several measures including: demolition methodology, ground protection measures, tree protection fencing and specific foundation support.

4.4.2.2 Part of the construction of the proposed extension is within the RPA of a T001 (Sycamore) therefore, traditional strip foundations are not suitable in this area. It is proposed that the section of the extension that is within the RPA of T001 is constructed with a reinforced concrete slab cast above existing ground level and this section of the supported by strip foundations outside of the RPA and a cantilevered steel frame. The soil will be protected from concrete leaching. Further detail and protection measures are provided in the arboricultural method statement.

4.4.2.3 A small enclosure, housing a water booster and heater is proposed within the RPA of T001. This will be supported by existing hardstanding if suitable, or with an anti-compaction cellular confinement system, such as Cellweb ®TRP and therefore no impact is expected.

5.3.2.4 The risk of damage in construction of the proposed extension will be controlled by the foundation design and building method. It is proposed that the section of the extension that is within the RPA of T001 is constructed with a reinforced concrete slab, cast above existing ground level and this section is supported by strip foundations outside of the RPA and a cantilevered steel frame.

5.6.2 As most of the land of 130 Field End Road where the development is taking place contains RPAs it is not practicable to install tree protection fencing to protect the RPAs. Instead, it is deemed suitable to install fencing around the trunk of T001. This will prevent storage and other activity within unprotected ground, protect the trunk from contact damage and act as a visual reminder of the consideration and protection of all trees in and around the site. Tree protection signage must be attached on each side of this fencing. An example of suitable signage is provided in *Fig. 4* in the appendix.

5.8.1 The low canopy of T001 will need to be lifted to prevent damage and access requirements of the development. It is considered that lifting the canopy to 4.5m above ground level will be sufficient, however if greater ground clearance is required the AC should be contacted so this can be assessed and alternative pruning planned.
