**Ashby Farm
Bat Survey Report
Holland and Holland
06 March 2026**

Project information
File reference	DWE 0975
Document title	Ashby Farm Bat Report
Client	Holland and Holland
Date	06 March 2026
Status	Issued
Survey by	Andrew Latham ACIEEM and David Kent MCIEEM
Prepared by	Andrew Lathan ACIEEM and Roisin Jones ACIEEM
Reviewed by	Diane Davidson-Watts MCIEEM

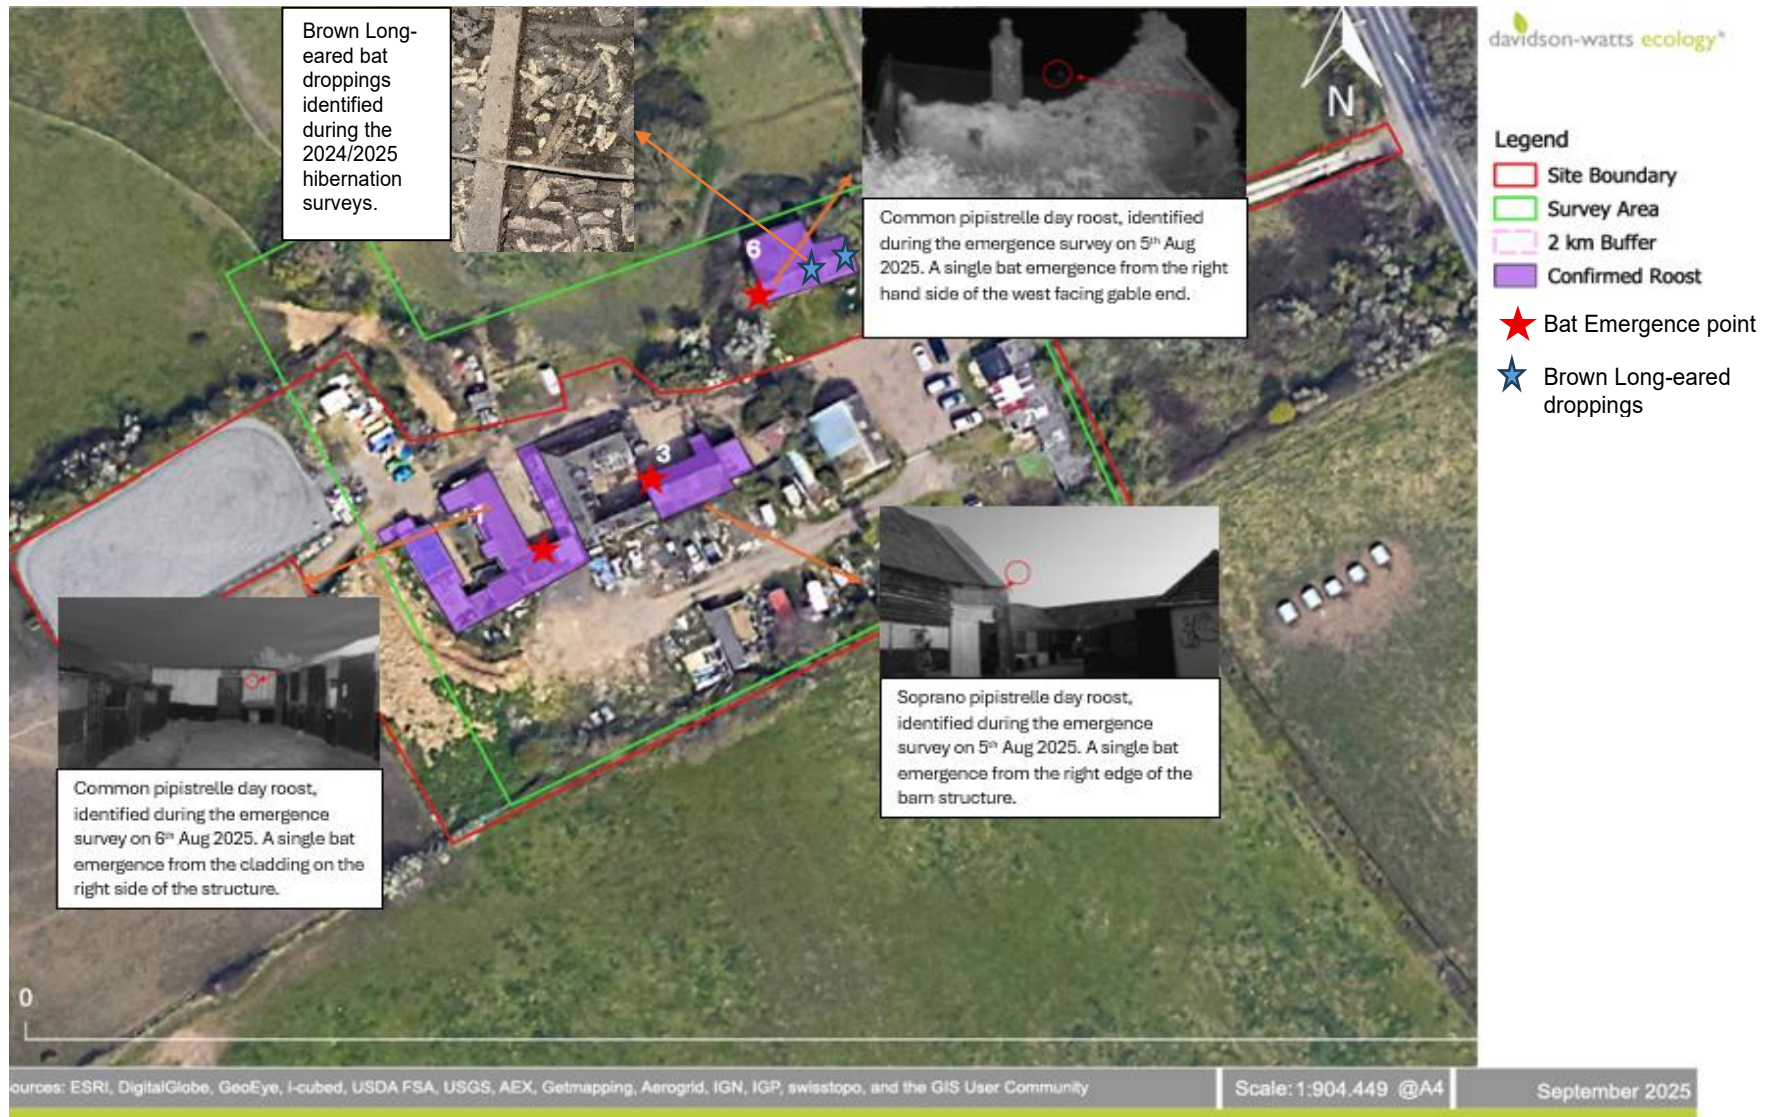
Figure 5 Emergence Survey Results

- On the 5th August a single common pipistrelle was observed emerging from the south west corner of Building 6 (Table 5, Figure 5).
- During the 5th August survey on Building 3, a single soprano pipistrelle was also observed emerging from the east aspect of Building 3 (Table 5, Figure 5)

- On the 6th August, a single common pipistrelle bat was observed emerging from the north facing aspect of the southern section of Building 1 (Table 5, Figure 5).

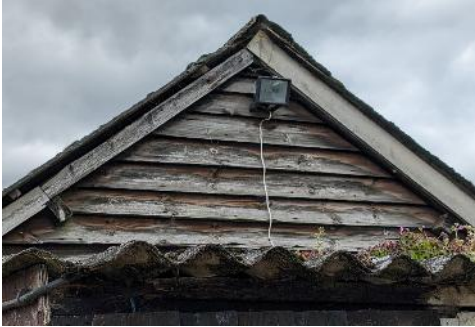
<p>7</p>	<p>2</p>

External PRFs for Building 2 are focused on gaps likely to be present on the northeastern gable end, at the joins between the timber panelling, barge board and purlins [Plate 7]. At the lower elevation, the external timber panels appear to be typically tight and in solid condition. All accessible sections of Building 2 present clear access into the various interiors through the open stable entry voids and open entranceways. Both outbuildings, although closed and/or locked have lateral gaps above the doorframe and small gaps at the join of ply sheets [Plate 8]. The northeastern gable end outbuilding has a small window open that was left open at the time of survey [Plate 9].

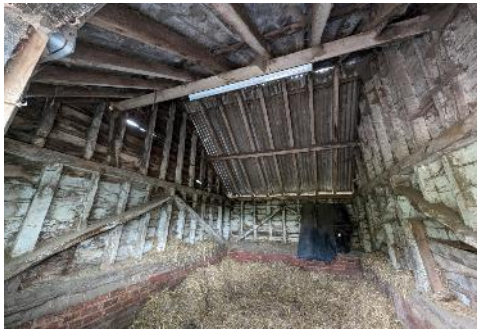
10	2

Internal PRFs within Building 2 are present for both void and crevice-dwelling bat species due to the steeper pitch of the roof, which presents both a larger volume of timber to support it and a more open roof void within [Plate 10]. The internal timbers present are modern and directly adjoin the sheet roof panels with no roof decking, whilst a considerable amount of detritus/cobwebs are present lining the walls. The western part of the stable blocks is noted to be slightly lighter due to the presence of the skylights, whilst those north-facing stable blocks are anticipated to be darker and have minimal daylight spill notable from inside. Both outbuildings are very cluttered internally and appear to have little suitable roosting substrate as PRFs within.

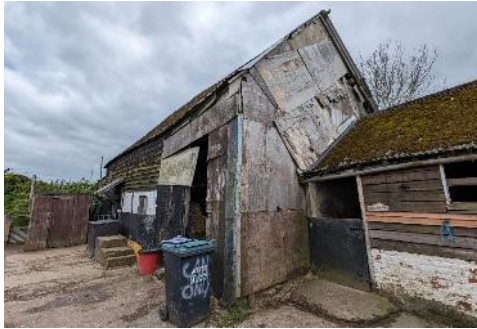
11	3

measuring approximately 12x7x10m: this appears likely to be the oldest of the structures within the survey area [Plate 11]. This large barn has its original timber structure still present, with hand-cut timber used for the joists, collars, struts, purlins and rafters, with woodworm and wet rot evident [Plate 12]. The building has lost its original roof and been replaced with a mixture of corrugated cement and metal sheet roofing, which is steeply pitched. The external walls are comprised of timber panelling of various ages, in places covered over with plywood sheets [Plate 13]. The barn has a tall open-fronted access on its northern aspect and has had a mezzanine floor added, used for additional storage of materials. The overall condition of the structure appears to be poor, with a lean notable from the exterior.

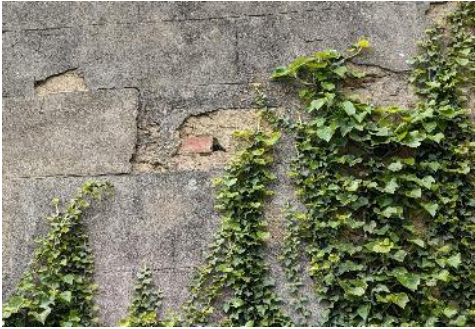
26	6

Areas of render have crumbled on parts of the building's exterior, revealing small areas of brick and mortar that have further degraded over time to leave small PRFs [Plate 26]. The removal or collapse of the door lintel on the eastern aspect has also left two access points into the interior [Plate 27].

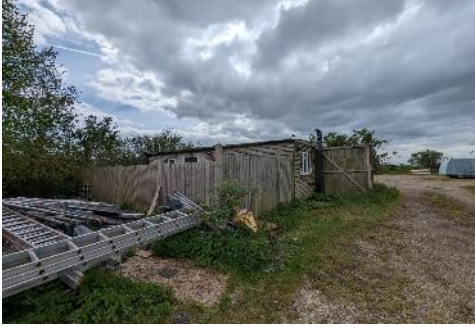
33	11

This is a single-storey cabin-type structure to the south of the survey area, also relatively recently constructed. This building is entirely wood-panelled, with modern uPvc windows and a flat felt roof [Plate 33]. The building has an aerial on the roof, indicating domestic use and has an exterior fence that restricted clear view during the survey beyond the northern aspect. There is security lighting present visible on the northern and eastern aspects. Due to its condition and likely regular use, it is considered unlikely to offer bat PRFs.
