Landmark Trees

ARBORICULTURAL IMPACT ASSESSMENT REPORT:

Proposed Lidl Store
Former Hayes Swimming Pool Site
Botwell Lane
Hayes
Middlesex

Ref: LUK/BLH/AIA/01d

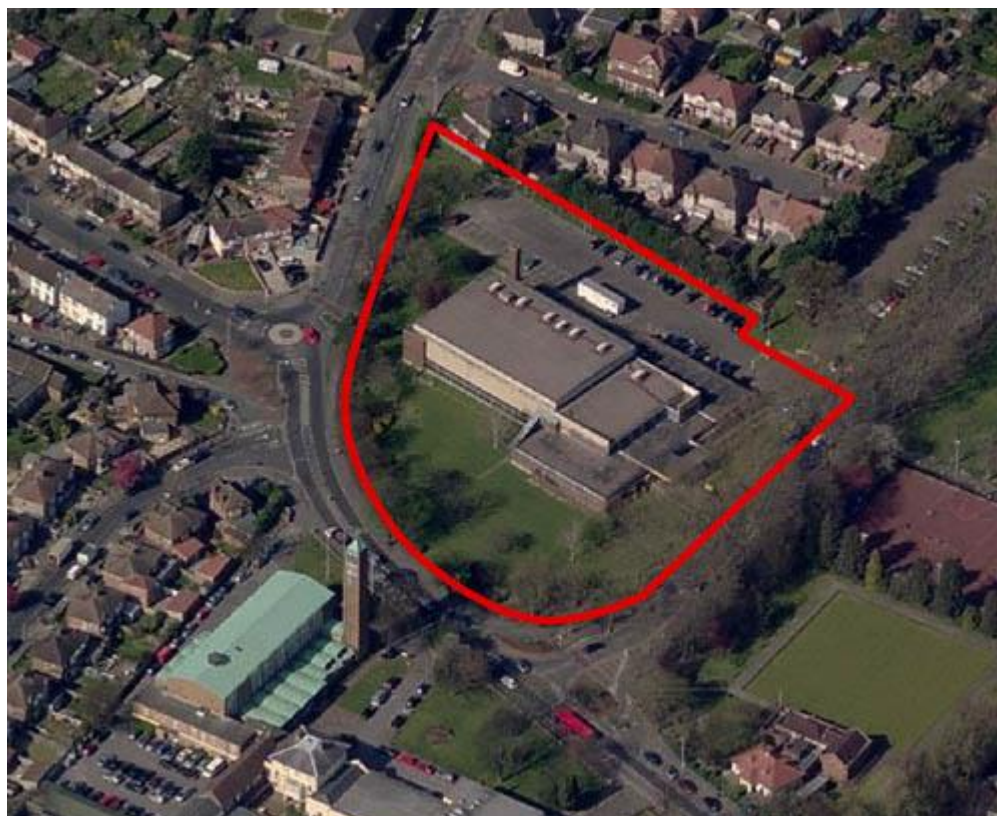
Photograph 1: Former Hayes Swimming Pool Site, Botwell Lane, Hayes, Middlesex
