Landmark Trees

### ARBORICULTURAL IMPACT ASSESSMENT REPORT:

Proposed Lidl Store  
Former Hayes Swimming Pool Site  
Botwell Lane  
Hayes  
Middlesex

**Ref:** LUK/BLH/AIA/03a

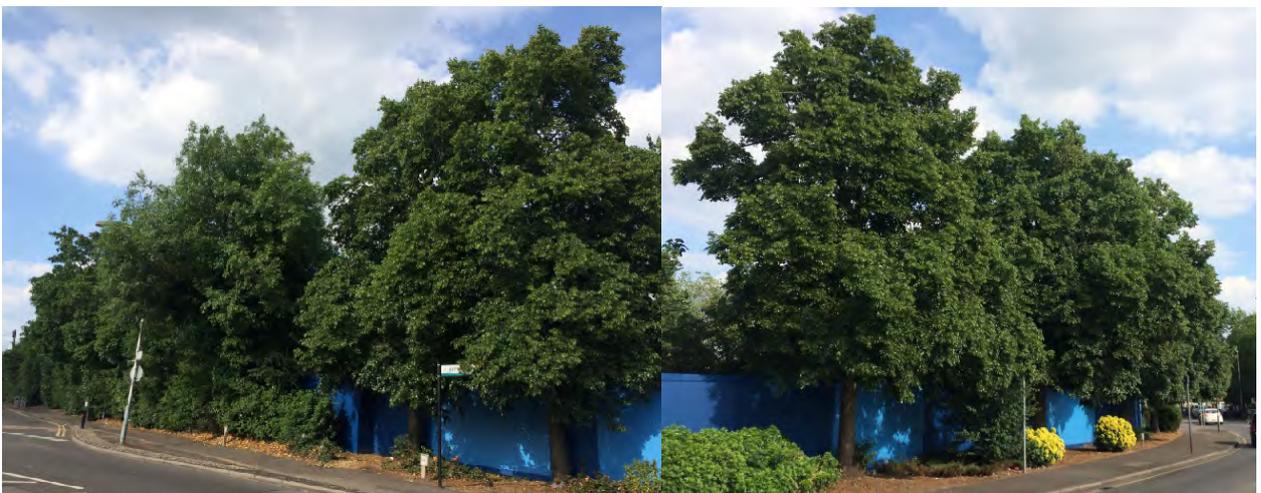
Photographs 2 and 3: London Plane trees along Central Avenue by Botwell Lane Junction

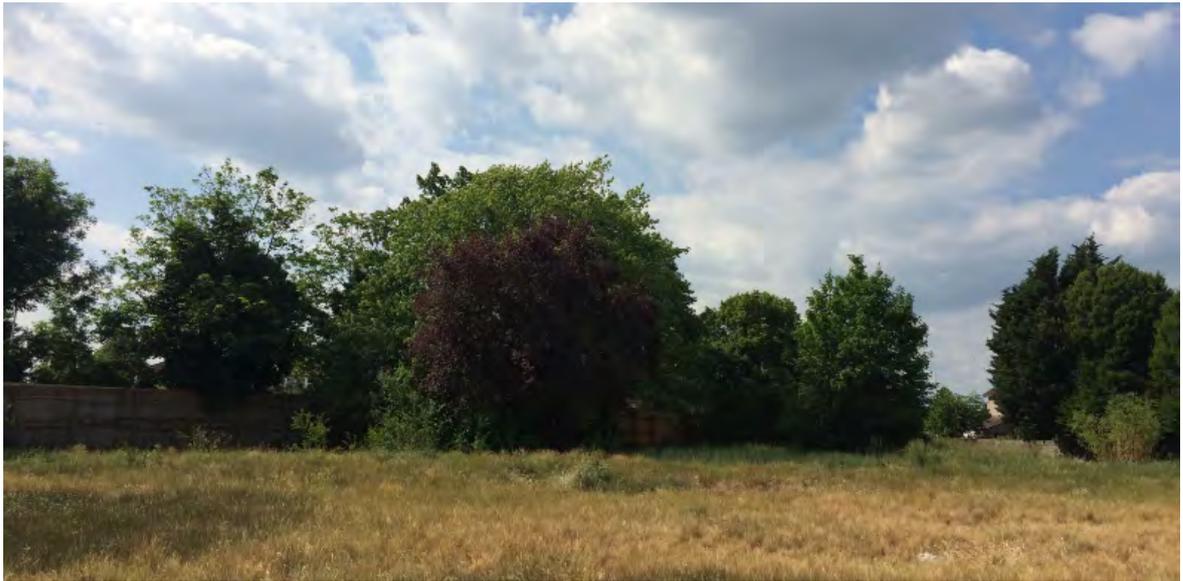
Photograph 4: Trees T38 – 49 looking northwards

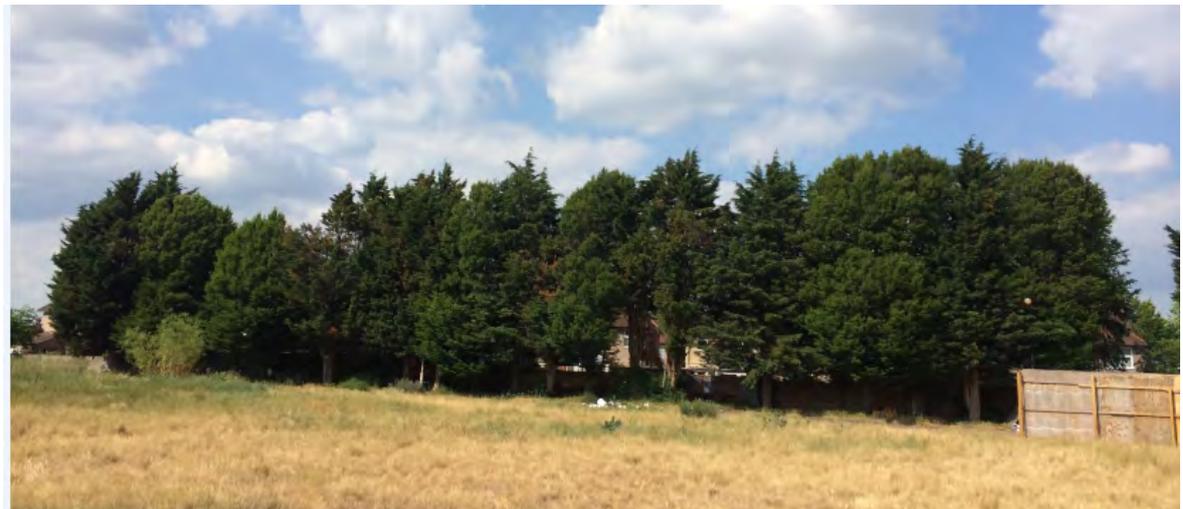
Photograph 5: Row of Trees T48 – T63

- 1.6 The new and replacement hard surfaces for the parking areas will require no-dig construction techniques, either using cellular confinement systems or, in some areas such as the line of trees T48 – T61, the existing sub-base. All existing hard surfacing should be removed with care, using an air spade or manually.

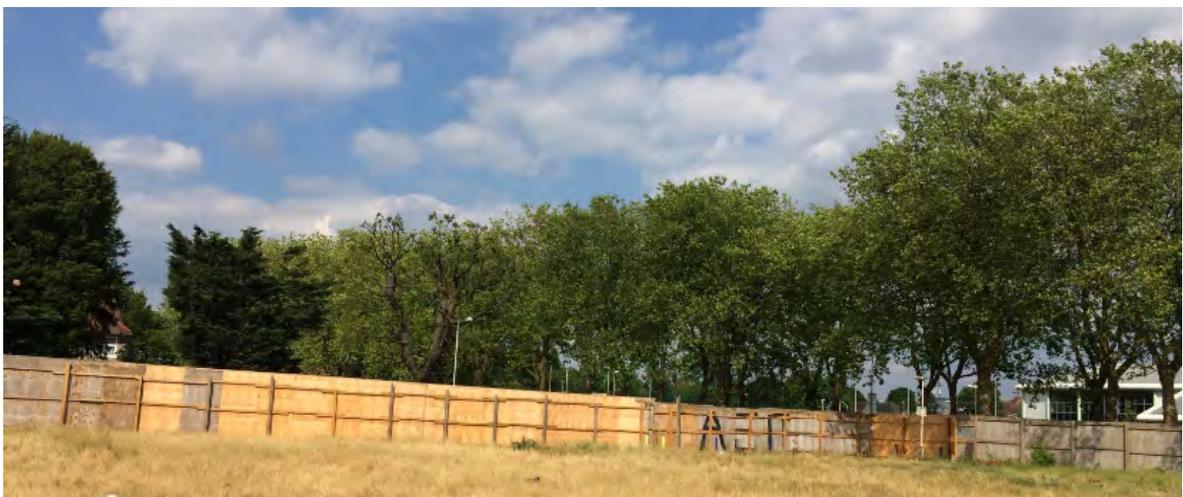
Photograph 6: Row of London Plane along north eastern Central Avenue
