**Arboricultural Implications  
Assessment  
for a proposed development  
at  
Downside  
Kewferry Drive  
Northwood  
HA6 2NU  
Rev A**

**Client: Sujeewan Sugumar  
Flat 3 Tamarind House  
653-659 Uxbridge Road  
Pinner  
HA5 3LW**

**Date**  
05/01/2025

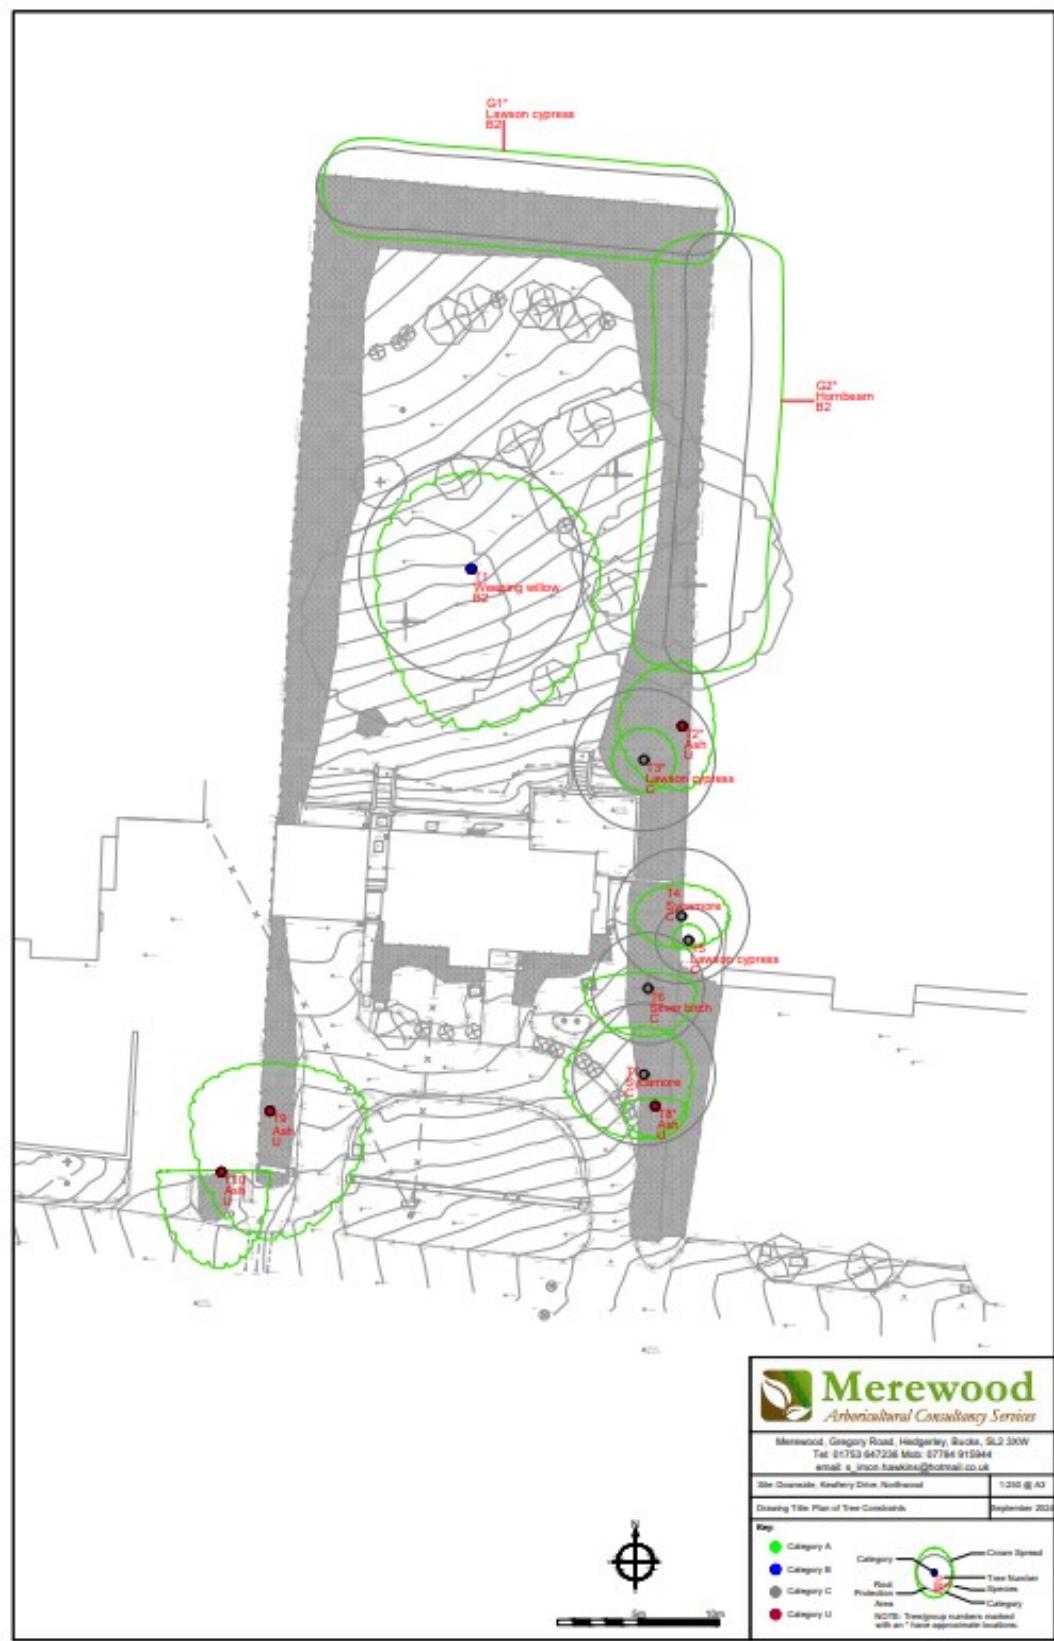
### Plan of Tree Constraints

Tree no	Species	Height	Stem diameter	Crown spread				Physiological condition	Structural condition	Age	Observations/ Management recommendations	Life expectancy	Category
				North	South	East	West						
T1	Weeping willow	15	580	6	10	8	6	F	F	M	Tree shows lowered vitality. Moderate volume of deadwood present in crown	20 - 40	B2
T2	Ash	17	450	4	4	2	4	F	F	M	Early signs of Chalara die back of ash	<10	U
T3	Lawson cypress	15	250 270	2	2	2	2	G	G	M		40+	C
T4	Sycamore	17	350	2	2	3	3	G	P	M	Twin stemmed tree with a tightly forked stem (weak structure)	20 - 40	C
T5	Lawson cypress	13	170	1	0.5	1	1	P	F	M		10 - 20	C
T6	Silver birch	17	290	1	3	3	4	F	G	M		20 - 40	C
T7	Sycamore	17	260 260	3	4	3	5	G	F	M	Twin stemmed tree with a tightly forked stem (weak structure)	20 - 40	C
T8	Ash	15	150 150	0.5	2	2	2	P	F	M/A	Affected by Chalara die back of ash	<10	U
T9	Ash	19	700	3	8	6	5	P	F	M	Affected by Chalara die back of ash	<10	U
T10	Ash	17	360	0	6	3	4	P	F	M	Affected by Chalara die back of ash	<10	U

G1	Lawson cypress	12	200	3	3	2	2	G	G	M	Hedge not formally managed	40+	B2
G2	Hornbeam	10	170	2	2	4	4	G	G	M	Hedge not formally managed	40+	B2

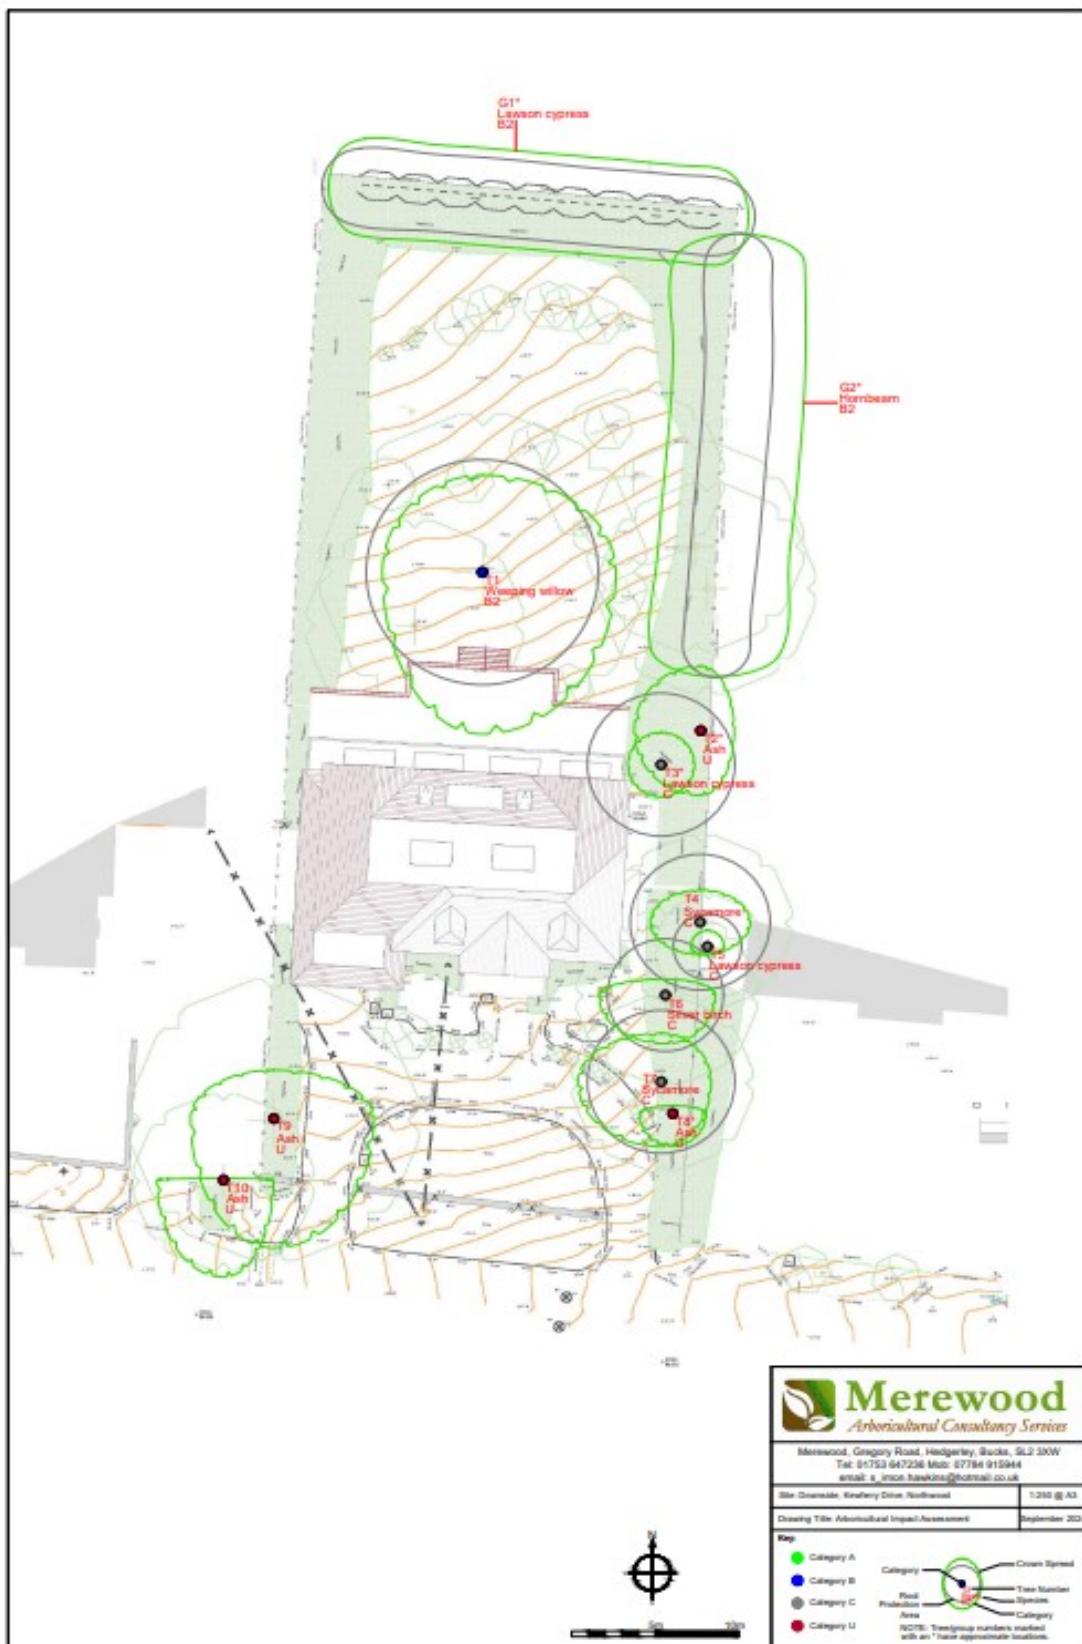
### Impact Assessment Plan

3.6.1 The excavation of the proposed foundations for the new extensions are to take place outside the RPA's of the retained trees and will not affect any trees. There is a small encroachment onto the RPA of the willow (T1) created by the widening of the patio.

3.6.2 The extent of this encroachment amounts to 9.7m<sup>2</sup> out of a total RPA of 152m<sup>2</sup>, or 6.3%. It is considered that such a small encroachment is acceptable in this instance, as the roots of this tree are uninhibited in their growth in all other directions, so that the minimum volume of soil required to sustain the tree in normal health is not only maintained but also exceeded.
