**Arboricultural Implications  
Assessment  
for a proposed development  
at  
Downside  
Kewferry Drive  
Northwood  
HA6 2NU**

**Client: Sujeevan Sugumar  
Flat 3 Tamarind House  
653-659 Uxbridge Road  
Pinner  
HA5 3LW**

**Date**  
30/09/2024

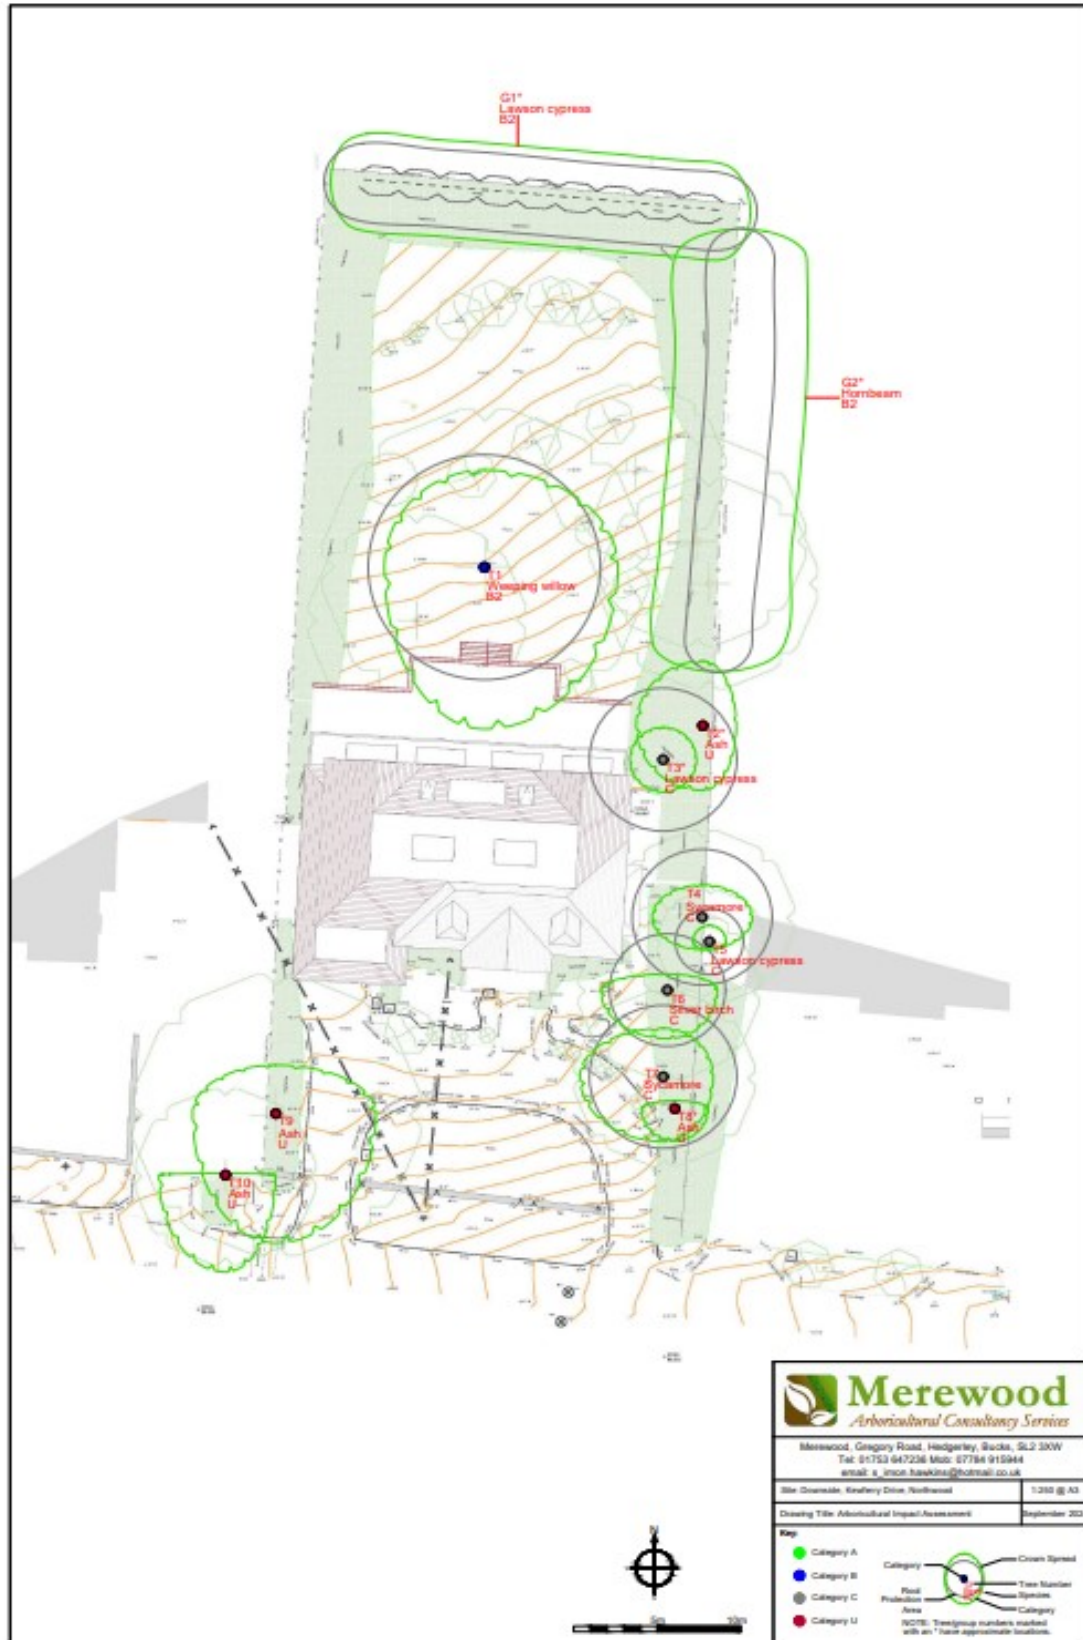
### Impact Assessment Plan

- 3.6.1 The excavation of the proposed foundations for the new extensions are to take place outside the RPA's of the retained trees, other than a small excavation at the rear that extends into the RPA of the willow (T1).
- 3.6.2 The extent of this encroachment amounts to 9.7m<sup>2</sup> out of a total RPA of 152m<sup>2</sup>, or 6.3%. It is felt that such a small encroachment is acceptable in this instance, as the roots of this tree are uninhibited in their growth in all other directions, so that the minimum volume of soil required to sustain the tree in normal health is not only maintained, but also exceeded.
- 3.6.3 The excavation of service trenches is another site activity that can cause harm to root systems. However, in this instance, the existing infrastructure is to be connected to the new extensions within the building and away from any RPA's, thereby avoiding any issues.
