ARBORICULTURAL REPORT

**99 Denecroft Crescent
Hillingdon
UB10 9HZ**

Produced for: Golzari NG Architects

Date: 28-10-23

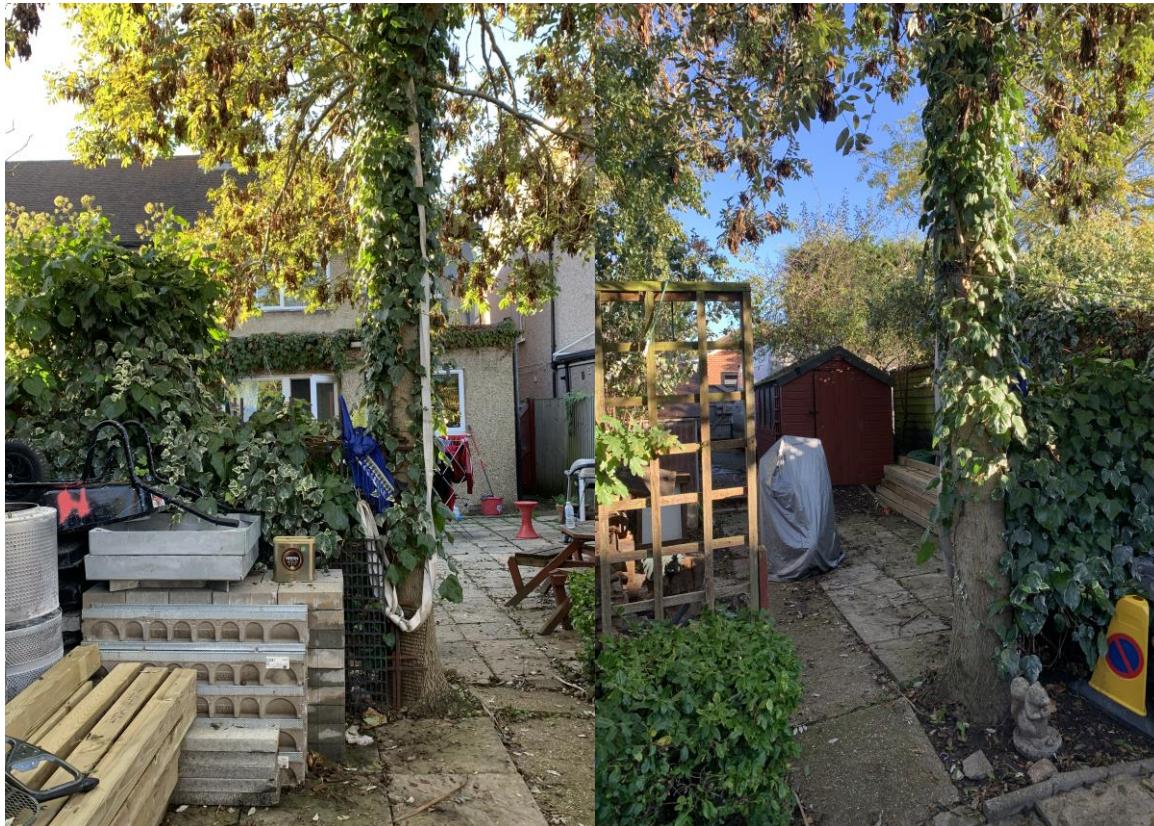
IMAGES OF T1.

4.1. There are two mature Ash trees in the backyard (T1 & T2) the yard is completely paved over.

8.1. Fencing will be installed to protect T1 before any works commence; the fencing will be constructed in accordance with BS 5837: 2012 (*Appendix 1.*) The area enclosed by the fencing will be considered a complete exclusion zone; there will be no vehicles, equipment or machinery within the fenced off area. Under no circumstances will any materials be stored within the fenced off area, and no cement, diesel or oil stored near to it.

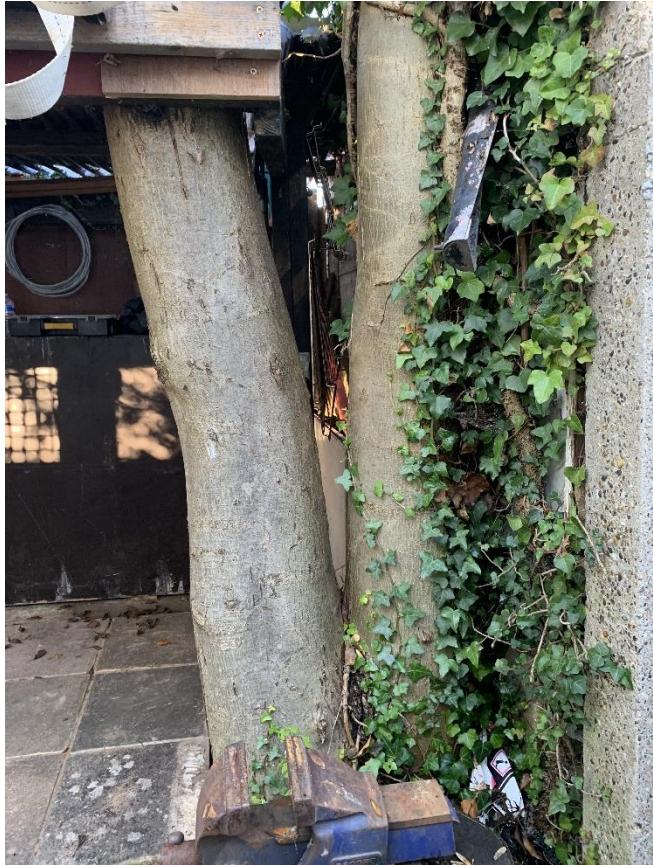
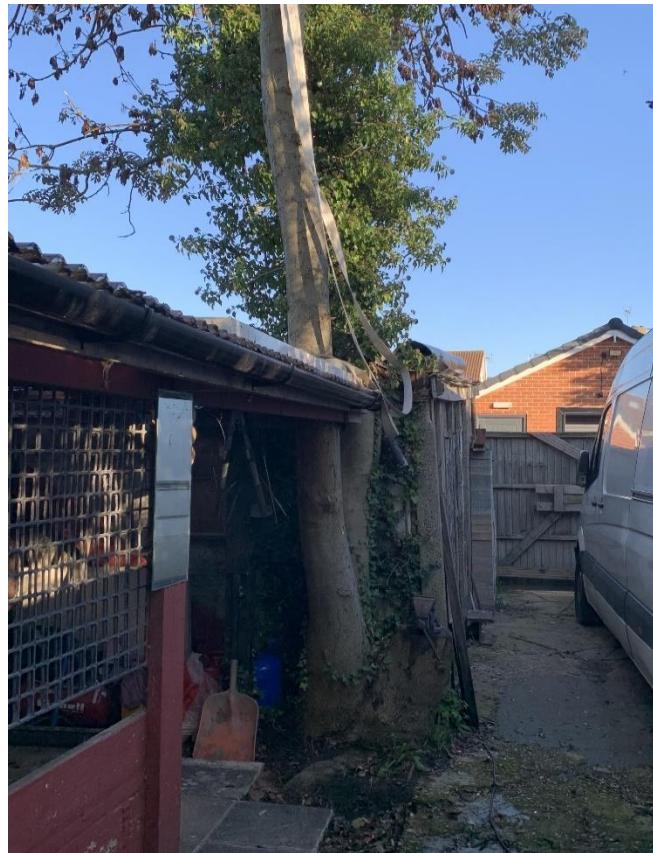
IMAGES OF T2.

4.2. T2 is growing against the wall of the existing garage and will cause structural damage if not removed.

Tree No.	Species	Height m	Stem Diameter mm	Branch Spread m	Height Above Ground Level m	Age Class	Observations	Structural condition	Preliminary Management Recommendations	Estimated Remaining Contribution (years)	Category Grading U,A,B,C 1,2,3
T1	Common Ash <i>Fraxinus excelsior</i>	17	260	N 3 E 3 S 3 W 3	Canopy 3 Fsb 3 Direction S	Mature	Minor dieback	Fair	Monitor	10+	B1
T2	Common Ash	18	270 260	N 3 E 3 S 3 W 3	Canopy 2 Fsb 3 Direction S	Mature	Growing against the garage	Poor	Fell	-10	U

4.3. I recommend that T2 is felled and a replacement tree is planted, I suggest a smaller species that will be more suited to a cramped suburban space; a pollinator species such as an ornamental Cherry would be a good choice.

6.1. The loss of T2 should be mitigated by planting a new tree in the yard after the works are completed.
