## Photos of the existing site – ventilation equipment

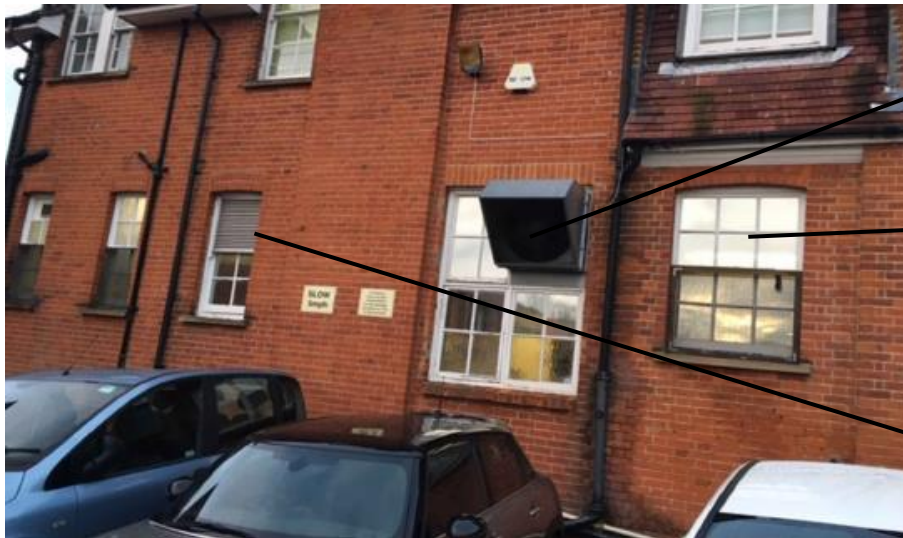
Photo of the southern elevation of the catering block

Existing extract fan to be removed and window reinstated

Location of proposed louvre on the top half of the sash window

Existing louvre to be replaced with new high performance louvre

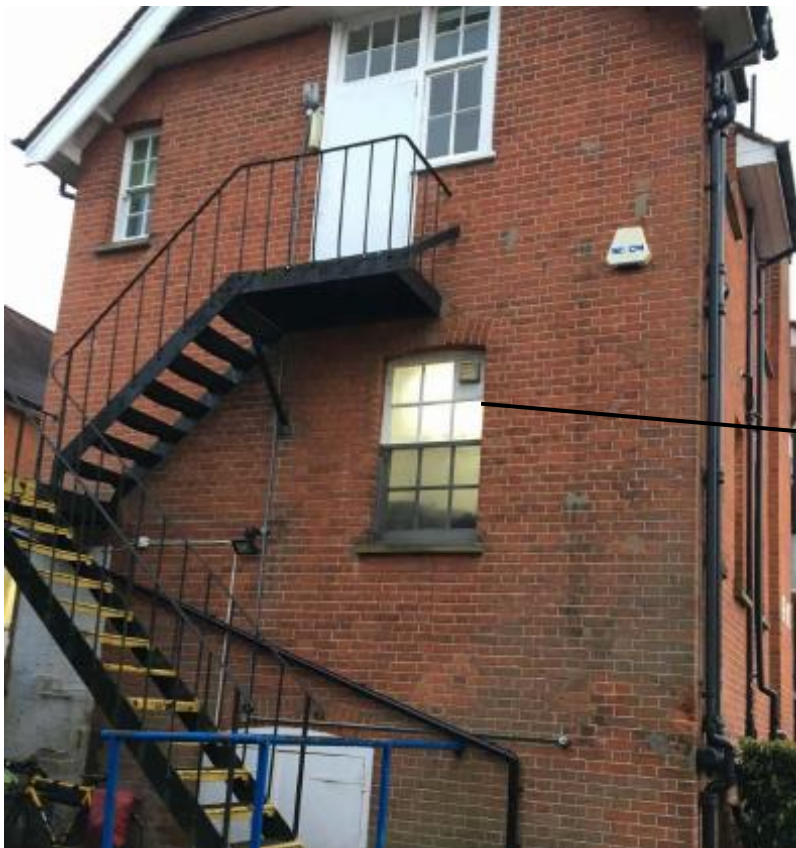
Photo of the western elevation of the catering block

Location of proposed ductwork on the upper half of the sash window.
