# BS5837 Arboricultural Impact Assessment & Method Statement

18 Harvil Road, Ickenham, Uxbridge, UB10 8AJ

Client: Multi Creation

July 2023

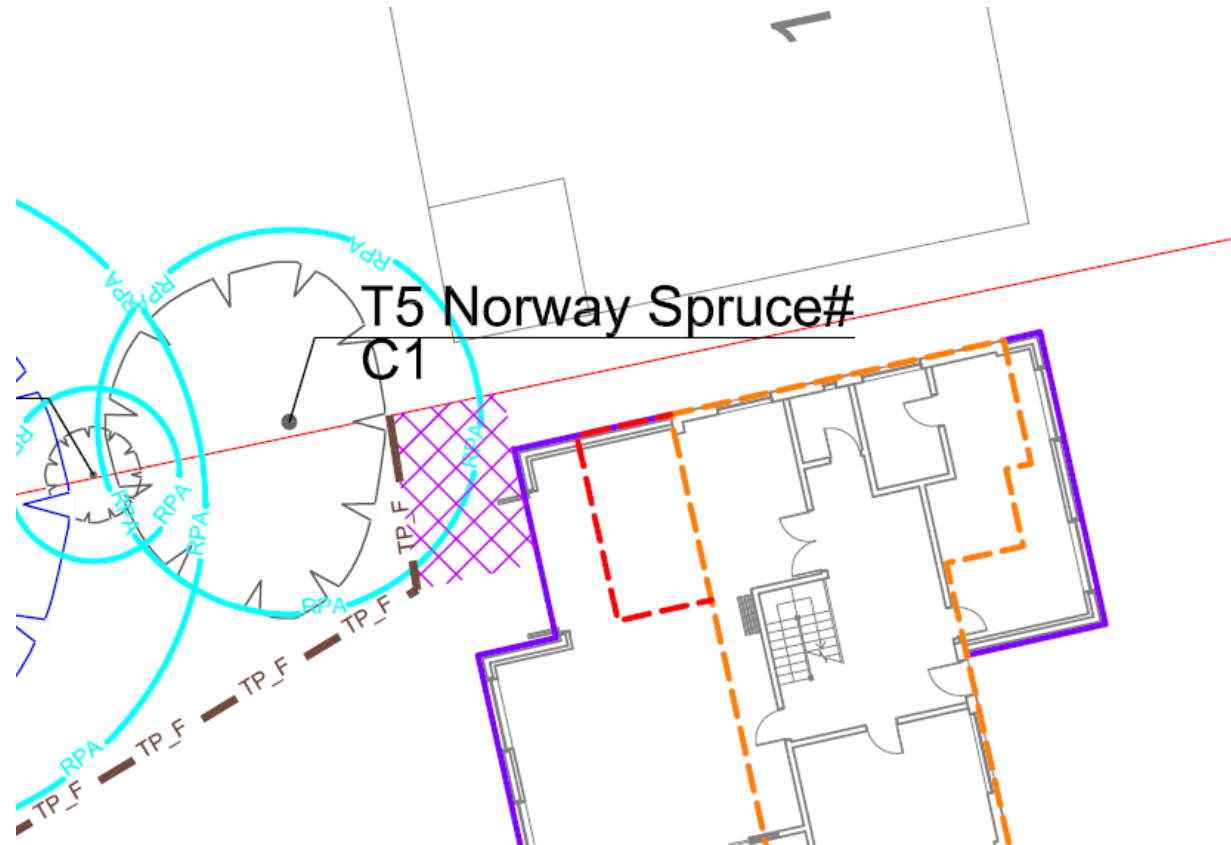
**Fig 8 – Temporary ground protection will be used to work around the proposal area (hatch) where it is close to T5.**

- 5.4.4 Temporary ground protection is required to allow safe movement around the proposal relative to T5. It should be installed prior to any site activity and maintained for the duration of the works.

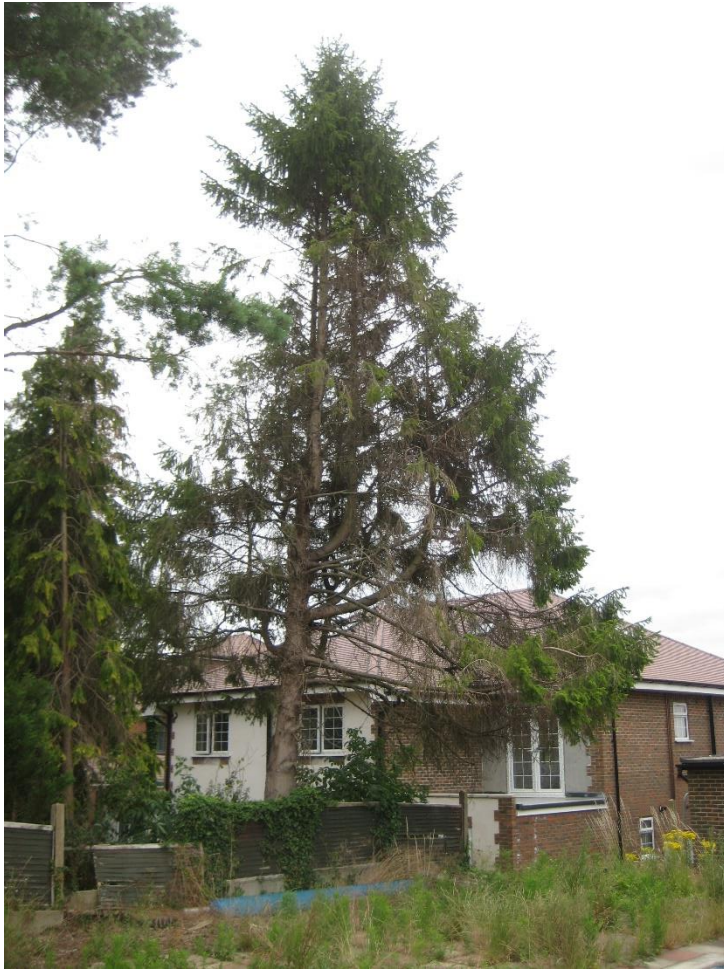
**Image 2 – T5 (Norway Spruce)**

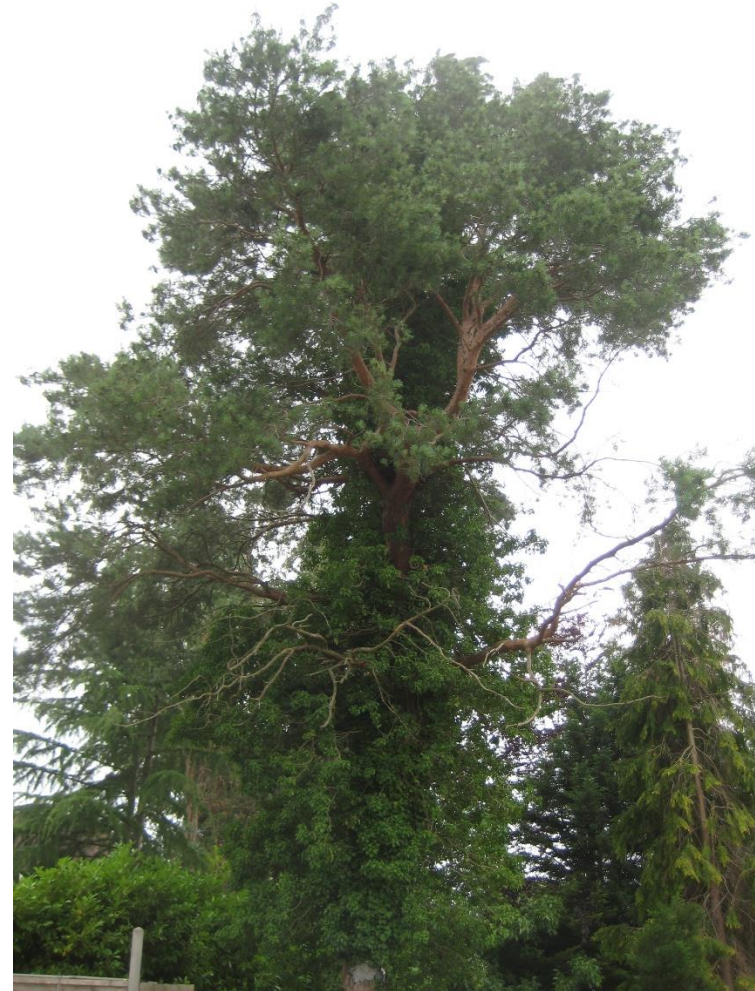
**Image 3 –T7 (Scots Pine)**
