# BS5837 Arboricultural Impact Assessment & Method Statement

18 Harvil Road, Ickenham, Uxbridge, UB10 8AJ

Job Reference: 04022Rv2

Planning Ref: 22534/APP/2023/2082

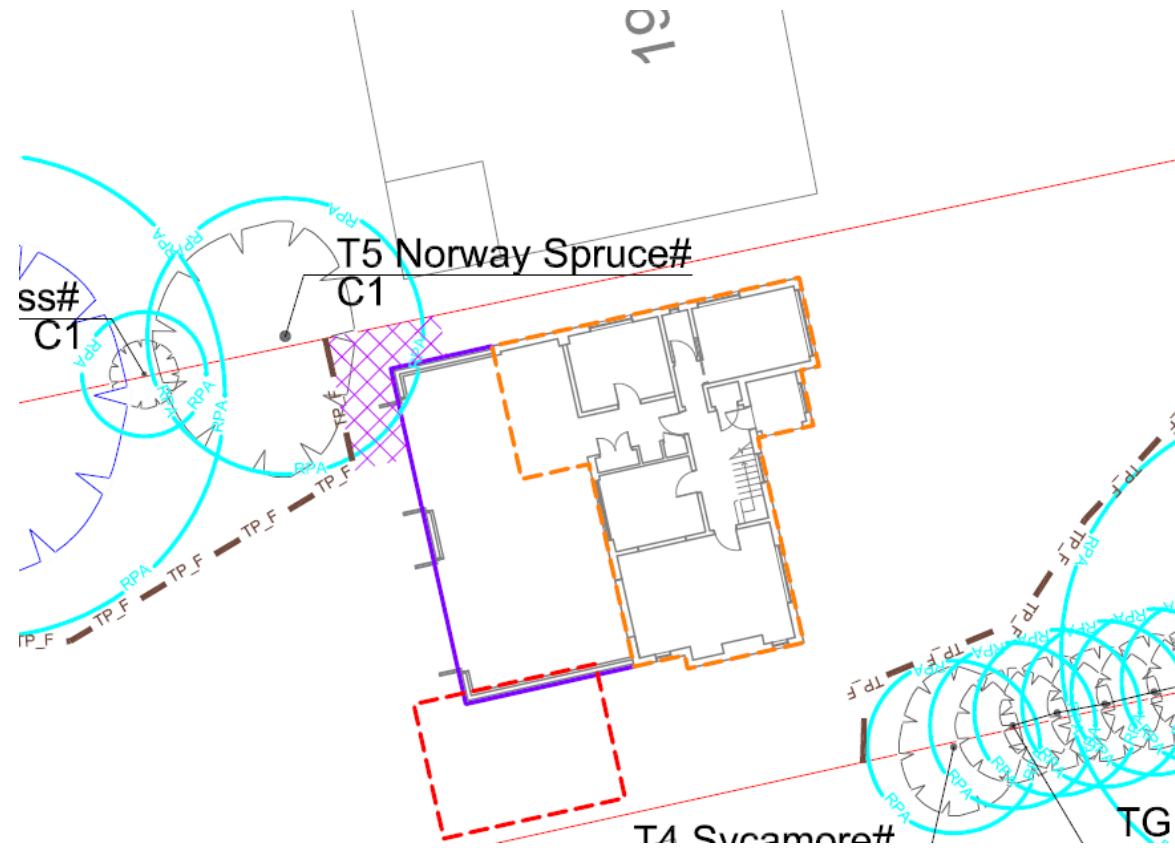
**Fig 8 – Temporary ground protection will be used to work around the proposal area (hatch) where it is close to T5.**

- 5.4.4 Temporary ground protection is required to allow safe movement around the proposal relative to T5. It should be installed prior to any site activity and maintained for the duration of the works.

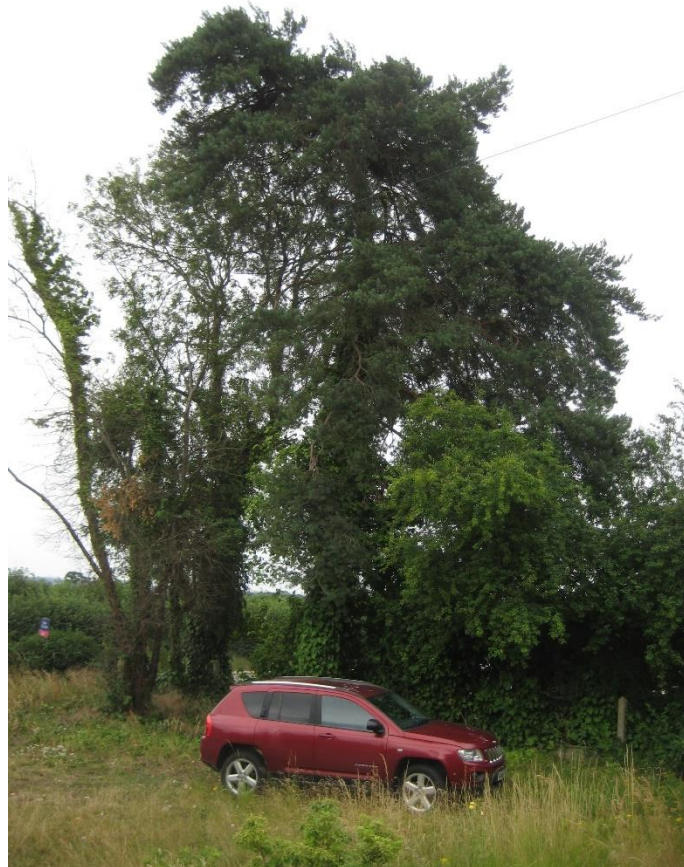
**Image 1** – Looking towards T1, T2 & T3

- 5.3.1 No trees will be removed to facilitate the works although removal of T1 (Sorbus) and T2 (Ash) is advised on the basis these are Cat U trees. T1 is nearly completely dead and T2 is showing signs of Ash Die Back.
- 5.3.2 Both T1 & T2 are likely included in the TPO that affects the site. As a result replacement trees will be required. To help maintain the character of the area and diversify the age class we would recommend 2 Scots Pine (*Pinus sylvestris*) trees to be located on the front boundary to maximise their long-term amenity impact. The local authority may decide to condition these (or another species of tree) as replacements.

| Tree No. | Species | DBH (m) | No of Stems | Ht (m) | Crown Spread | | | | BS Cat | Age Class | Life Expect | Cr Ht (m) | Observation | Recommendations | RPR (m) |
|---|---|---|---|---|---|---|---|---|---|---|---|---|---|---|---|
| T1 | Sorbus | 0.45 | M/S | 9.5 | 4.3 | 5.8 | 2.5 | 2 | U | Mature | <10 | 1.7 | Dead. | Remove & Replace | 0.45 |
| T2 | Ash | 0.7 | 1 | 11 | 4 | 5.8 | 5 | 3.6 | U | Mature | <10 | 2 | Ivy covered tree straddling boundary. Thinning canopy suggests early on set Ash Dieback. | Remove & Replace | 0.7 |

| Tree No. | Species | Proposed Tree Works | BS Cat |
|---|---|---|---|
| T1 | Sorbus | Remove & Replace | Cat U |
| T2 | Ash | Remove & Replace | Cat U |

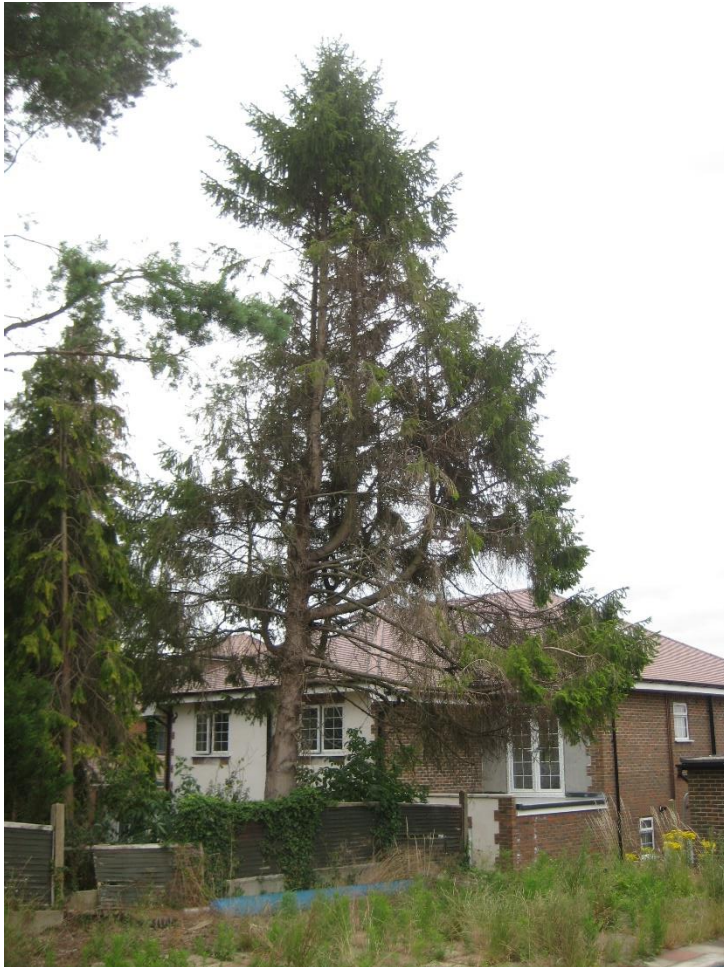
**Image 2 – T5 (Norway Spruce)**

- There is a very minor incursion into the RPA of T5.
- Minor risk to T4/ TG1 from any demolition and surface removal works. Mitigated by protective fencing being installed prior to the commencement of any site activity.
- **Note:** This level of risk is a visual guide only and is only relevant **if all advised tree protective measures are put in place prior to any on site activity and maintained for the duration of the works.**
- **Note:** Only on-site testing can confirm the local soil conditions below foundation level but available information suggests the presence of a GRAVEL overlying a CLAY.
