**BS5837 Arboricultural Report and
Arboricultural Impact Assessment**

OUR REFERENCE	AC.2025.903
CLIENT	Mr Faluck Patel
SITE	7 Thornhill Road, Ickenham, Uxbridge, Middlesex, UB10 8SF
REPORT BY	I S Thompson (known as Tom) M. Arbor. A., BSc. (Hons) Arb, MSc. eFor
DATE	3 rd December 2025
DATE OF SITE VISIT	12 th September 2025

7 Thornhill Road, Ickenham, Uxbridge, Middlesex, UB10 8SF

Front and rear extension to the existing detached residential dwelling.

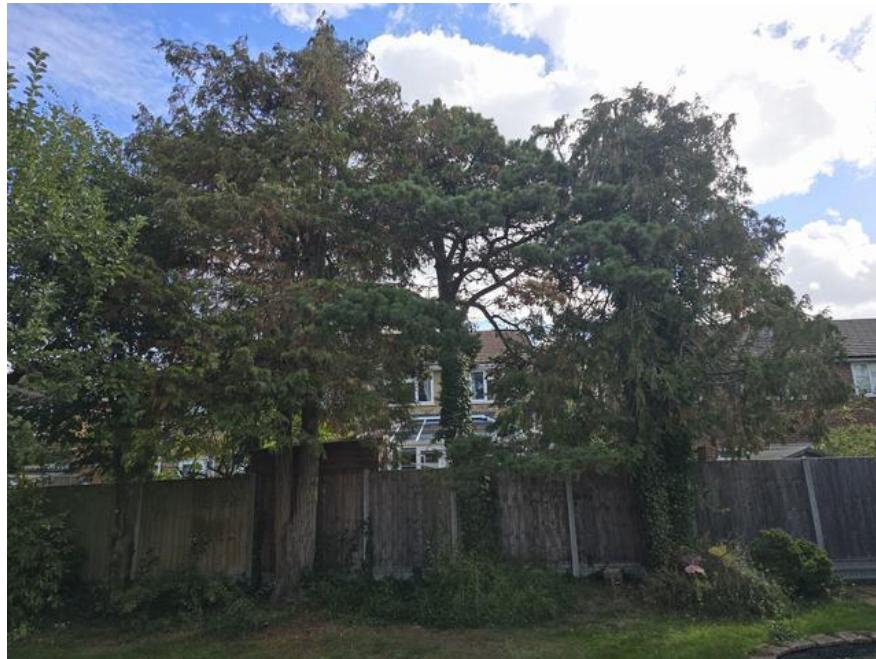
2.2.4 There were a total of seven trees surveyed. T01 to T04 were across the rear boundary, see Image 1 in Appendix III. T01 was a C1/2 category Lawson cypress. T02 was a B1/2 pine, T03, was a C1/2 Lawson cypress, and T04 was a small C1/2 plum tree, see Image 2. They extended across the rear boundary with mutual crown suppression.

Image 1 T01 to T04 across the rear boundary.

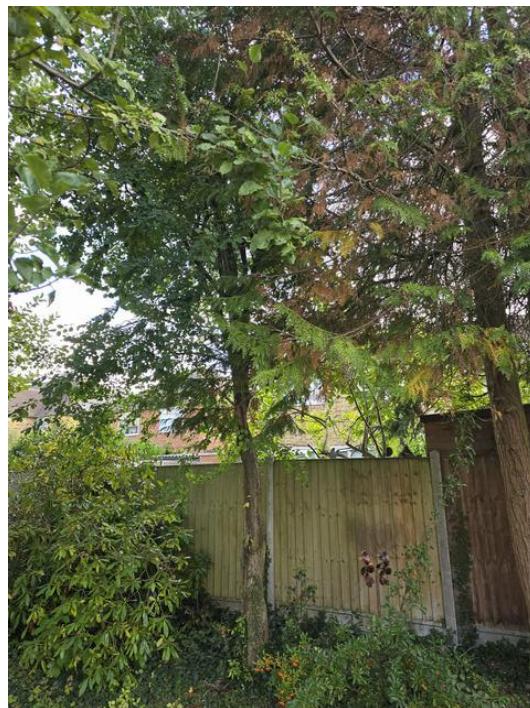
Image 2 T04 a small plum tree on the rear boundary.

Ref	Species	Measurements	Spread	General Observations	Retention Category	RPA	Recommendations	Condition	Reinspect
T04	Cherry plum (<i>Prunus cerasifera</i>)	Height (m): 7.5 2 stems (mm): 140, 90 Spread (m): 2N, 2E, 1S, 2W Crown Clearance (m): 2.5 Life Stage: Semi Mature Rem. Contrib.: 10+ Years	N:2 E:2 S:1 W:2	Twin stemmed from around 1 m. Strong U-shaped union. Mutual crown suppression.	C1,2	Radius: 2.0m. Area: 13 sq. m.	NAR Install temporary tree protection measures during the construction works.	Physiological Cond: Good Structural Cond: Fair Bat Habitat: None	3 Yrs.
T05	Cultivar apple (<i>Malus domestica</i>)	Height (m): 6.5 3 stems (mm): 300, 240, 200 Spread (m): 3.5N, 2E, 4.5S, 4W Crown Clearance (m): 2 Lowest Branch (m): 1(E) Life Stage: Over Mature Rem. Contrib.: 10+ Years	N:3.5 E:2 S:4.5 W:4	Multi stemmed from the ground. Localised cavities in previous pruning wounds. Epicormic growth on the lower branches. Mutual crown suppression.	C1	Radius: 5.2m. Area: 85 sq. m.	NAR Install temporary tree protection measures during the construction works.	Physiological Cond: Good Structural Cond: Fair Bat Habitat: None	3 Yrs.

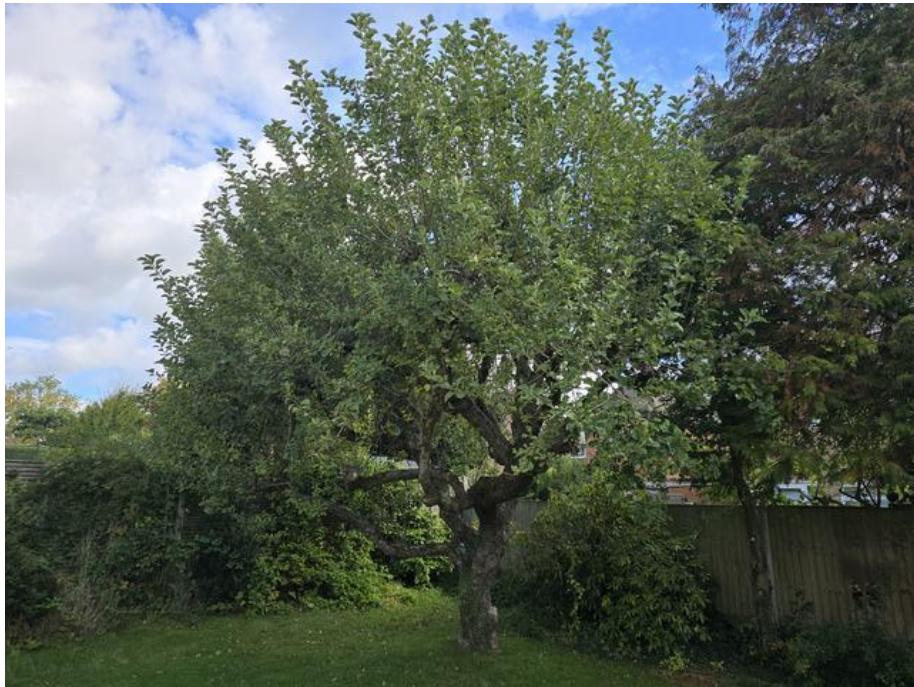
Image 3 T05 an aging apple tree in the centre of the back lawn.

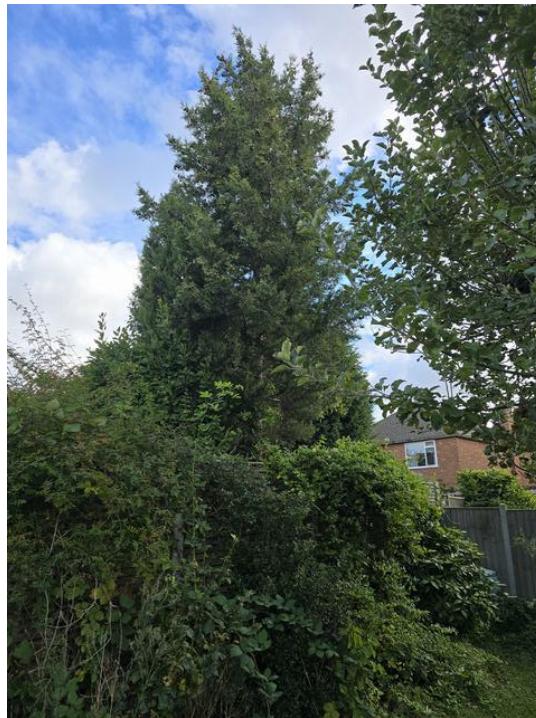
Image 4 T06 an Italian cypress tree in the adjacent property.

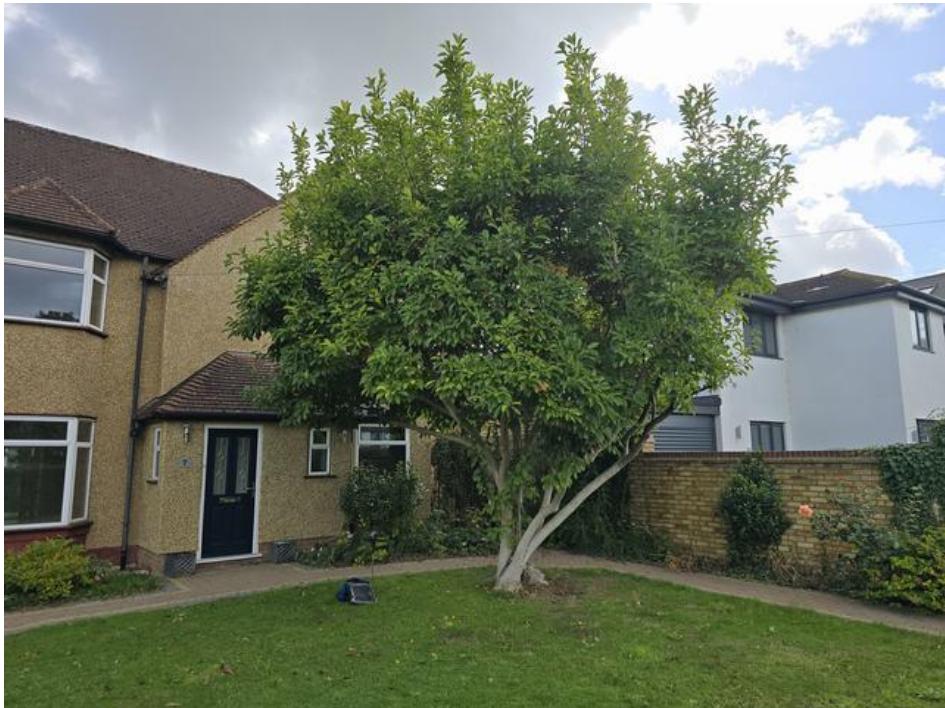
2.2.5 T05 was an aging apple tree in the centre of the back garden, see Image 3. T06 was a C1 Italian cypress tree in the adjacent back garden, see Image 4. T07 was a C1 magnolia tree in the front garden, see Image 5. It had multiple stems and poor form see Image 6.

Image 5 T07 a multi stemmed magnolia tree in the front garden.

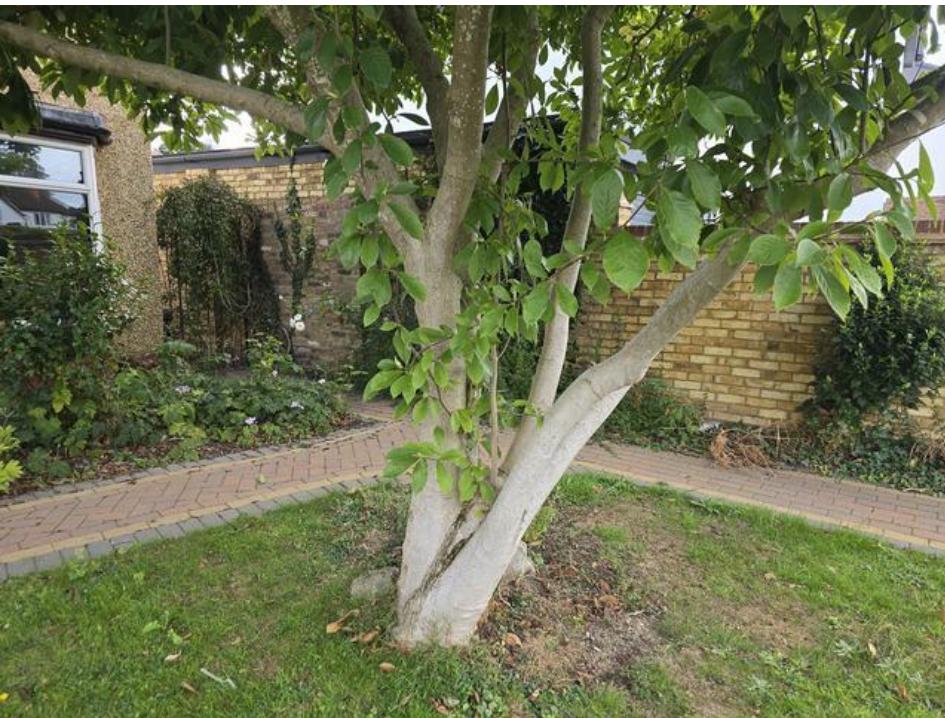
Image 6 Poor form and structure on the magnolia tree T07.

Ref	Species	Measurements	Spread	General Observations	Retention Category	RPA	Recommendations	Condition	Reinspect
T07	Magnolia (<i>Magnolia</i> sp.)	Height (m): 6 2 stems (mm): 130, 140 Spread (m): 3N, 4E, 4S, 3W Crown Clearance (m): 2 Lowest Branch (m): 0.5(W) Life Stage: Early Mature Rem. Contrib.: 10+ Years	N:3 E:4 S:4 W:3	Multi stemmed from the ground. Tight unions and included bark. Low side branches.	C1	Radius: 2.6m. Area: 21 sq. m.	NAR Install temporary tree protection measures during the construction works.	Physiological Cond: Good Structural Cond: Fair Bat Habitat: None	3 Yrs.
