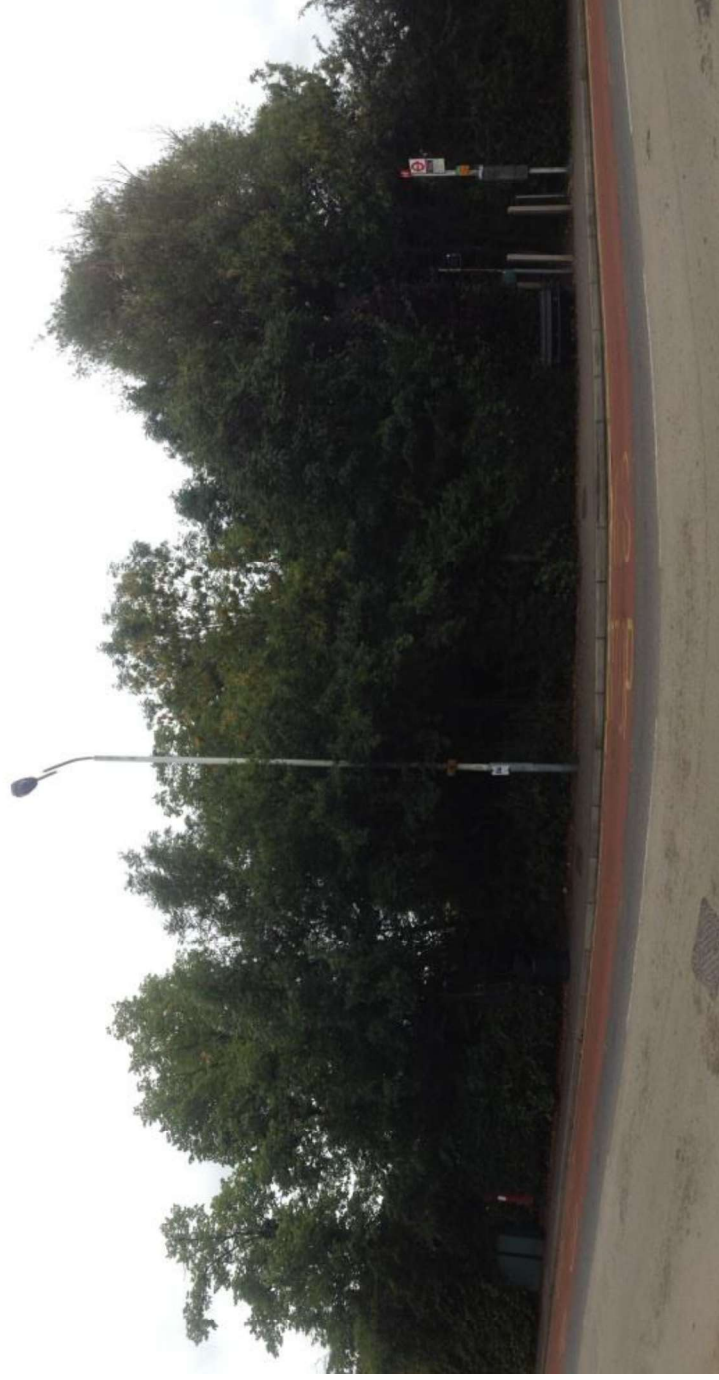
**Image 4 – T15, T16 & TG5 prior to tree works**
