# BS5837 Arboricultural Impact Assessment

Northwood and Pinner Cottage Hospital, Pinner Road, HA6  
1DE

Job Reference: 02370Rv9

## March 2021

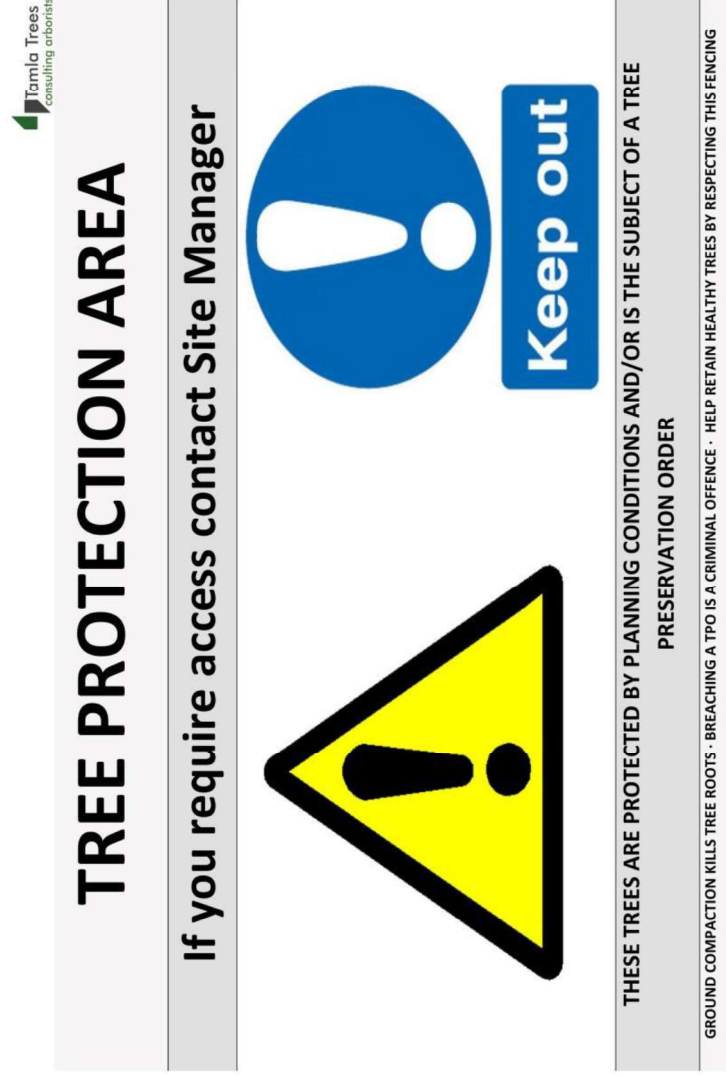
**Fig 2 – Professional grade weatherproof tree protection signs no smaller than 297 x 420 mm (A3) will be located at 5m intervals and all ‘return’ faces for tree protective fencing**

5.4.4 All internal tree protection must be appropriately signed to ensure that all site operatives know its purpose.

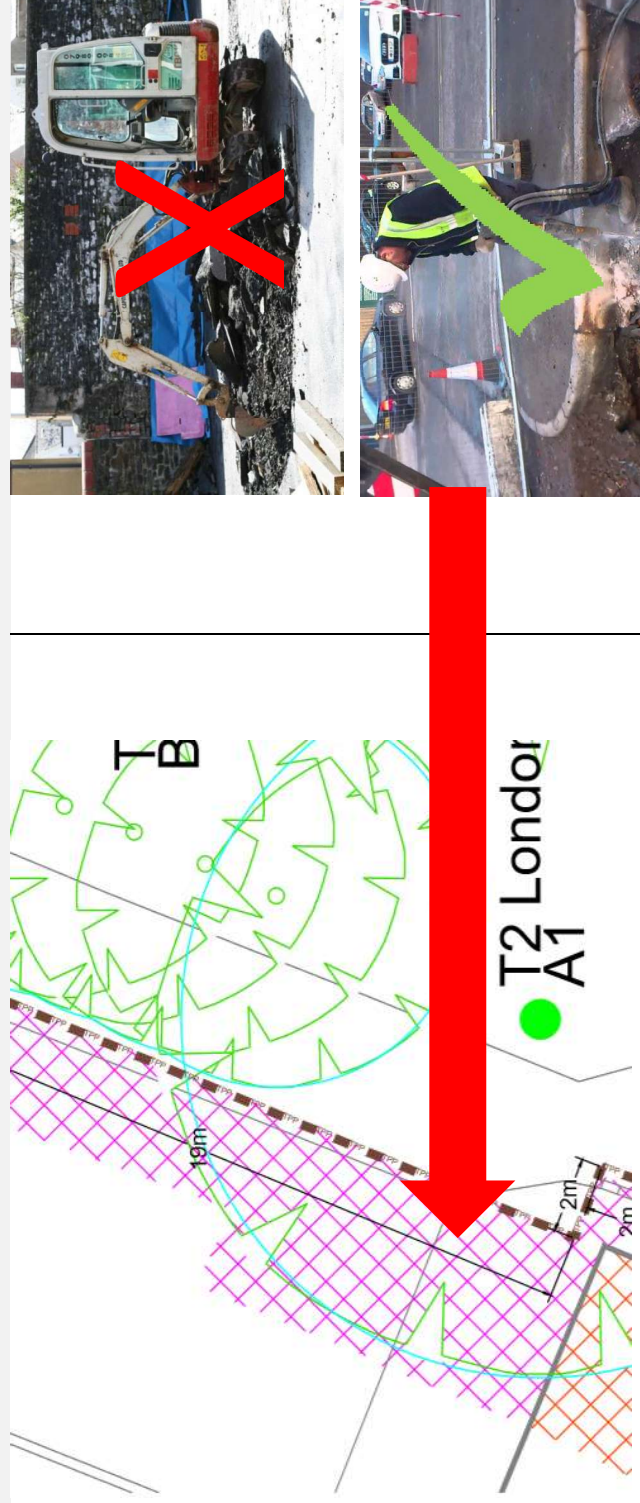
### Surface and Edge Removal Works

**Threat Level to Retained Trees**

**HIGH**

5.5.2 Any work to remove existing surfacing must be completed after a toolbox talk with the project arboriculturalist. Localised jack hammer works can be undertaken (if required) but should stop prior to breaking through the surface. Edging and posts should also be removed by hand. A detailed toolbox talk is undertaken with the working areas marked out on site by hand with appropriate site supervision. The existing subbase can then be topped up before a new permeable wearing course is laid. This approach minimises the risk of inadvertent damage to underlying tree roots.

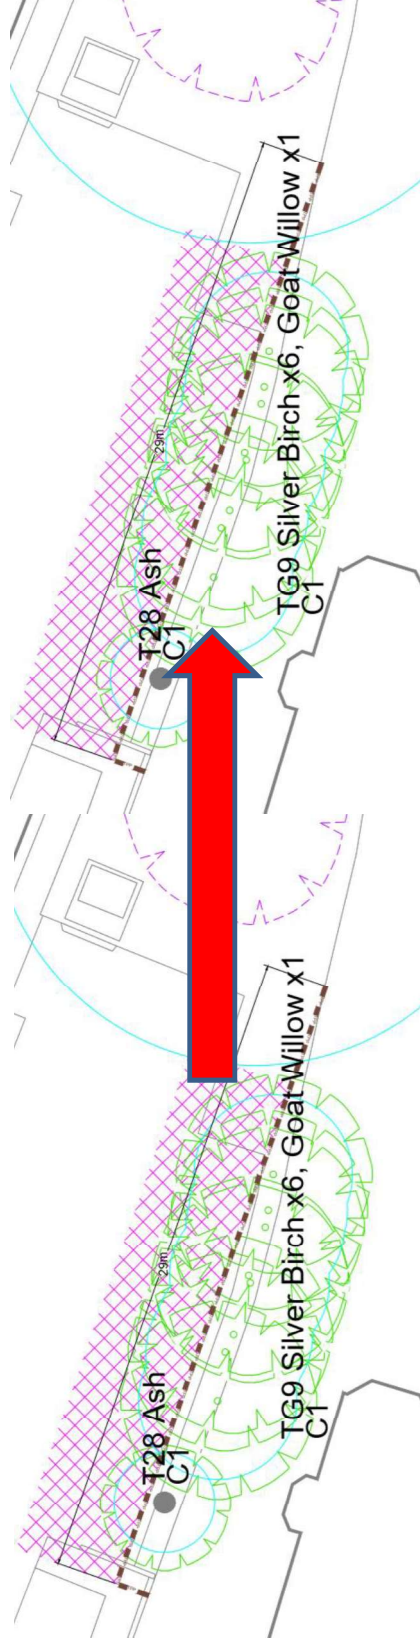
**Fig 3 – Existing parking (left) with proposed (right). The existing subbase is retained and the new wearing course is permeable to deliver a benefit to the retained trees. The competence of the contractors is key to the successful delivery of these works.**

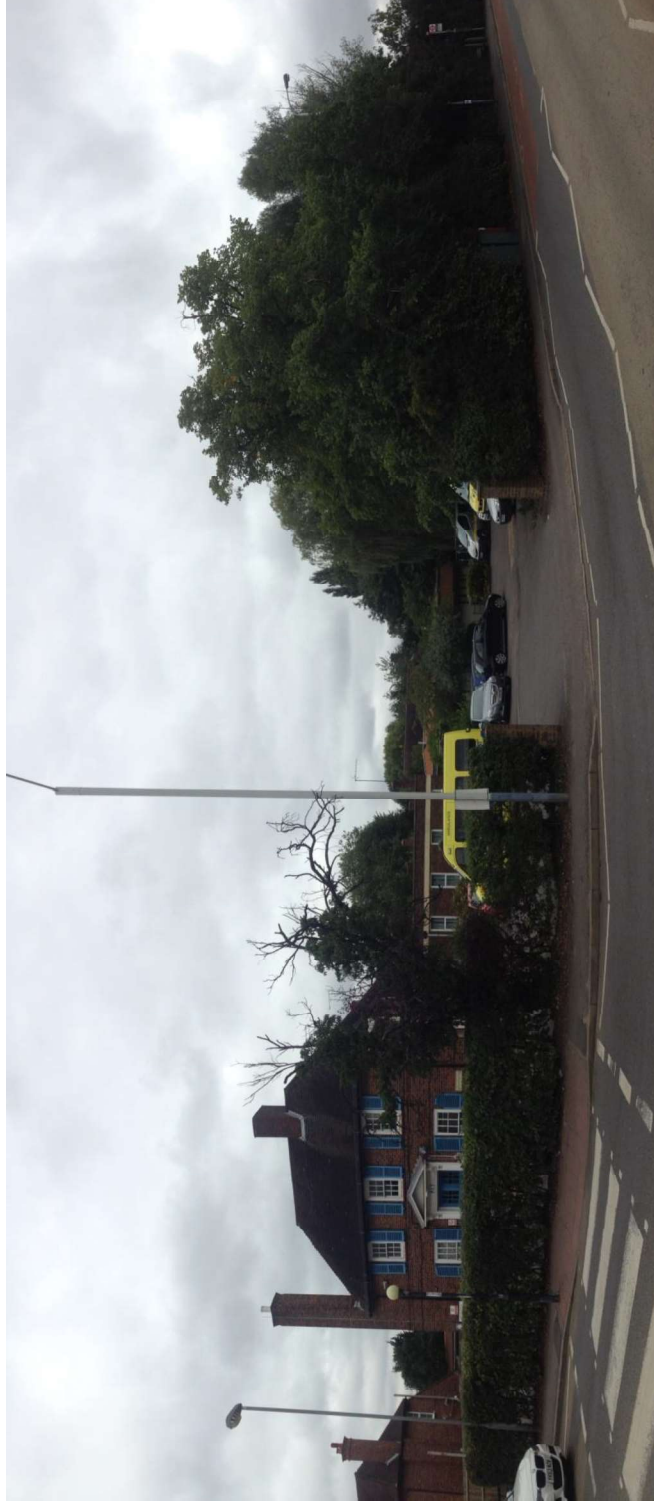
**Image 1 – Site frontage southern boundary (2017)**
