**BS5837 Arboricultural Report and
Arboricultural Impact Assessment**

OUR REFERENCE	AC.2025.353
CLIENT	Mr Kahn
SITE	19 Blossom Way, Uxbridge, UB10 9LL
REPORT BY	I S Thompson (known as Tom) M. Arbor. A., BSc. (Hons) Arb, MSc. eFor
DATE	15th March 2025
DATE OF SITE VISIT	14th March 2025

19 Blossom Way, Uxbridge, UB10 9LL

Side and rear extension to the existing detached residential dwelling.

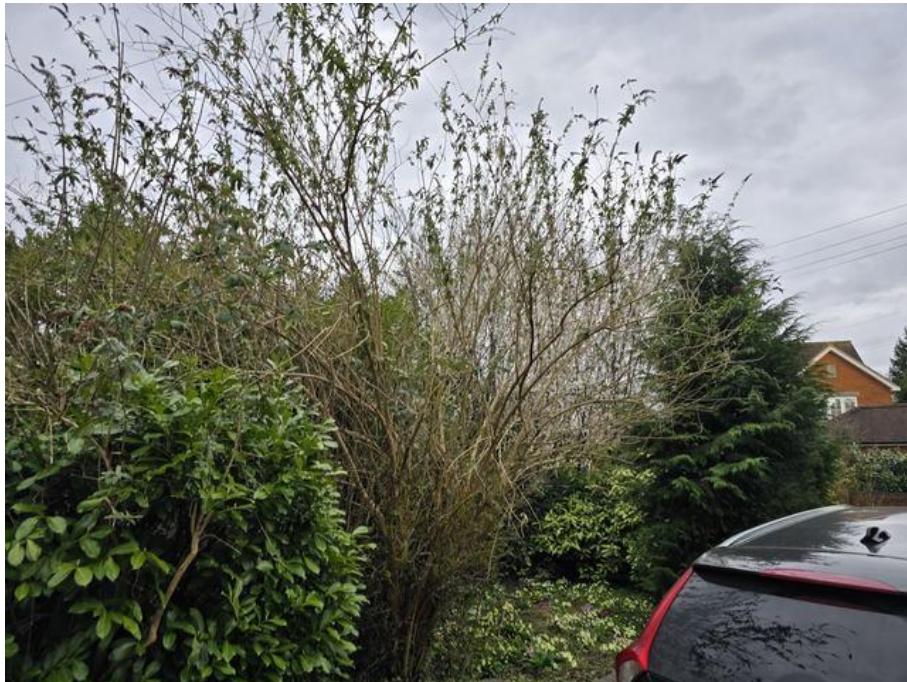
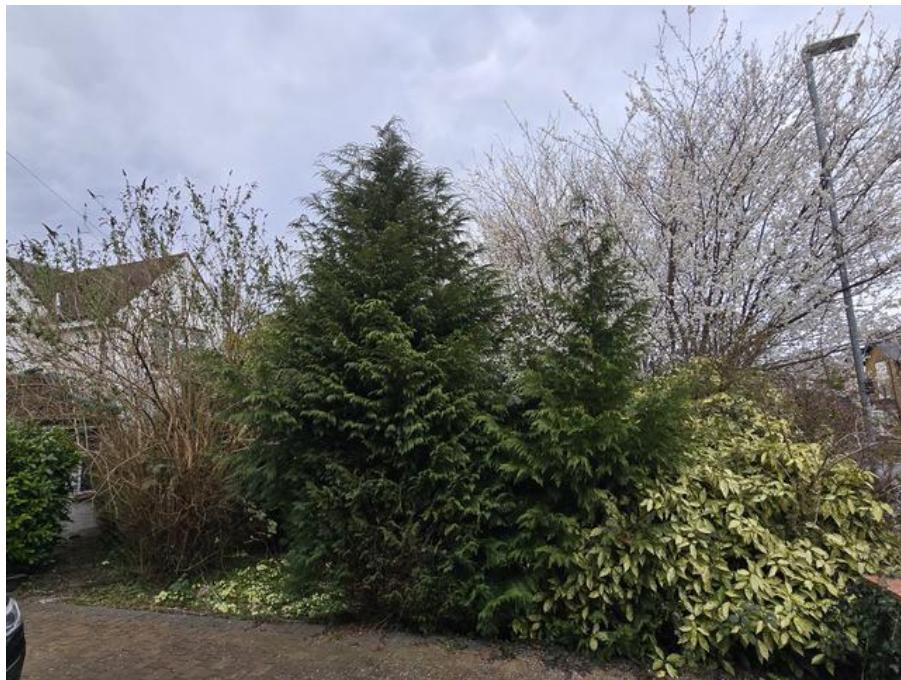
2.2.4 There were a total of six groups and 9 individual trees surveyed, see Chart 1 below and Tree Survey Records in Appendix IV. They were 80% category C1/2 trees and groups, see Chart 2 below. G01 was an overgrown group of shrubs and some young trees covering most of the front garden, see Images 1 and 2 in Appendix III. This was categorised as C2.

Image 1 G01, many shrubs and some young trees covering the front garden.

Image 2 G01, many shrubs and some young trees covering the front garden.

- 3.2.1** There are four groups of shrubs and trees, and seven individual trees proposed for removal. The shrubs proposed for removal are G01 and G04 both in the front garden, and G08 and G09 both near to the rear of the house in the back garden. They are all C2 category groups.

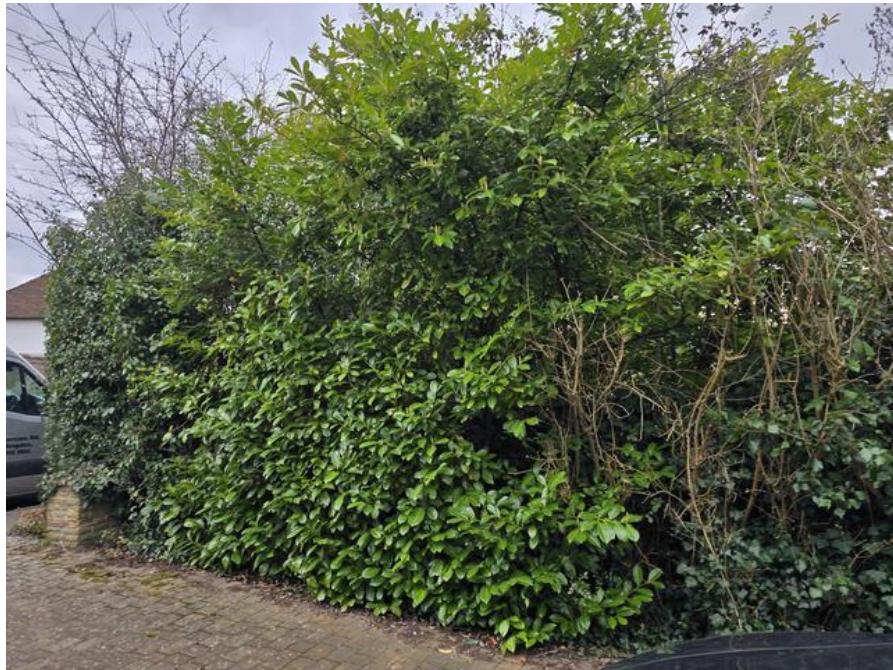
2.2.5 G02 was a group of shrubs along the front boundary with the adjacent property. This was also categorised as C2, see Image 3. G04 was a small group of shrubs near to the existing property, also categorised a C2, see Image 4.

Image 3 G02 a screening hedge along the boundary at the front.

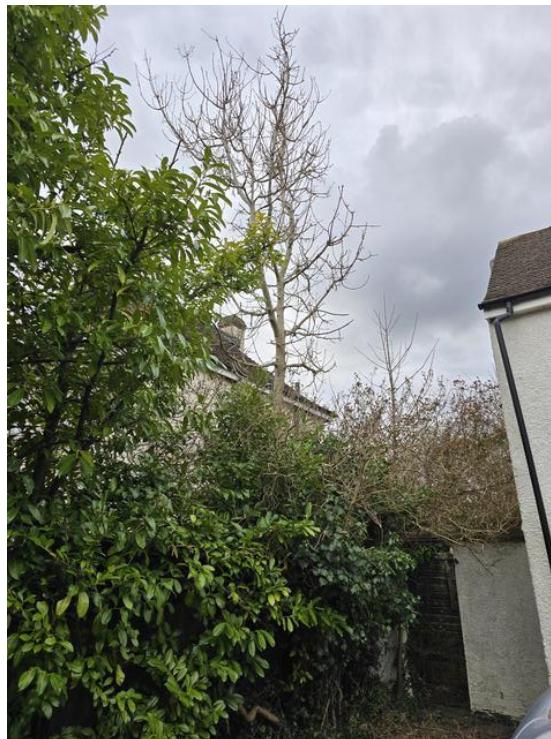
Image 4 G04 and ash tree T03, close to the house and closer to the proposed footprint.

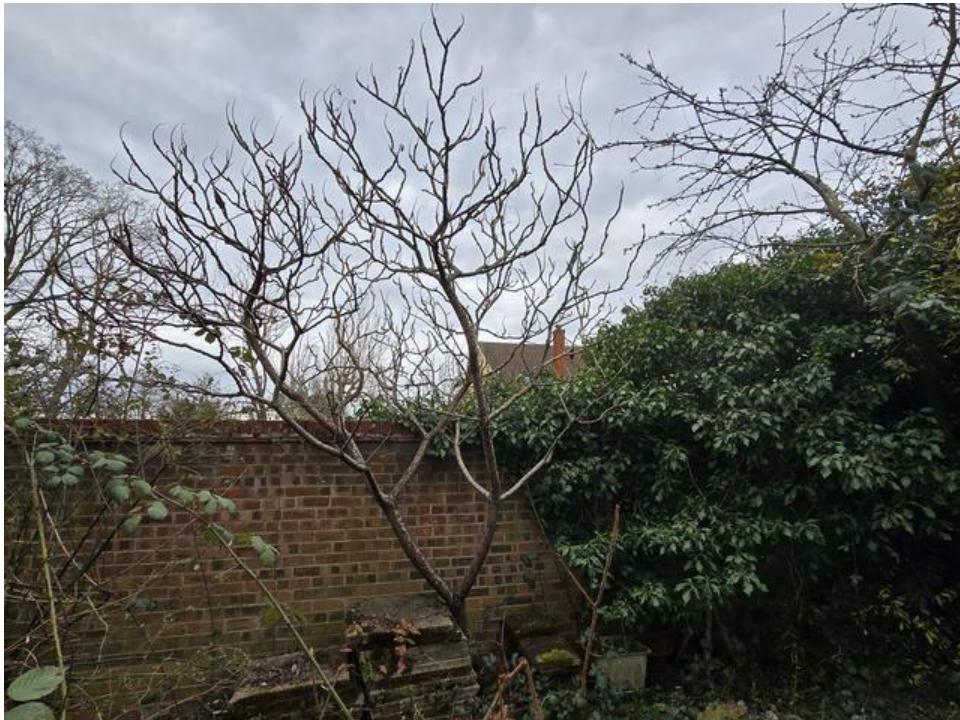
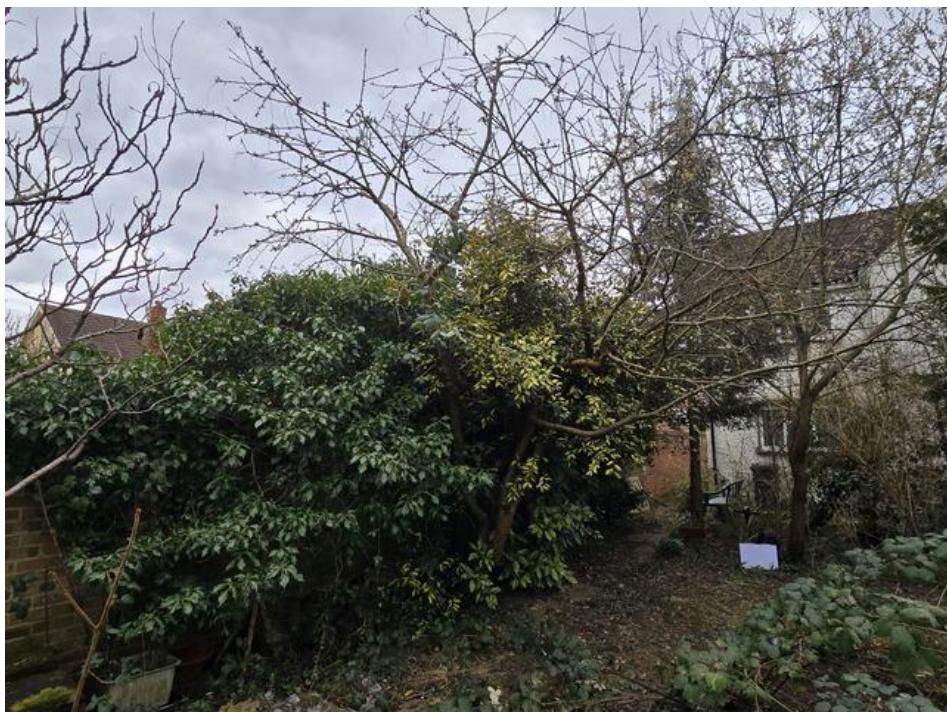
2.2.6 At the rear of the property G08 was a small group of C2 shrubs close to the existing house. G09 was a group of small trees and shrubs along the northeast boundary. This comprised of laurel, sumac and plum, see Images 5 and 6. Both of these groups were categorised as C2.

Image 5 G09 mixed species including laurel, plum, and sumac in the rear garden.

Image 6 G09 mixed species including laurel, plum, and sumac in the rear garden.

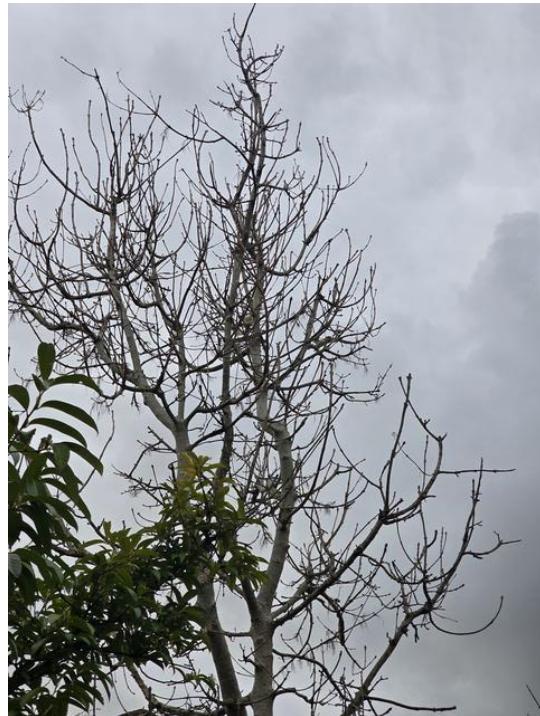
2.2.7 T03 was a small C1 ash tree in the proposed footprint at the front, see Images 4 and 7. T05 was a small C1 cypress tree, see Image 8. T06 was a B1 yew tree, see Image 9. T07 was a small C1 holly tree. T10 was a poorly formed C1 willow, see Image 10. T05, T06, T07 and T10 were all close to the existing building a very close to or in the footprint of the proposed extension.

Image 7 Upper crown of ash tree T03, with signs of dieback.

- 3.2.2** The trees proposed for the removal are T03 an ash tree, T05 a cypress, T06 a yew, T07 a holly, and T10 a willow. This are all close to the house and very close or within the proposed extension footprint. They are all C1 category trees, with the exception of the yew tree T06 which is just a B1 category despite being previously topped.

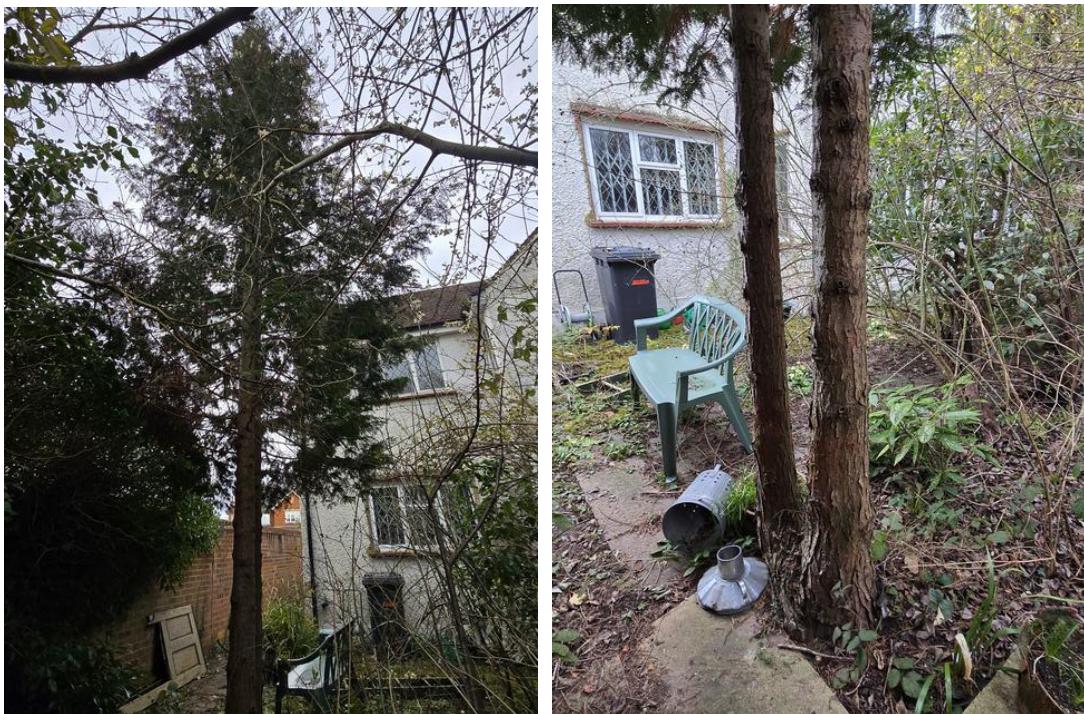
Image 8 Crown and twin stems of cypress tree T05 in the rear garden.

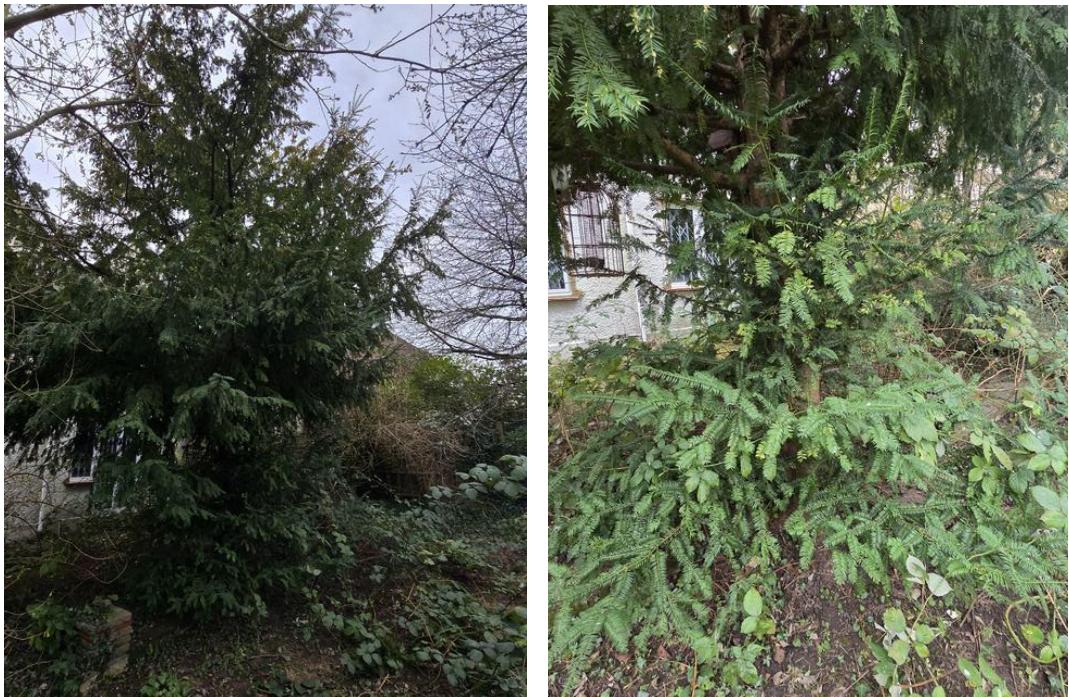
Image 9 Previously topped yew tree close to the existing dwelling.

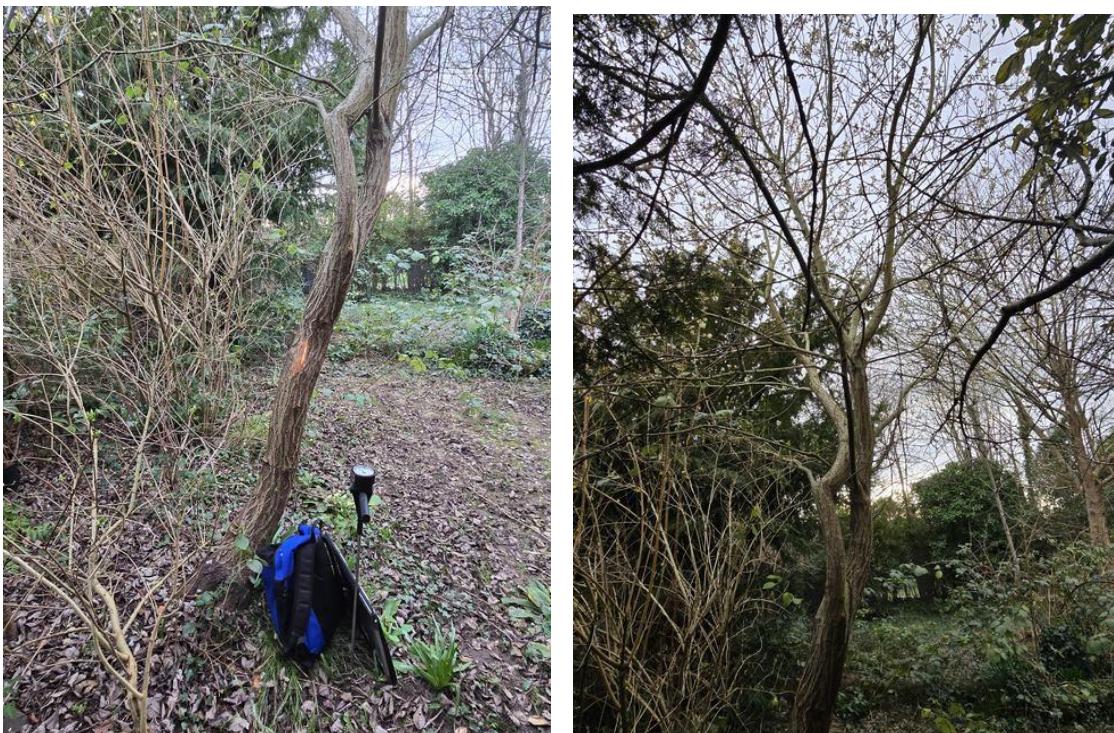
Image 10 The swept stem and crown of the goat willow tree, T10.

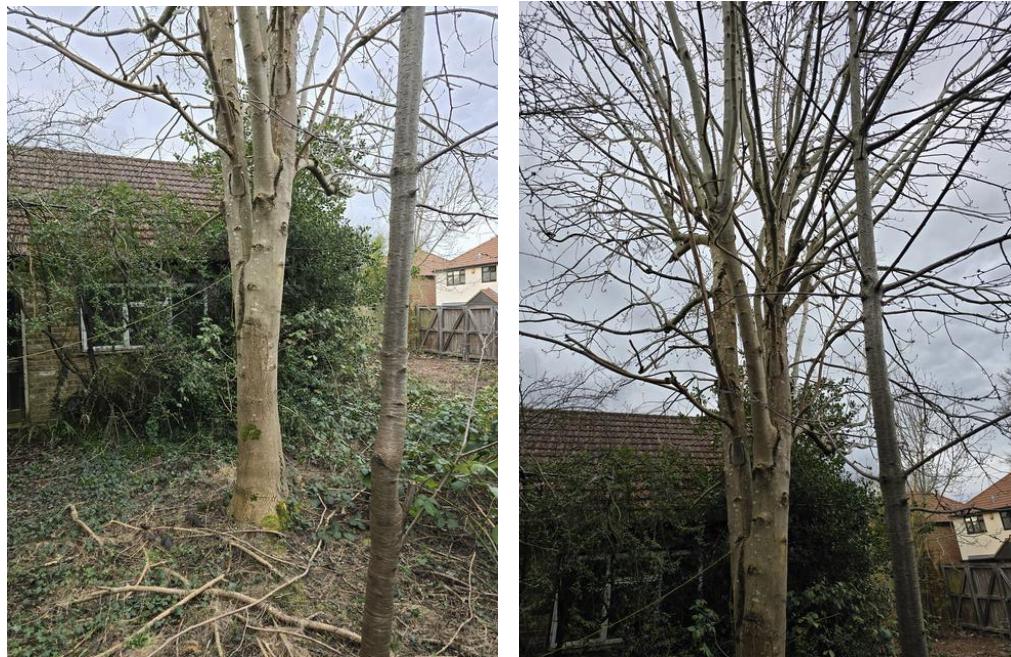
2.2.8 T11 is a large B1 ash tree in the rear garden, see Image 11. T12 is a large cherry tree in the rear garden, see Image 12, and T13 is a large ivy covered ash tree in the rear garden, see Image 13. They are all B1 category trees.

Image 11 Trunk and crown of large ash tree T11, no signs of dieback at this time.

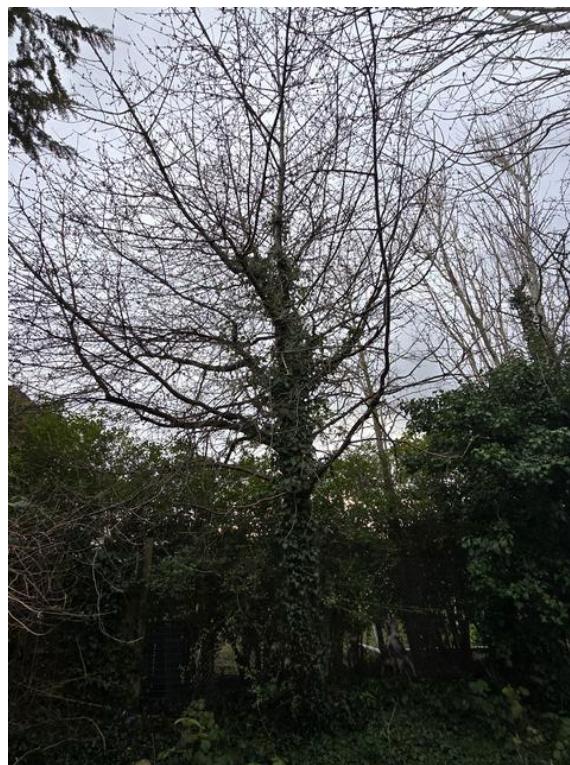
Image 12 T12 a large cherry tree on the side boundary at the rear.

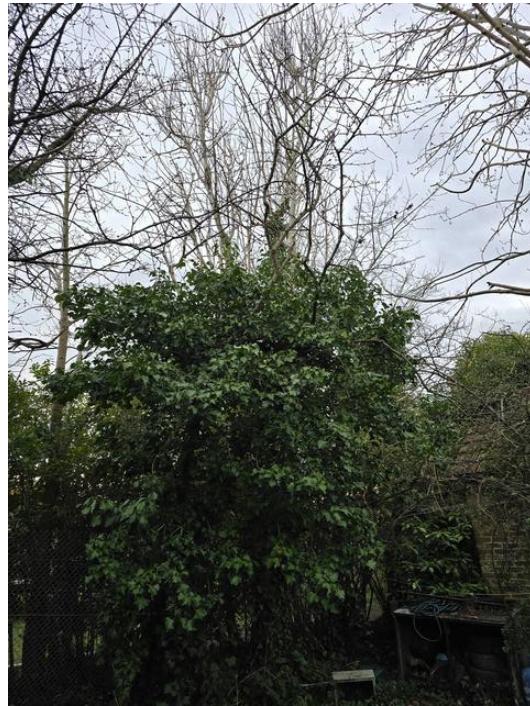
Image 13 T13 a large ash tree on the side boundary at the rear.

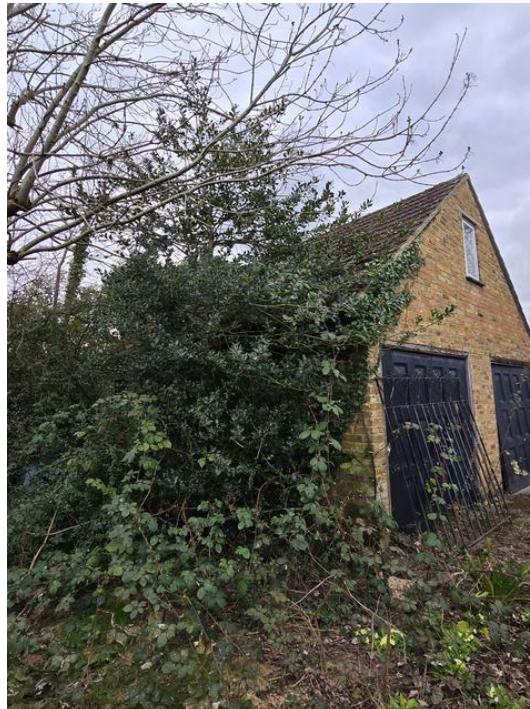
2.2.9 T14 was a C1 holly tree growing into and damaging the garage roof, see Images 14. T15 was a C1 leaning ash tree close to the rear entrance, see Images 15.

Image 14 T14 a holly tree growing into the garage roof.

- 3.2.3** Additionally the holly tree T14 is to be removed because it is damaging the garage roof, and T15 an as tree, which is leaning and growing over the rear entrance. They are both C1 category trees.

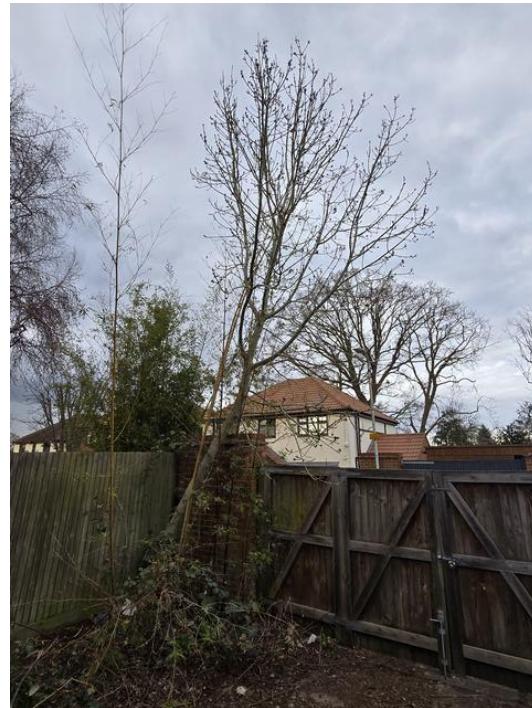
Image 15 T15 a leaning ash tree growing over the rear entrance.

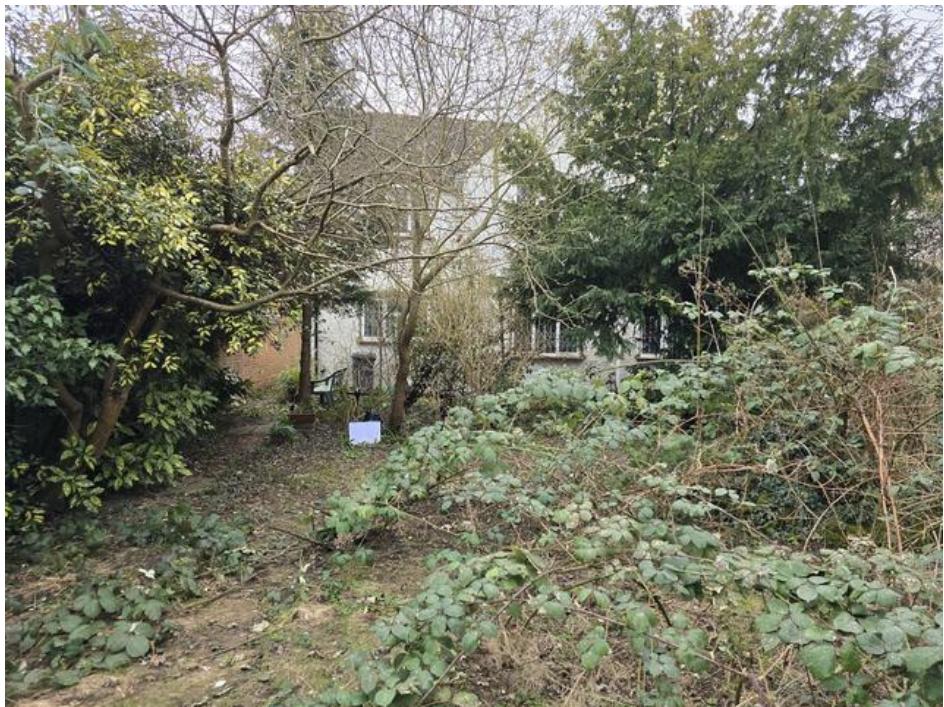
Image 18 Rear garden near the house overgrown with shrubs small trees and bramble.
