**BS5837 Arboricultural Report and  
Arboricultural Impact Assessment**

| OUR REFERENCE | AC.2025.396 |
| SITE | 19 Blossom Way, Uxbridge, UB10 9LL |

**Side and rear extension to the existing detached residential dwelling.**

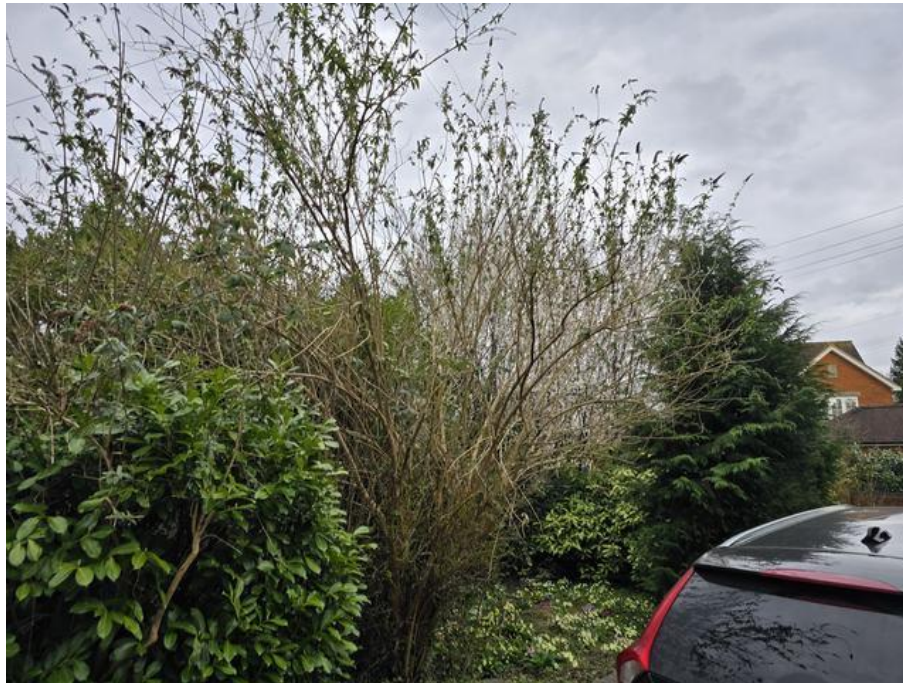
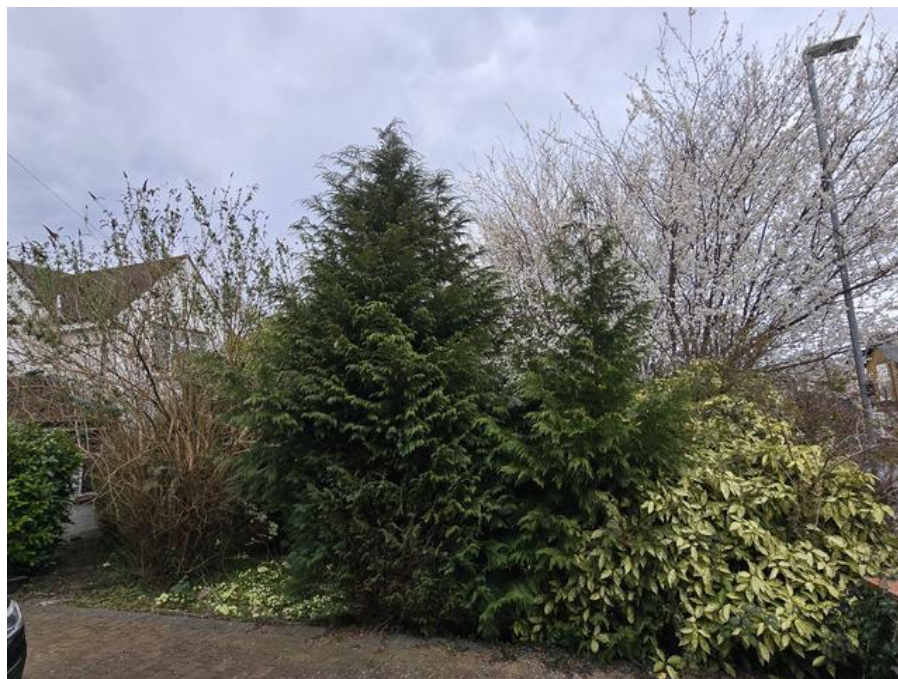
- 2.2.4** There were a total of six groups and 9 individual trees surveyed, see Chart 1 below and Tree Survey Records in Appendix IV. They were 80% category C1/2 trees and groups, see Chart 2 below. G01 was an overgrown group of shrubs and some young trees covering most of the front garden, see Images 1 and 2 in Appendix III. This was categorised as C2.

**Image 1** G01, many shrubs and some young trees covering the front garden.

**Image 2** G01, many shrubs and some young trees covering the front garden.

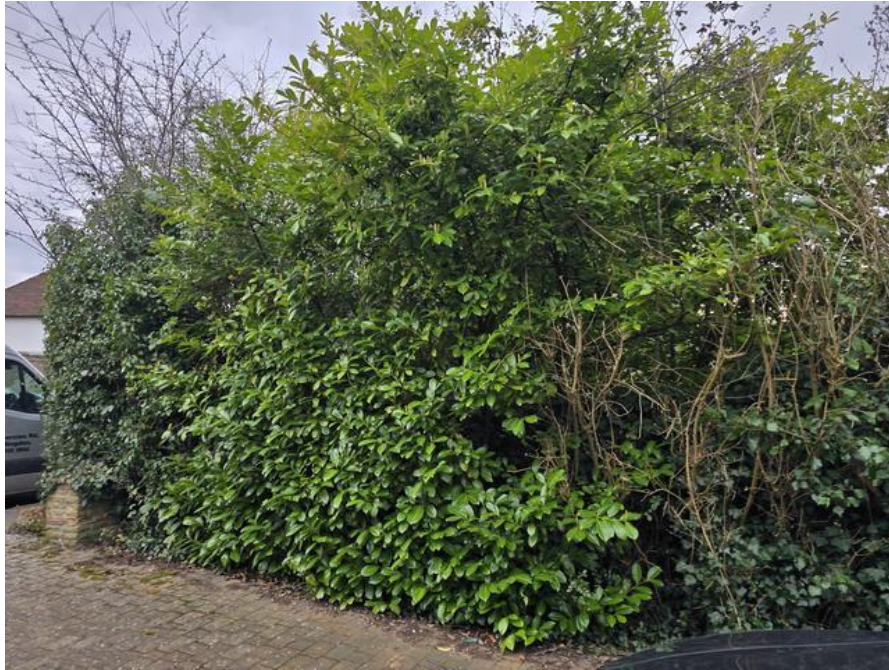
- 2.2.5** G02 was a group of shrubs along the front boundary with the adjacent property. This was also categorised as C2, see Image 3. G04 was a small group of shrubs near to the existing property, also categorised a C2, see Image 4.

**Image 3** G02 a screening hedge along the boundary at the front.

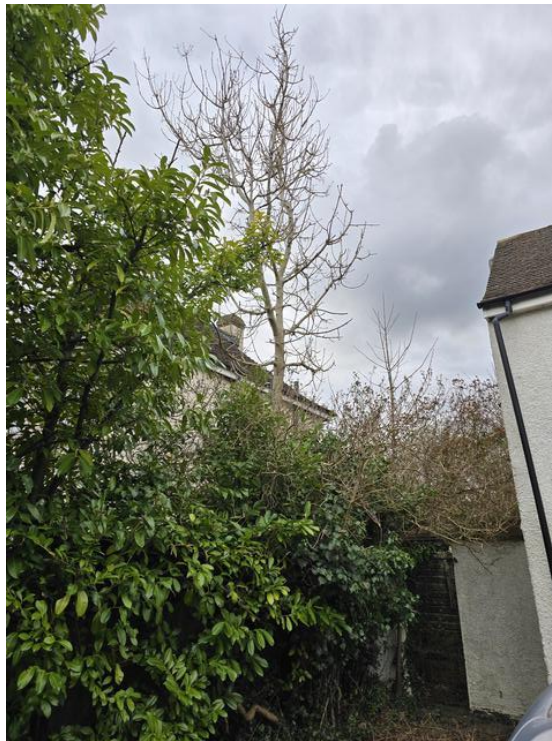
- 2.2.7** T03 was a small C1 ash tree in the proposed footprint at the front, see Images 4 and 7. T05 was a small C1 cypress tree, see Image 8. T06 was a B1 yew tree, see Image 9. T07 was a small C1 holly tree. T10 was a poorly formed C1 willow, see Image 10. T05, T06, T07 and T10 were all close to the existing building a very close to or in the footprint of the proposed extension.

**Image 4** G04 and ash tree T03, close to the house and closer to the proposed footprint.

**3.5.1** There is limited space for new tree planting, but the garden area is being re-landscaped to improve the general appearance of the site. There will be a replacement planting to mitigate the loss of G04 and T10, both being removed. This will be detailed in a separate planting report and plan.

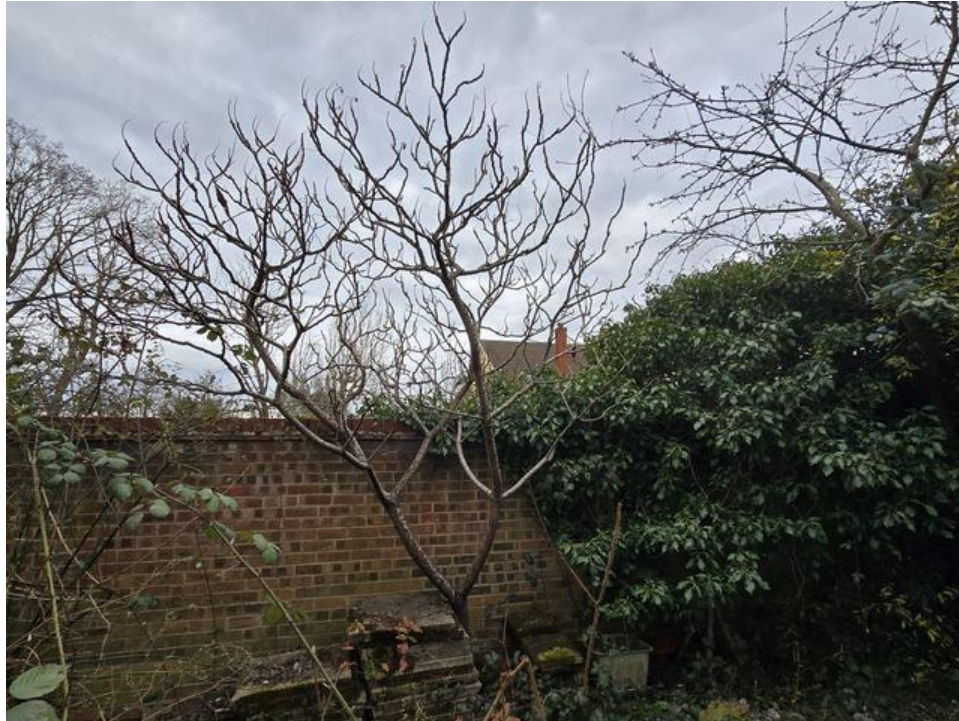
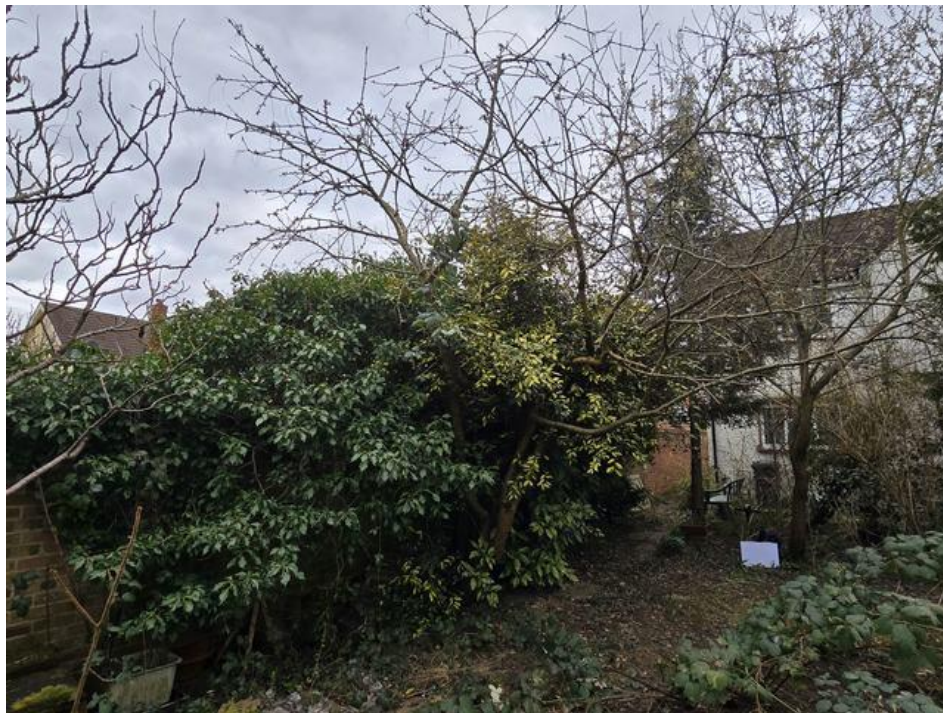
- 2.2.6** At the rear of the property G08 was a small group of C2 shrubs close to the existing house. G09 was a group of small trees and shrubs along the northeast boundary. This comprised of laurel, sumac and plum, see Images 5 and 6. Both of these groups were categorised as C2.

**Image 5** G09 mixed species including laurel, plum, and sumac in the rear garden.

**Image 6** G09 mixed species including laurel, plum, and sumac in the rear garden.

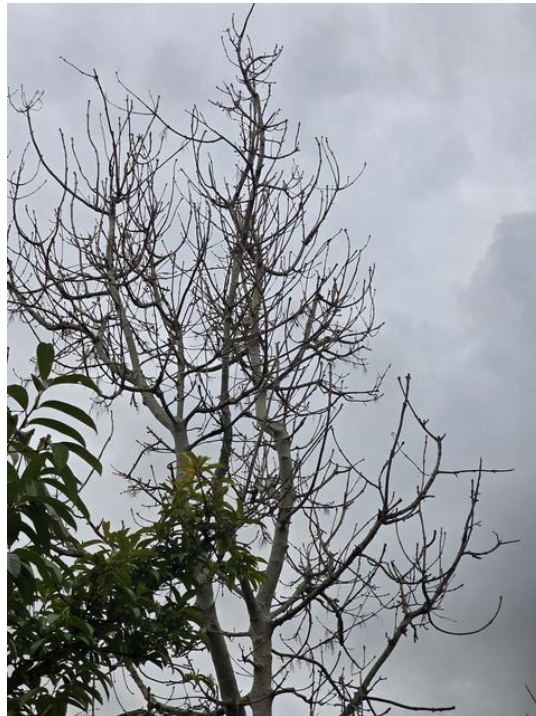
**Image 7** Upper crown of ash tree T03, with signs of dieback.

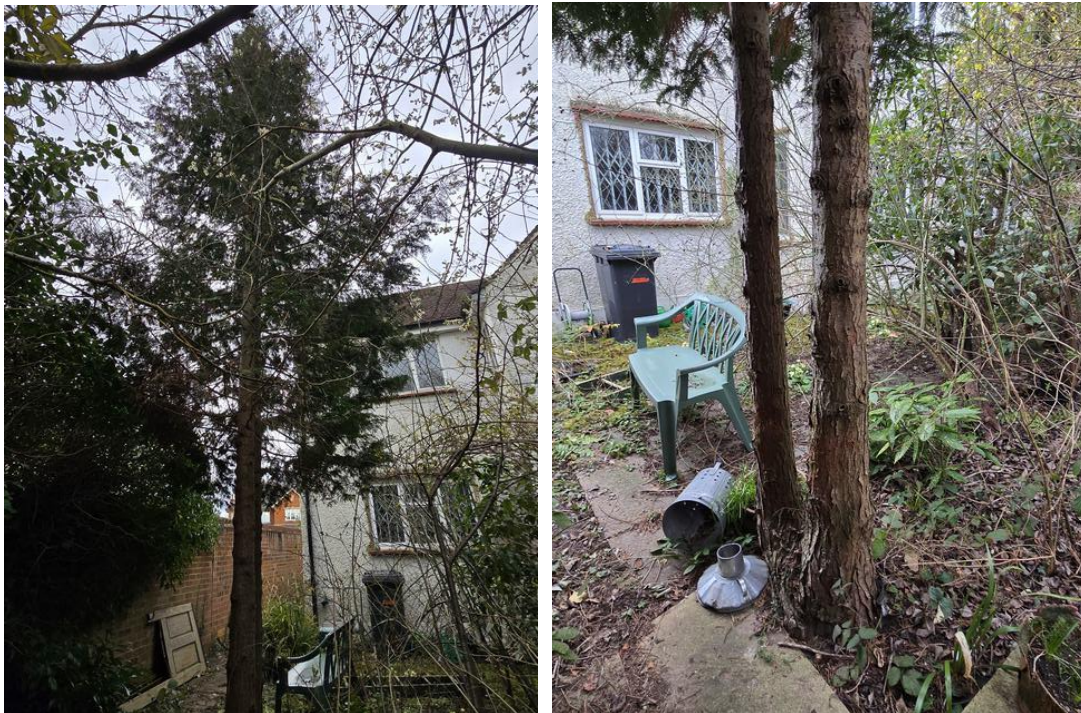
**Image 8** Crown and twin stems of cypress tree T05 in the rear garden.

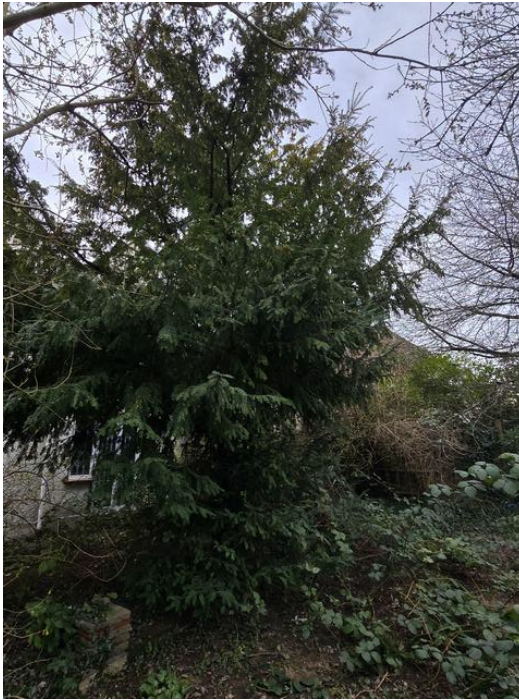
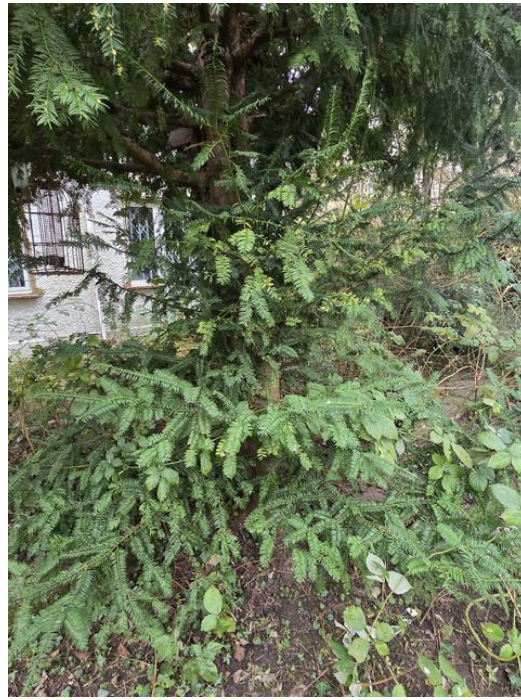
**Image 9** Previously topped yew tree close to the existing dwelling.

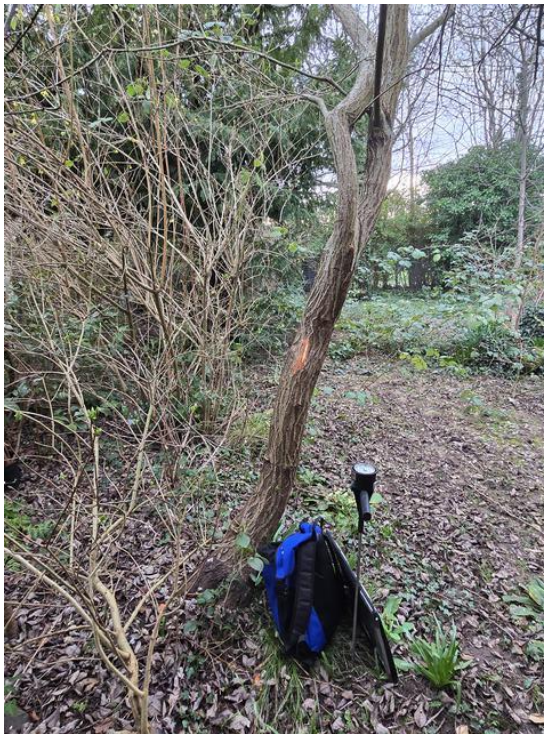
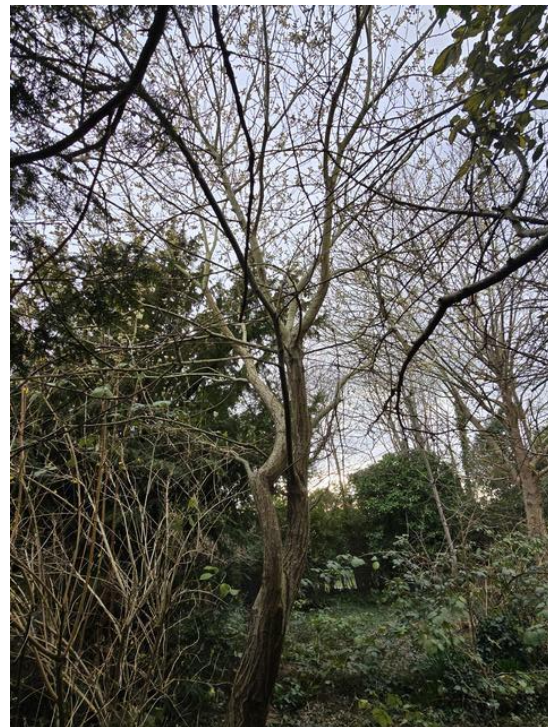
**Image 10** The swept stem and crown of the goat willow tree, T10.

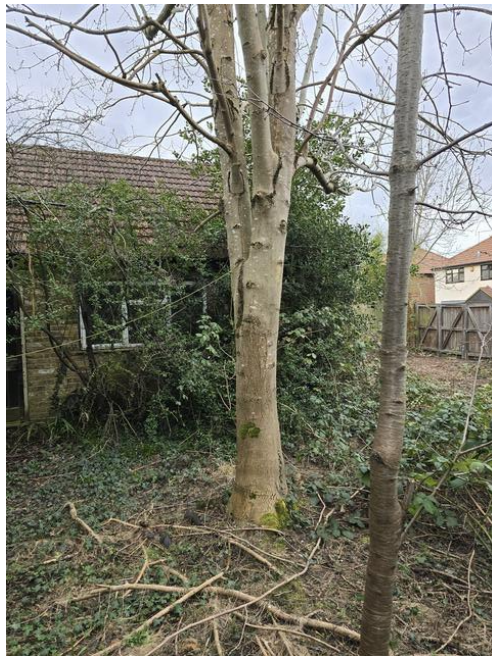
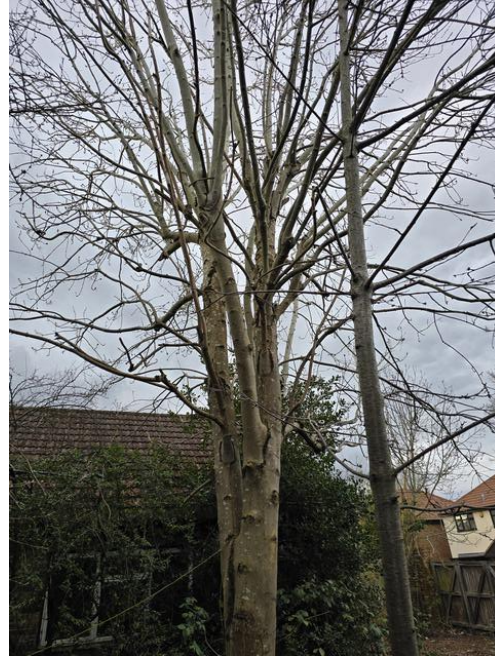
- 2.2.8** T11 is a large B1 ash tree in the rear garden, see Image 11. T12 is a large cherry tree in the rear garden, see Image 12, and T13 is a large ivy covered ash tree in the rear garden, see Image 13. They are all B1 category trees.

**Image 11** Trunk and crown of large ash tree T11, no signs of dieback at this time.

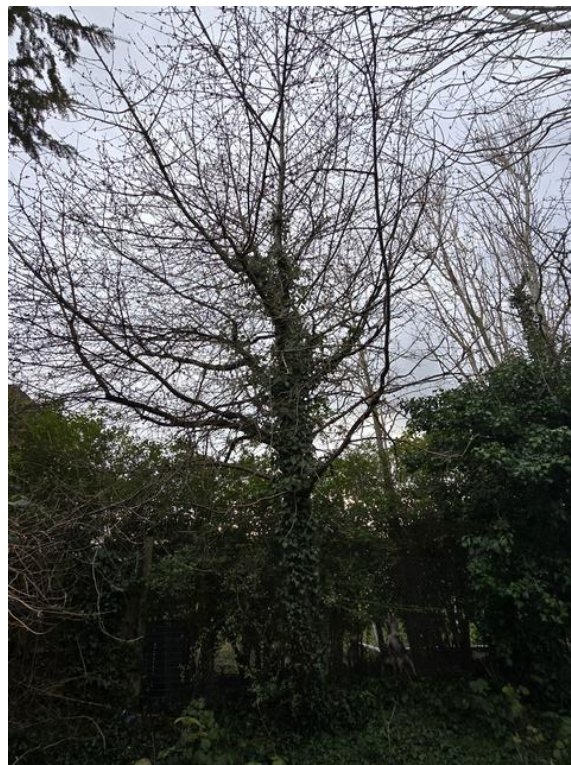
**Image 12** T12 a large cherry tree on the side boundary at the rear.

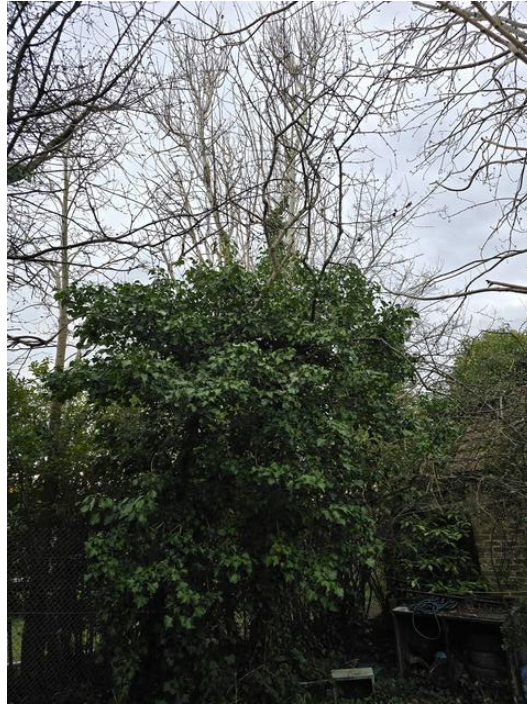
**Image 13** T13 a large ash tree on the side boundary at the rear.

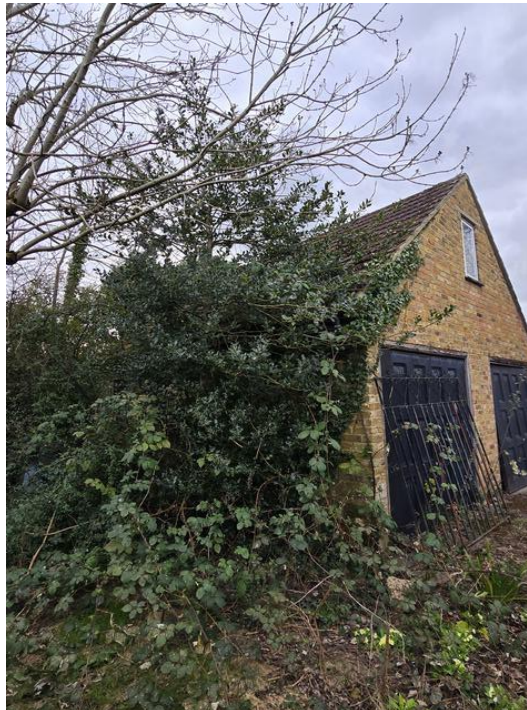
- 2.2.9** T14 was a C1 holly tree growing into and damaging the garage roof, see Images 14. T15 was a C1 leaning ash tree close to the rear entrance, see Images 15.

**Image 14** T14 a holly tree growing into the garage roof.

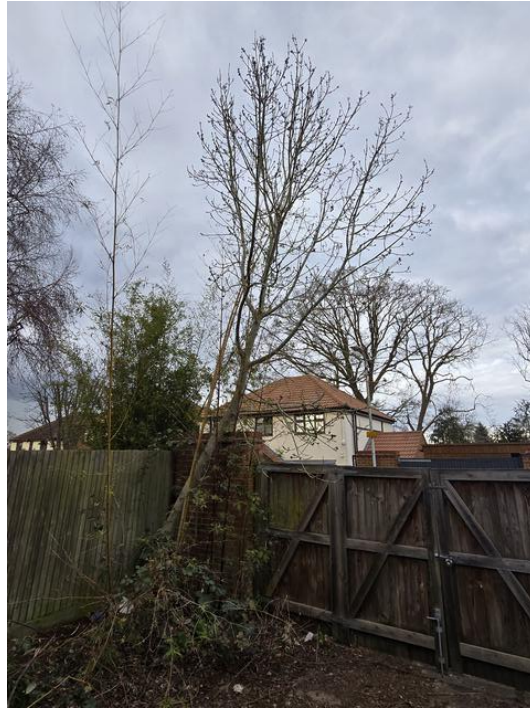
**Image 15** T15 a leaning ash tree growing over the rear entrance.

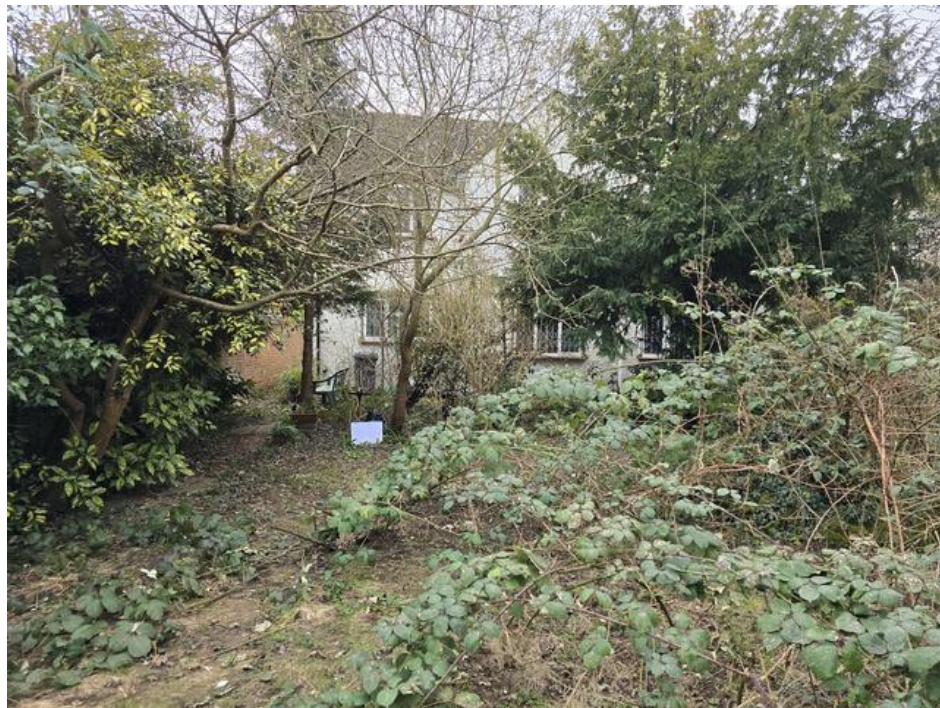
**Image 18** Rear garden near the house overgrown with shrubs small trees and bramble.
