# **Arboricultural Report**

## **Development at Cherry Yard, Holloway Farm Harmondsworth Road West Drayton**

**5<sup>th</sup> October 2016**

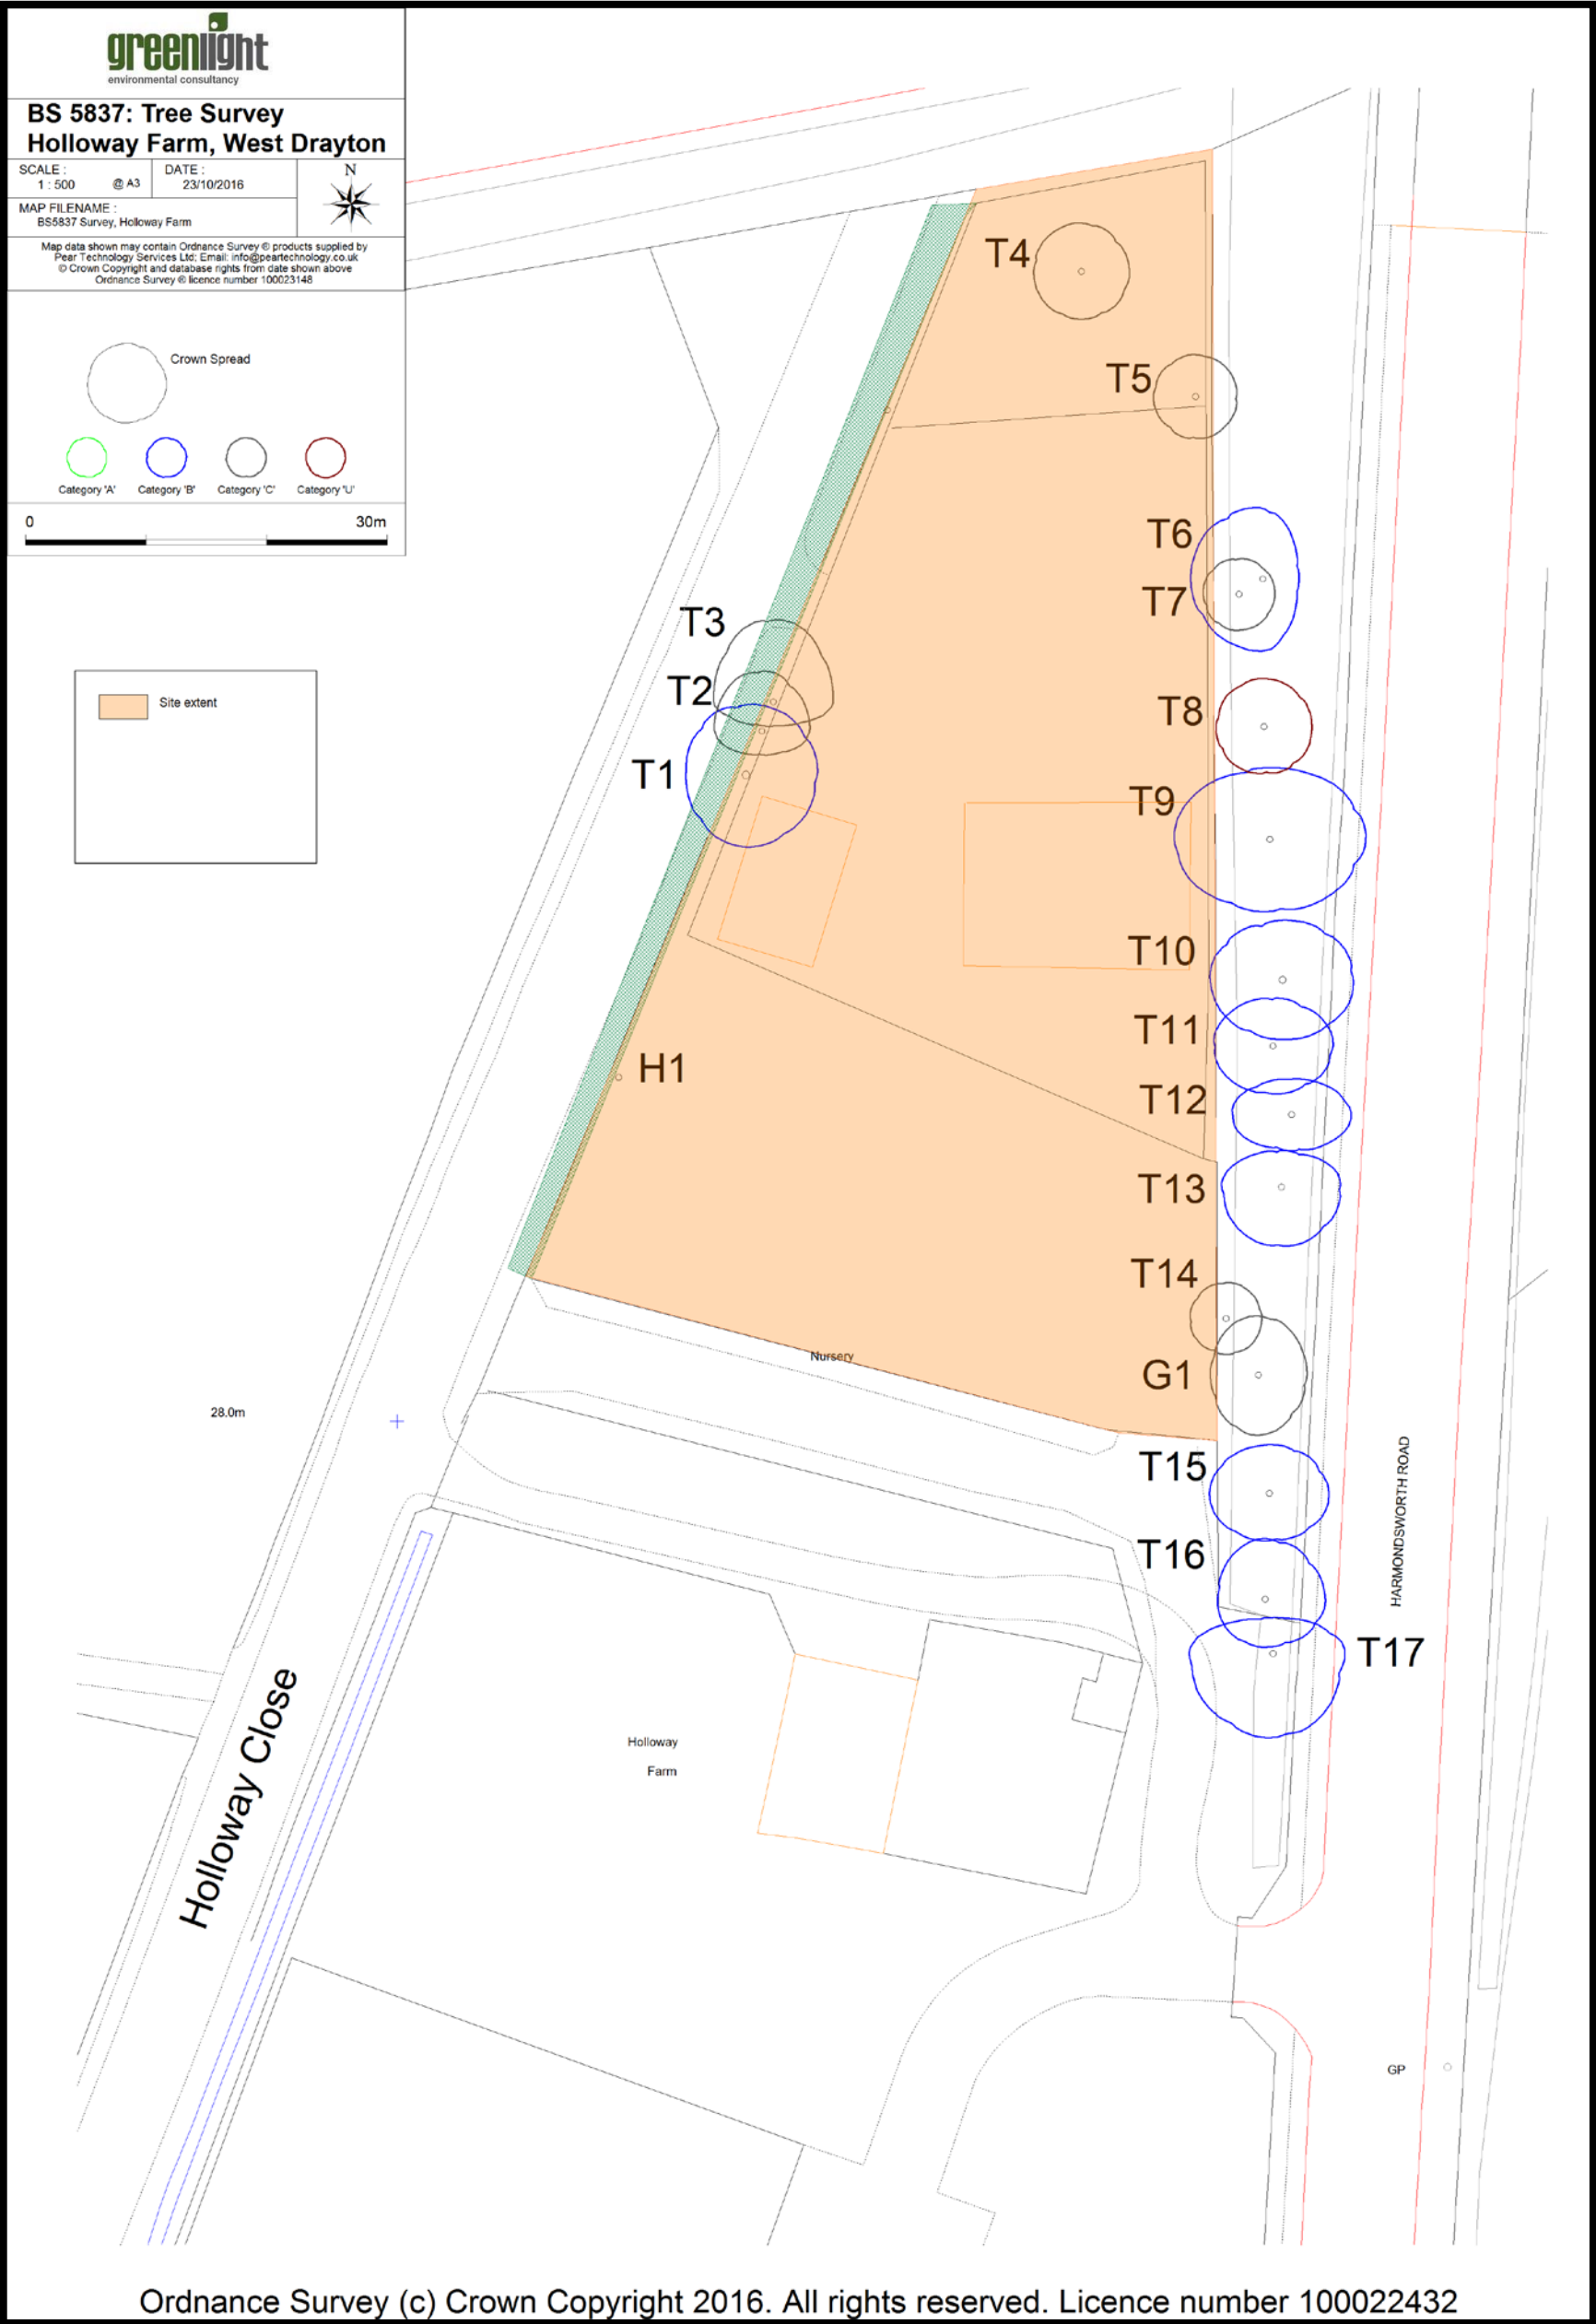
Figure 2: Tree Survey

- 4.1 The trees on the site are plotted on a plan shown in Figure 2 below. A schedule of the detailed survey data is reproduced in a table at appendix A.

- 4.3 The site is enclosed by mature vegetation. To the west is H1, the extension of the overgrown hedge/treeline running the full length of the western property boundary, a mixture of elm, sycamore and hawthorn with much declining elder and becoming engulfed with ivy and bindweed. Behind the pre-existing small shed are several stems of gum (*Eucalyptus spp.*). To the north are the trees and shrubs lining the M4 corridor. To the east is a narrow belt of trees which includes lime (*Tilia spp.*), Cherry (*Prunus spp.*), Norway maple (*Acer platanoides*) and ash (*Fraxinus excelsior*), growing on the embanked verge of Harmondsworth Road where it crosses the M4.

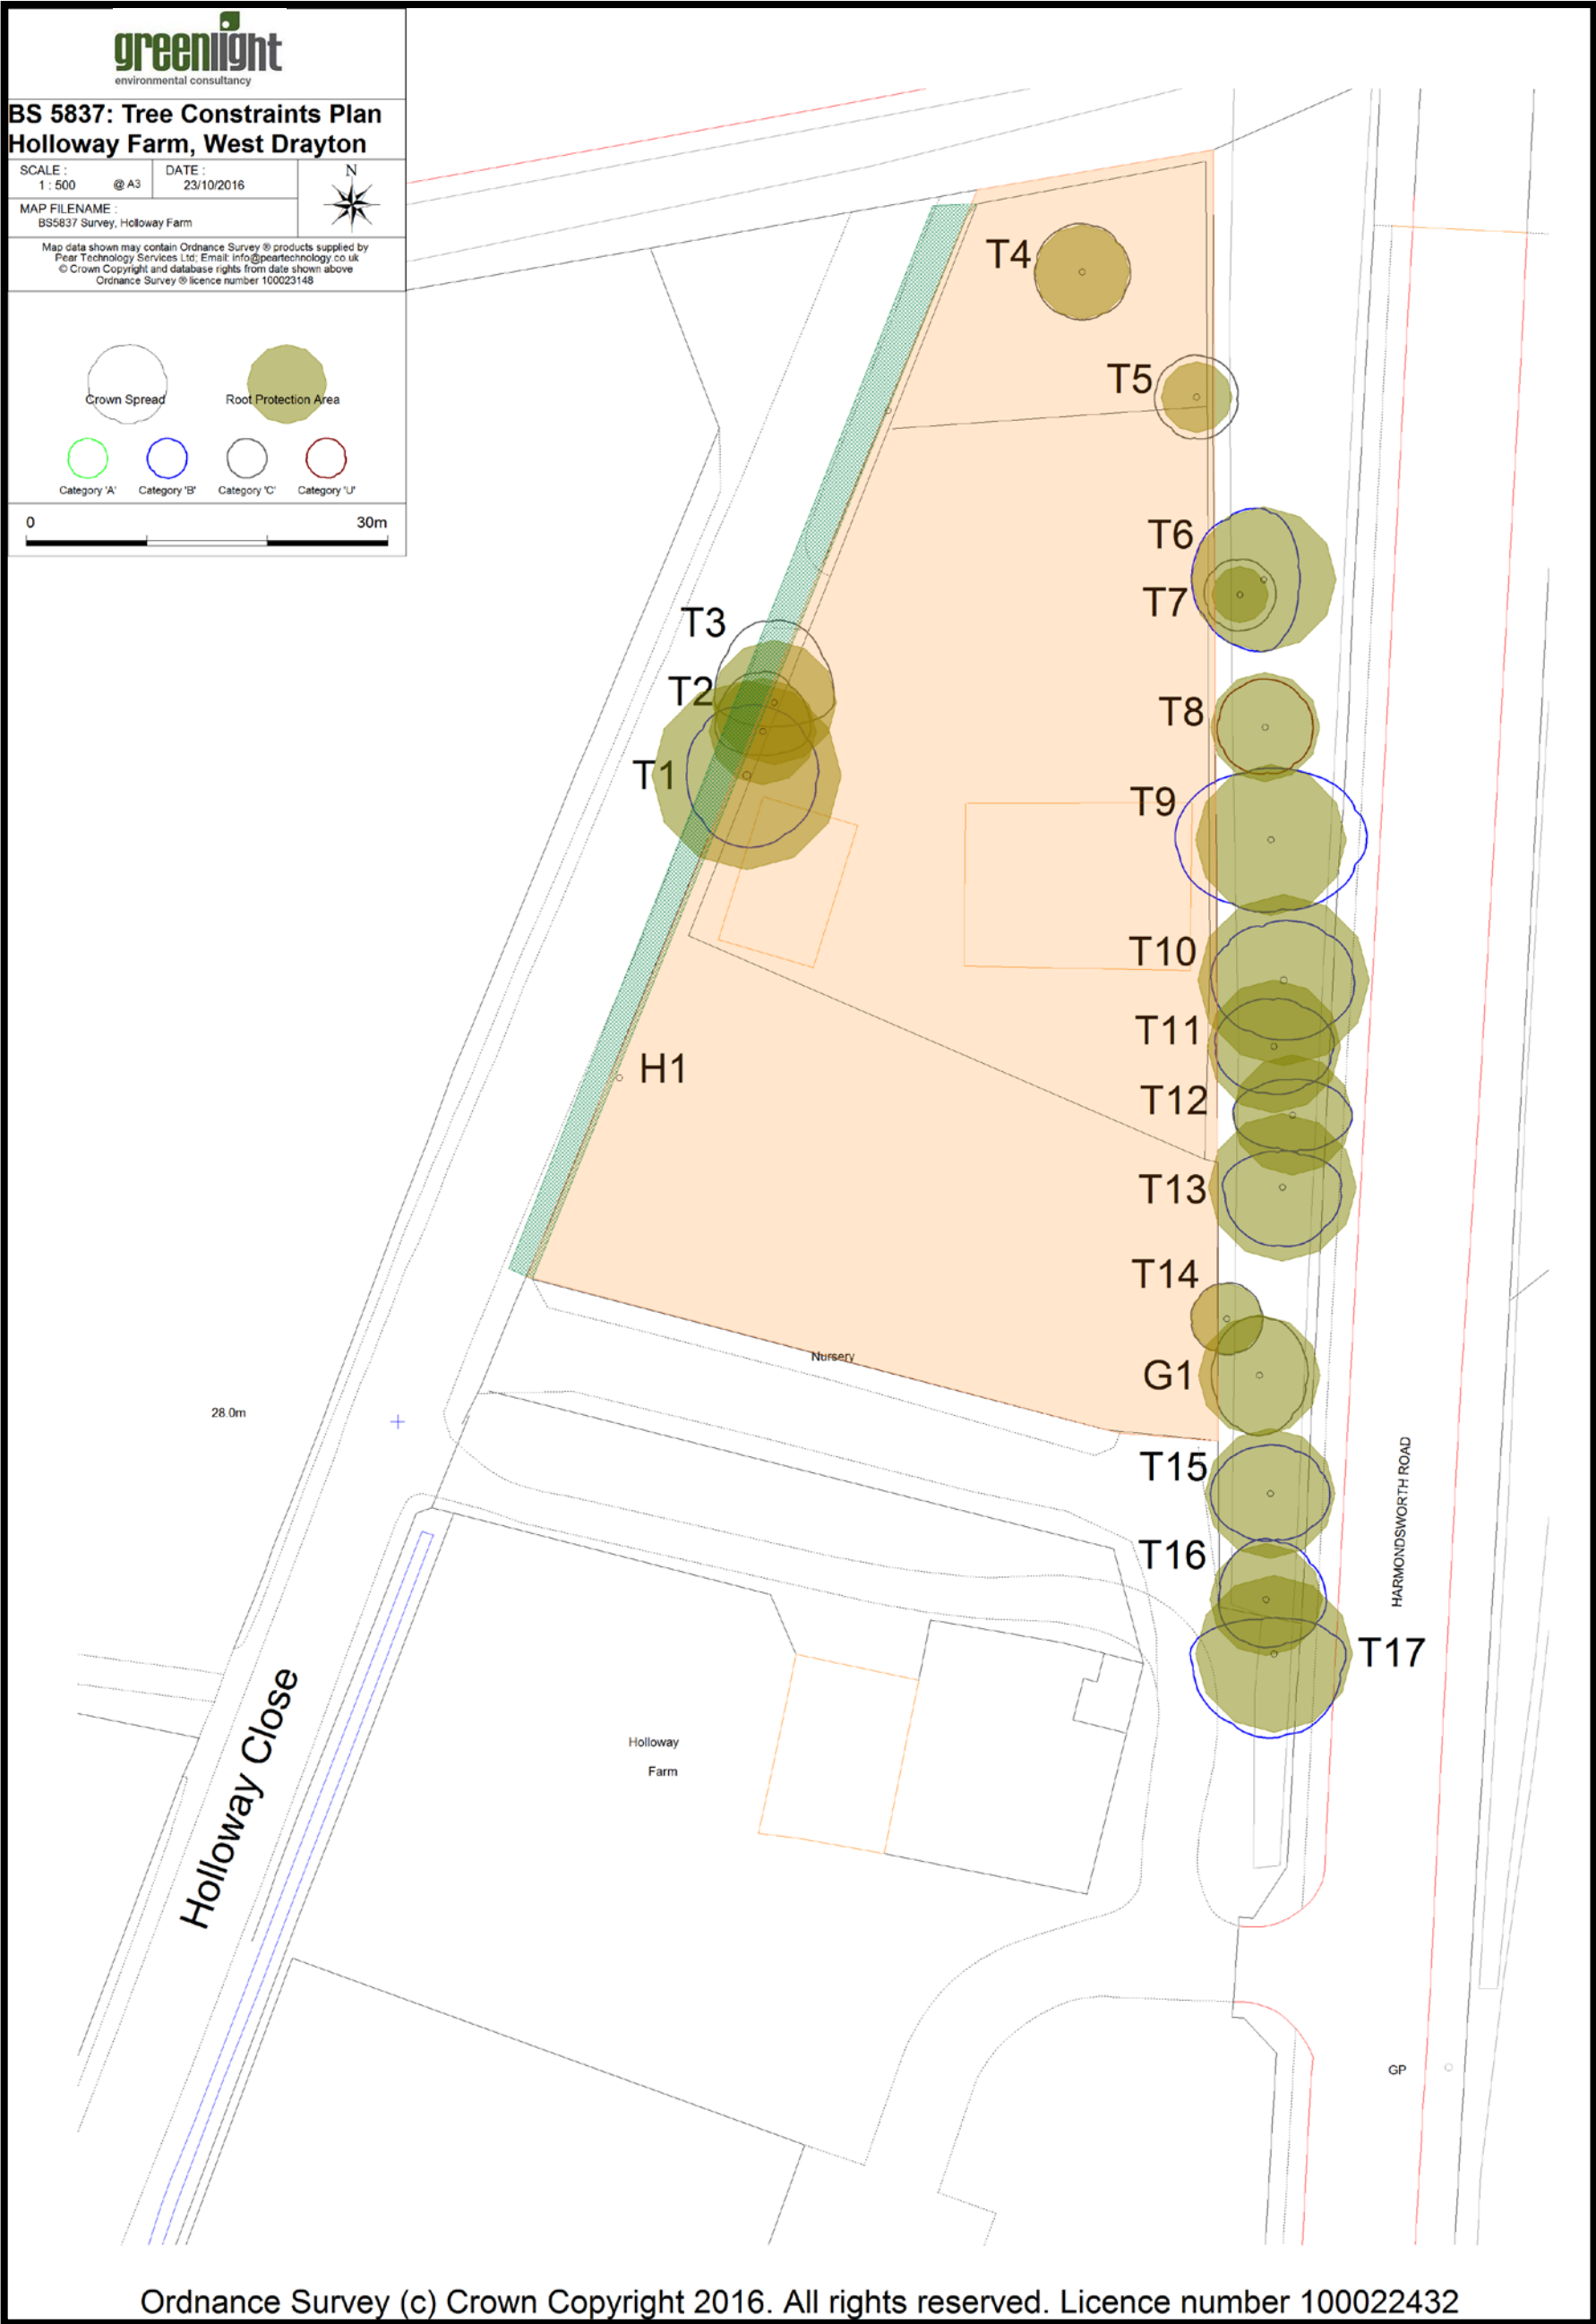
Figure 3: Tree Constraints Plan

- 5.1 The area shown on the plan in Fig 3. consists of the entrance to the site from Harmondsworth Road for all businesses and beyond the link road to the access road that runs along the western side of the site is an area of compacted gravel hardstanding. The boundaries have not changed since the development took place. It appears that all vegetation on the boundaries of the site have been retained. The hedgerow trees and shrubs are showing no signs of decline that can be attributed to the creation of the hardstanding. The elm is in decline for reasons quite unrelated to the development.

5.8 The Tree Constraints Plan in Figure 3 shows the trees retained after development. This plan shows the distance that construction should normally be kept away from the retained trees to provide the Root Protection Area (RPA) recommended in BS 5837: 2012 and how there has been no encroachment into any of the RPAs.

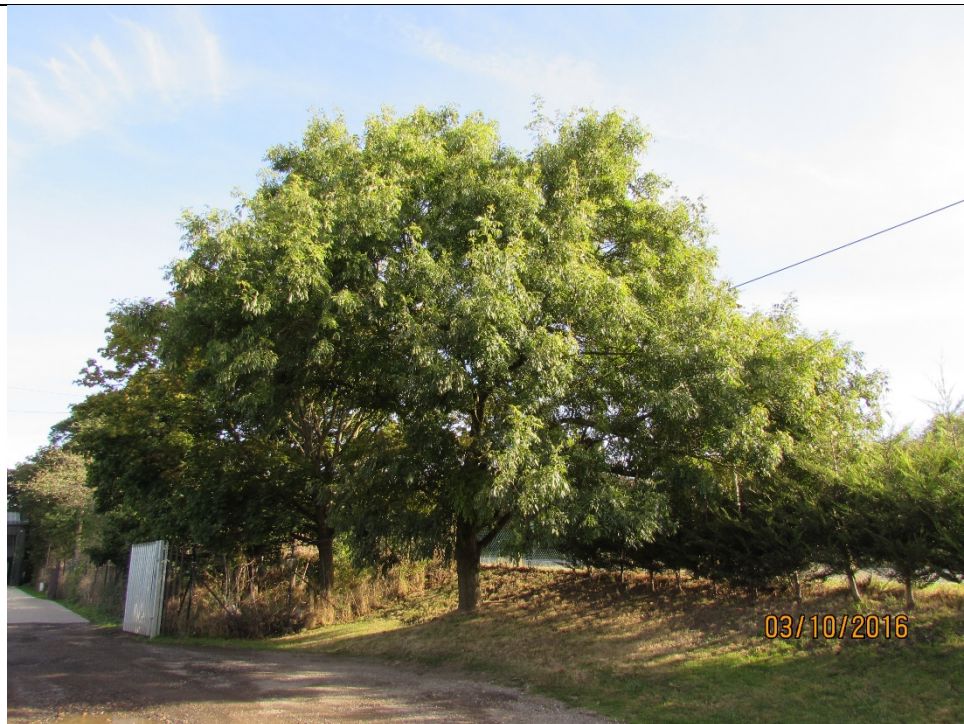
| Tree ID | Common Name | Maturity | Height (m) | Height and direction of first significant branch (m) | Diam (mm) | RPA radius (m) | RPA Area (m2) | Spread - N (m) | Spread - E (m) | Spread - S (m) | Spread - W (m) | Category | Life Expectancy | Phys Condition | Tree work recommendations | Comment |
|---|---|---|---|---|---|---|---|---|---|---|---|---|---|---|---|---|
| T17 | Common Ash | Mature | 12 | 1.3m E | 530 | 6.36 | 127 | 3 | 6 | 7 | 7 | B2 | >40 yrs | Good | No action | |

Overview of site entrance and ash T17

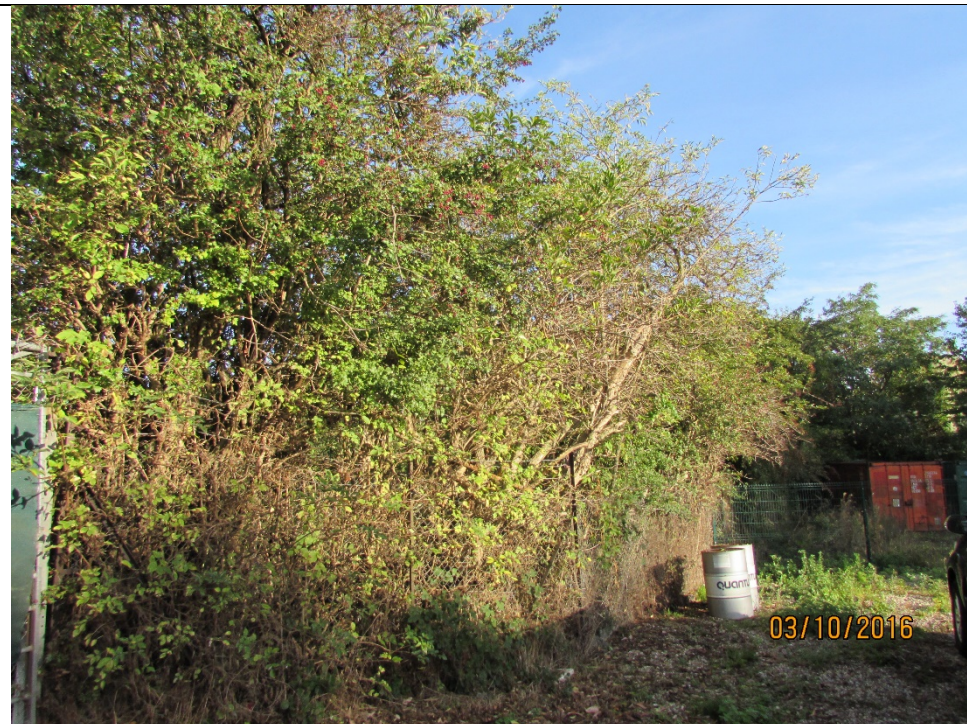
| Tree ID | Common Name | Maturity | Height (m) | Height and direction of first significant branch (m) | Diam (mm) | RPA radius (m) | RPA Area (m2) | Spread - N (m) | Spread - E (m) | Spread - S (m) | Spread - W (m) | Category | Life Expectancy | Phys Condition | Tree work recommendations | Comment |
|---|---|---|---|---|---|---|---|---|---|---|---|---|---|---|---|---|
| H1 | Mixed native hedge | Semi-mature | 6 | n/a | n/a | n/a | n/a | n/a | n/a | n/a | n/a | C2 | 20 to 40 yrs | Fair | No action | |

Mixed native hedge H1

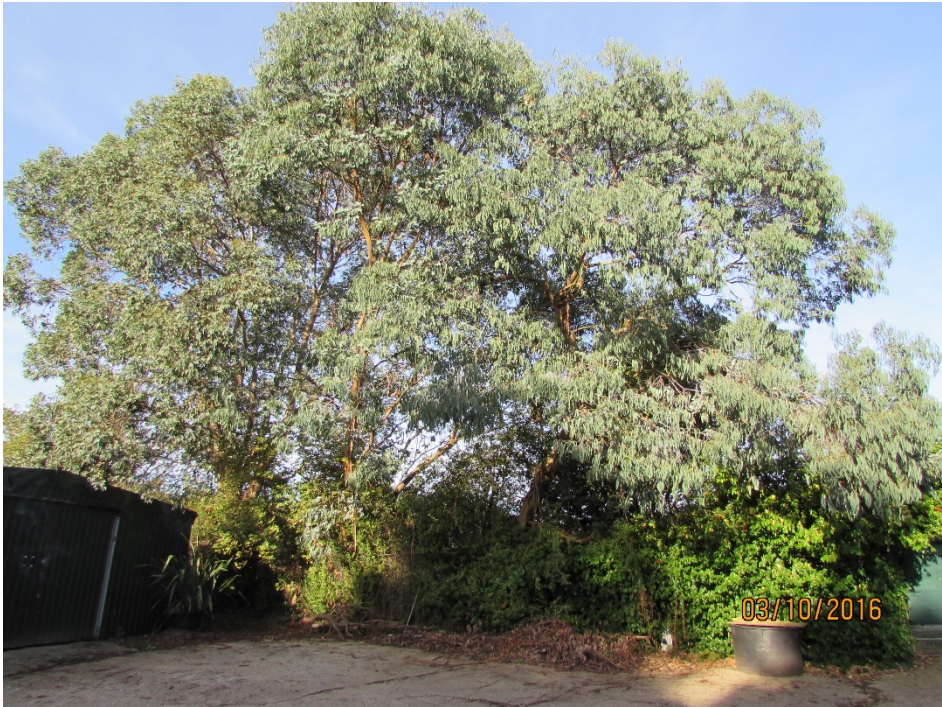
Blue gum trees T1-T3

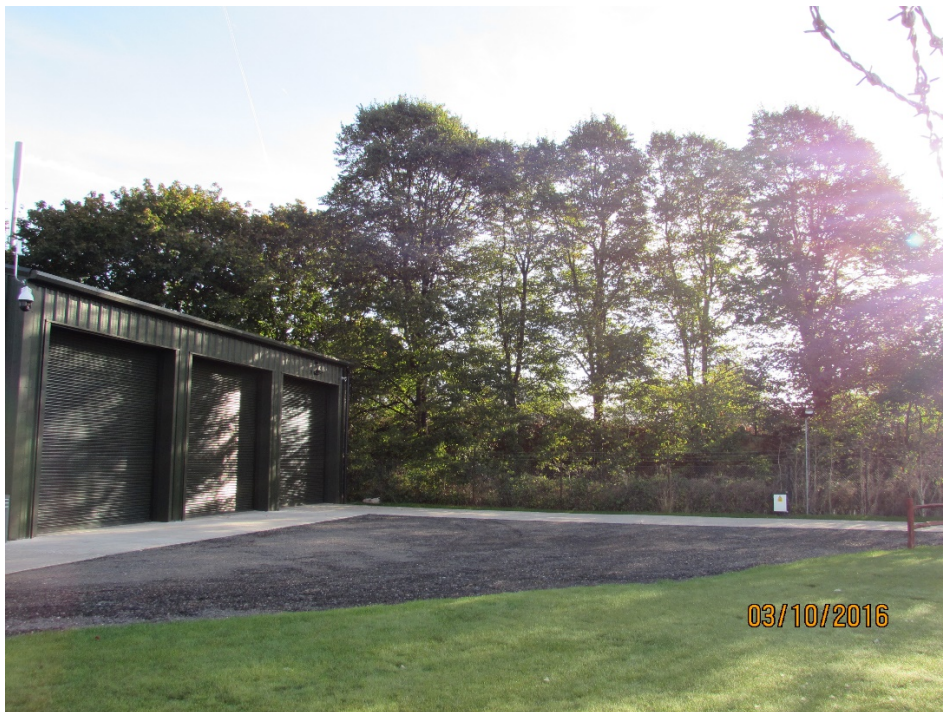
Norway maple trees T10-13

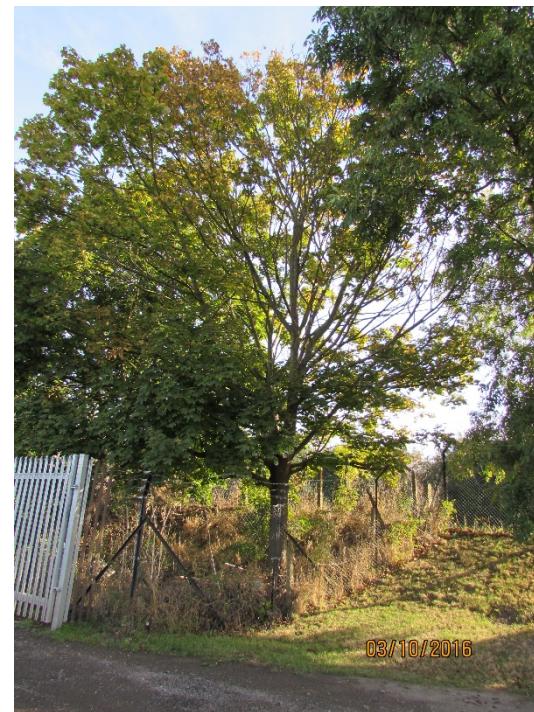
| Tree ID | Common Name | Maturity | Height (m) | Height and direction of first significant branch (m) | Diam (mm) | RPA radius (m) | RPA Area (m2) | Spread - N (m) | Spread - E (m) | Spread - S (m) | Spread - W (m) | Category | Life Expectancy | Phys Condition | Tree work recommendations | Comment |
|---|---|---|---|---|---|---|---|---|---|---|---|---|---|---|---|---|
| T16 | Norway Maple | Semi-mature | 12.5 | 2m W | 380 | 4.56 | 65 | 5 | 5 | 4 | 4 | B2 | 20 to 40 yrs | Decline | No action | |

Declining maple T16
