Arboricultural Impact Assessment

Harefield Grove, Rickmansworth Road, Harefield

Comer Homes

JBA 20/027 AR01

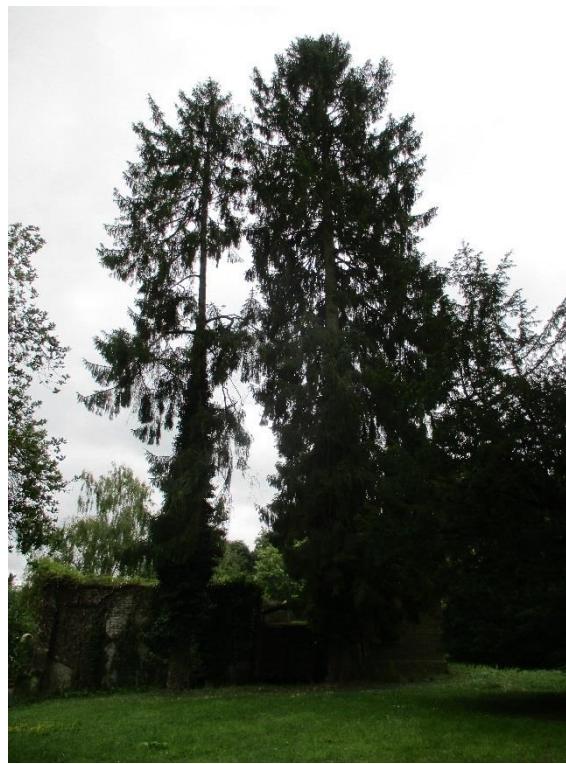
Photograph 4: View of spruces (T45 and T44) from the north

- 6.14 The refuse and cycle storage facilities encroach within the RPA of T44, a mature B category Norway spruce.
- 6.15 Proposed resurfacing of the main driveway from the site entrance will be within the RPAs of numerous mature and early mature trees, most of which are of high to moderate quality and value.

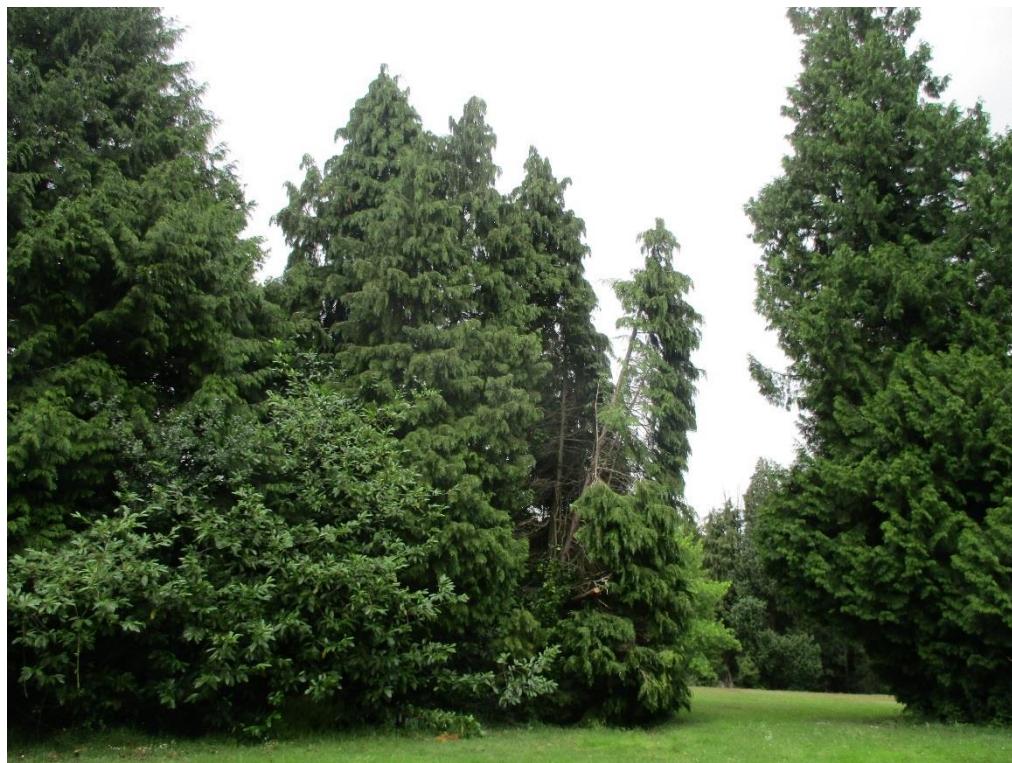
Photograph 5: View of G49, T57 and T50 from the south east

- 6.10 The eastern side of one group (G49) will be pruned where necessary to provide sufficient clearance prior to constructing the proposed original driveway to the main house. This will include cutting back of the evergreen shrub understorey and minor crown lifting of trees, which will not have an adverse impact on their condition or visual amenity value.
- 6.11 Two silver birches (T98 and T99) will have small diameter lower branches removed to provide sufficient clearance prior to building the approved house and parking spaces and restoring the adjacent conservatory. Such pruning will not adversely affect the trees' condition.
- 6.12 Selective pruning or removal of lower branches will be required to trees overhanging the proposed paths throughout the site; such works will be minor and will not have an adverse impact on their condition or visual amenity value

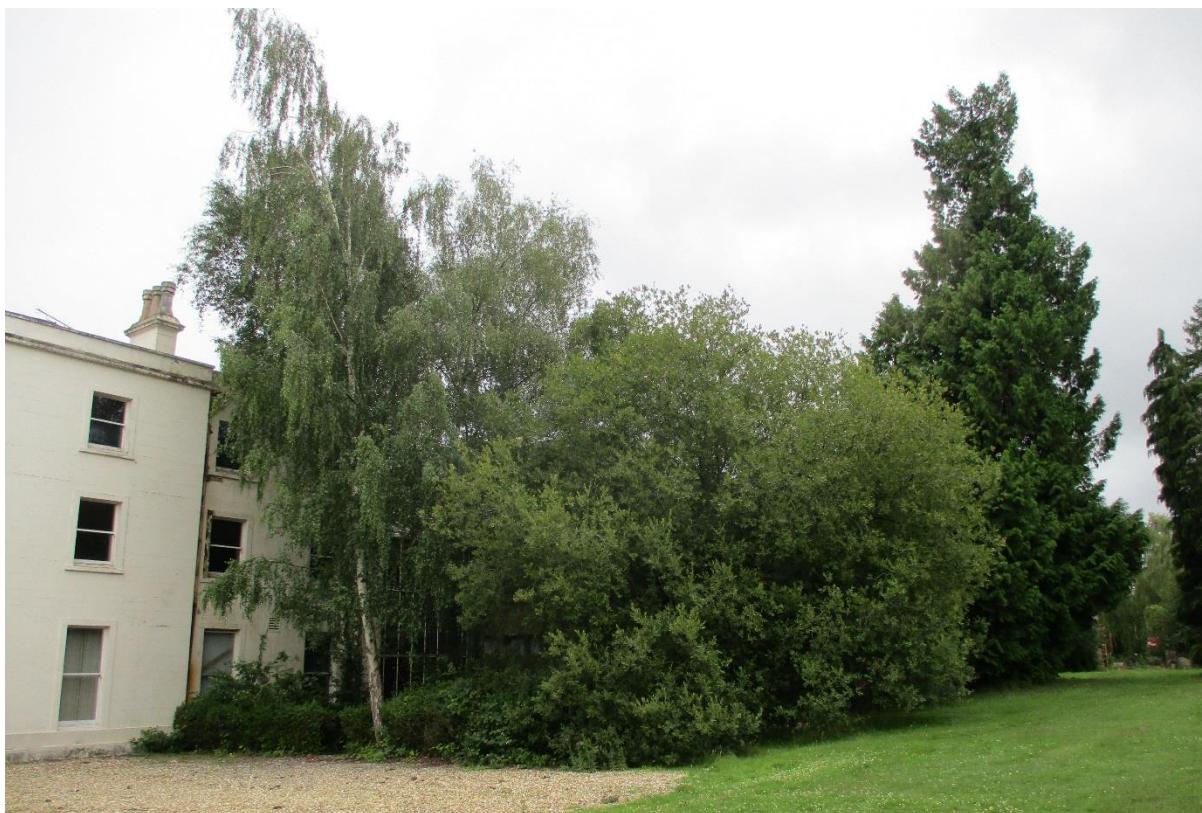
**Photograph 6: View of birches (T52-56), willow (T51) and Western red cedar (T50)
adjacent the main house**

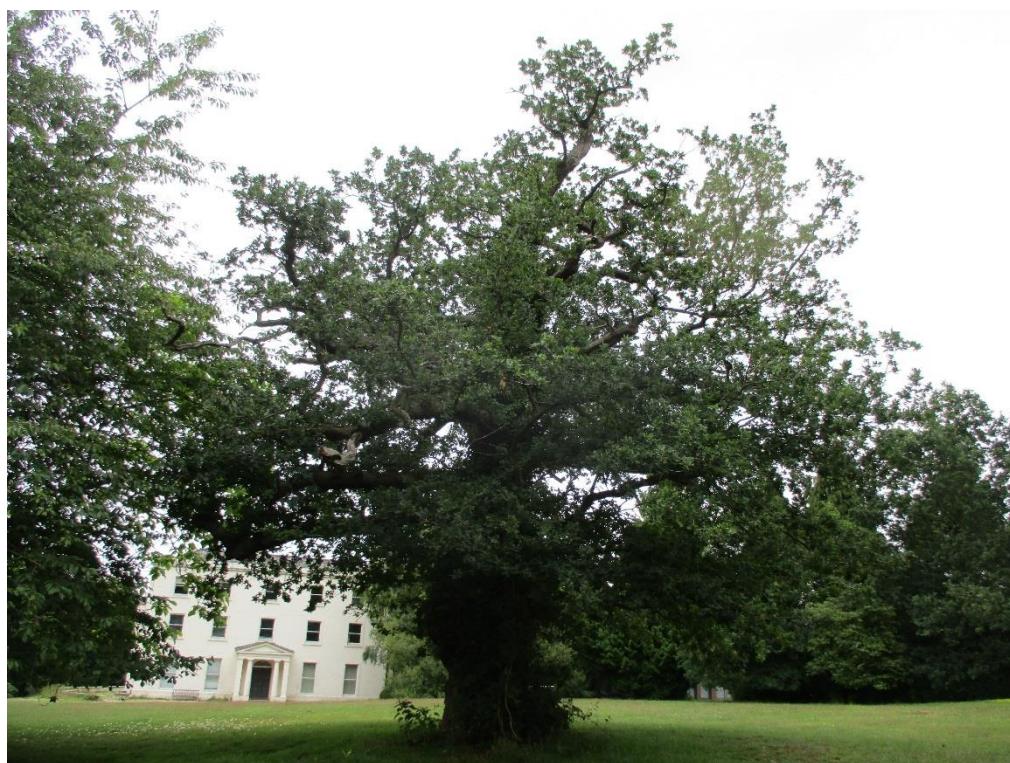
Photograph 7: View of veteran oak (T59) from the west

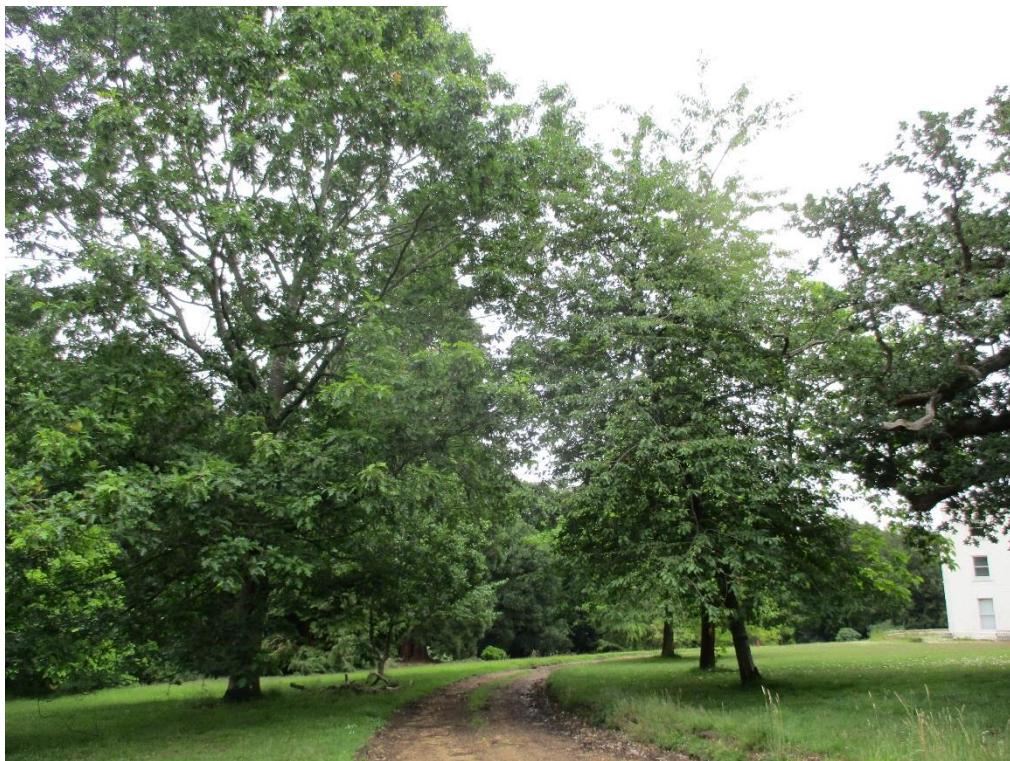
Photograph 8: View of trees T60-T64 from the south

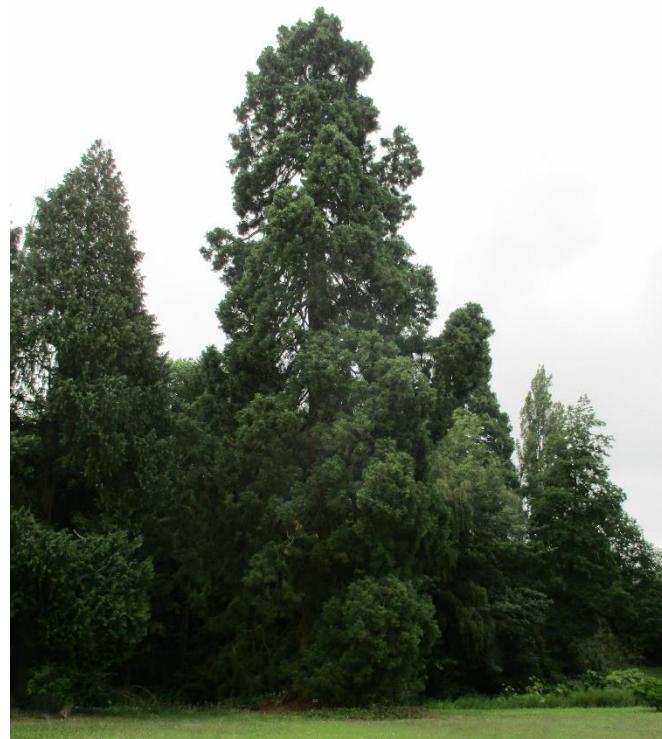
Photograph 9: View of Giant sequoia (T67) from the south east

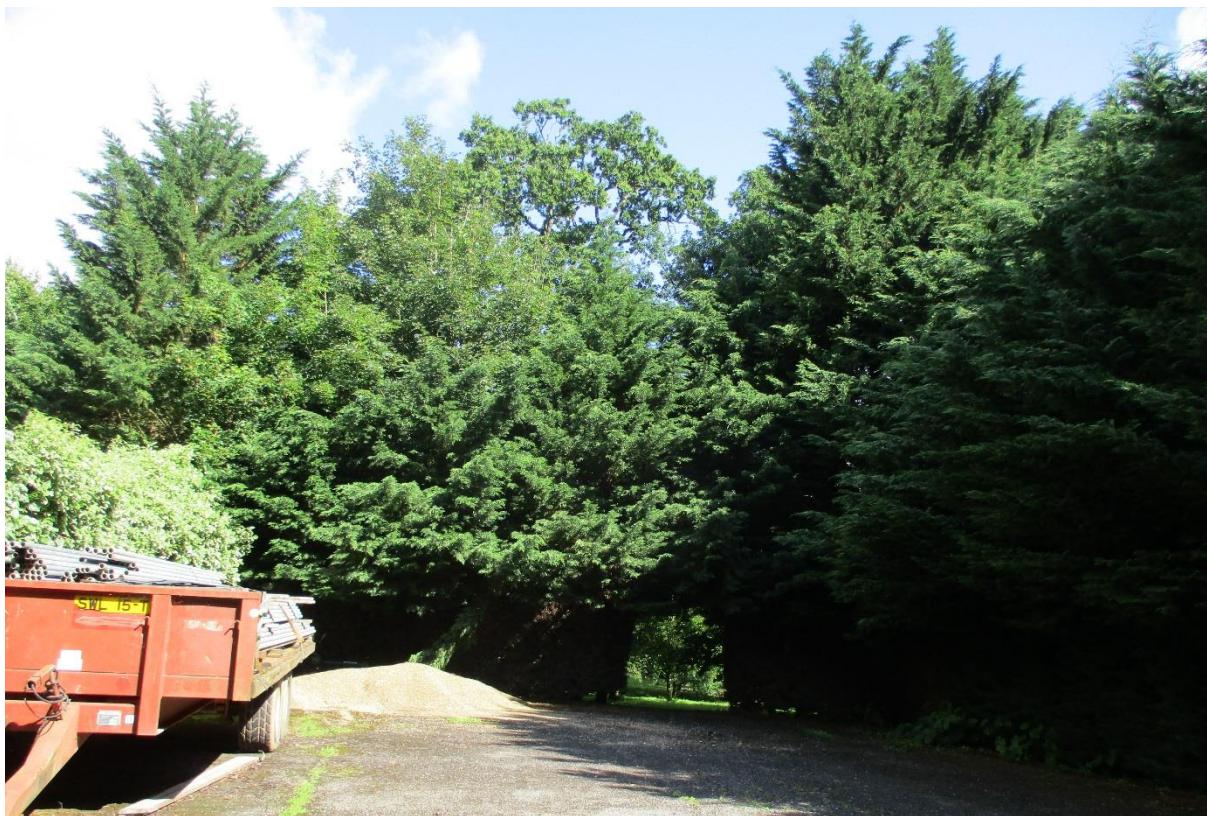
Photograph 11: View of G97 from the south

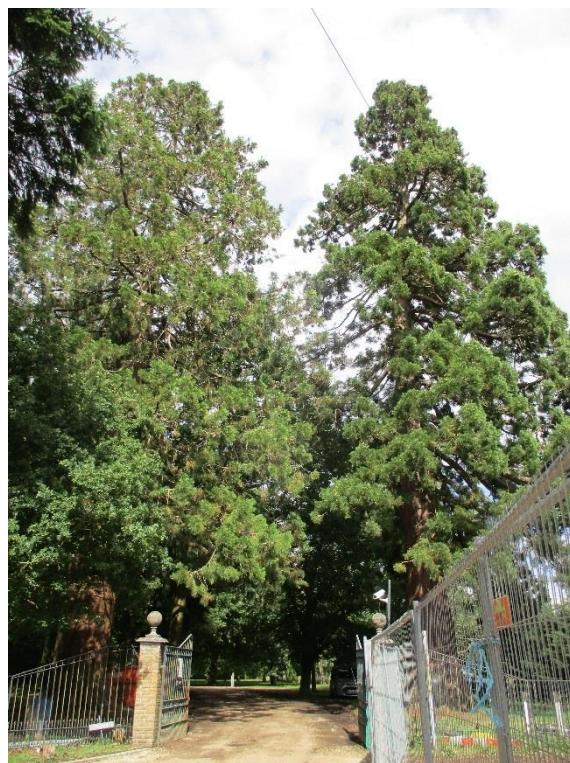
Photograph 14: View of Giant sequoias (T152 & T153) from the site entrance
