Preliminary Roost Assessment

77 Hilliard Road, Northwood Hills, HA6 1SL

November 2023

Project	77 Hilliard Road, Northwood Hills, HA6 1SL – Preliminary Roost Assessment
Client	Zoe Wilson & Michael Howard
Project Code	23-021
Report Ref.	23-021-PRA
Version	Issue 1

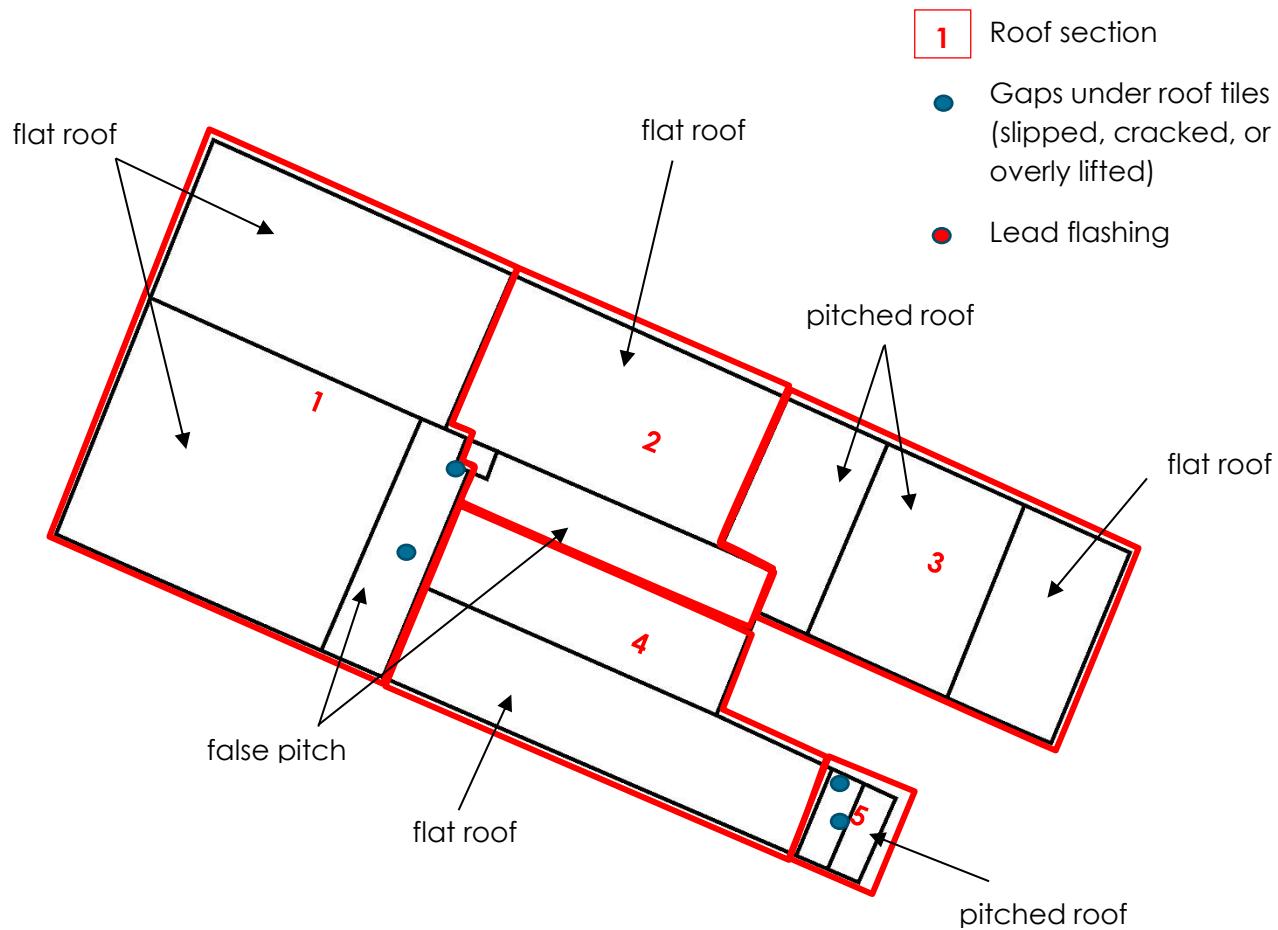
Building and PRF Descriptions	Suitability
Section 1	<p>Section 1 houses the main work area of the workshop with woodworking machinery still present. The workshop has been used daily until exchange of ownership with heavy machinery routinely in use creating significant dust, noise and vibration.</p> <p>Internally the workshop is cluttered with storage cupboards and units on the walls and significant timber offcuts stored in the rafters. The ceiling is flat wooden ply boards, abutted to the flat roofline. Inspection of the visible surfaces did not identify the presence of droppings or feeding remains. The space is sporadically filled with thick cobwebs, coated in dust.</p> <p>Externally there is a false pitch which faces southeast, this pitch leads directly into a corrugated metal roofline to both the north and west. The pitch is in reasonable condition with a lost tile replaced with a felt sheet. There are several disjointed tiles at the chimney exit point, however upon closer inspection with the camera pole (10x zoom), and where viewed internally there was no evidence of either bats, droppings or obvious staining. The back of the tiles has thick sheeted insulation present which gives minimal opportunity for crevice dwelling bats.</p> <p>It is highly unlikely due to the nature of the work which takes place that this section of the building would offer suitable roosting/feeding/hibernation potential for bats.</p>	Negligible

Section 2	<p>Section 2 follows a similar structure to Section 1 with a false pitch facing west, and a flat roof constructed of felt facing north and northeast. Externally, the pitched part of the roof has been backfilled with a mixture of insulation and expanding foam on the underside. The chimney sits between sections one and two, no loose tiles noted within section two roofline. The chimney is present at the western end of the false pitch. A bay window extends towards the courtyard (facing west) which is covered by polycarbonate sheets.</p> <p>Internally the building contains a partial suspended ceiling grid above which a collection of wood had been stacked. The internal make up is much the same as section one, with a cluttered workspace, full of cupboards, equipment, and wood stacked up into the rafters.</p> <p>There are no obvious signs of bats within this space, either externally or internally, as per section one, this area would also be affected by dust, noise and vibrations. Overall, this space does not offer any suitable roosting/feeding or hibernation opportunities for bats.</p>	Negligible

Section 3	<p>Section 3 is currently used as a wood storage area. The building has a pitched roof facing approximately northeast to south, this is then connected on the east and west pitches to a flat roof. The roof is supported by a combination of steel supports and brickwork columns. There is a metal roller shutter within the pitched element of the building which appears in a state of disrepair leaving the structure open at all times to the courtyard.</p> <p>Internally the workshop is cluttered with timber and offcuts stored in the rafters.</p> <p>Inspection of the roof using the 4K camera on a pole did not identify any slipped or missing tiles. No light ingress was observed from inside the building. The roof appears in good condition with no obvious defects. Although it was noted that the rafters are currently being supported by steel props implying instability within structure. There is a gap under the barge board which leads directly into the open space, no evidence of bats was noted when viewed with a high-powered torch/endoscope.</p> <p>Overall, this space is unlikely to offer suitable roosting/feeding or hibernation potential for bats. As the structure is open, it is affected by the weather. To a lesser degree compared to section one and two, it will be affected by noise and vibration, and frequent use of removing and storing wooden planks, both on the ground, and up towards the roofline pitch.</p>	Negligible

Section 4	<p>Section 4 is an open fronted, red brick walled structure with a corrugated tin roof and partial wooden ceiling. It is open to the courtyard with only half brick, half wooden support columns, and no separating wall. It also includes the polycarbonate panel covering which encompasses half of the courtyard.</p> <p>No internal or external features of interest were present, due to the nature of the roofline and its open nature the building does not offer any opportunities for bats.</p>	None

Section 5	<p>Section 5 is a small toilet block. The building is in a state of disrepair, with the internal plywood ceiling appearing wet and mouldy with areas peeling away. Externally, several slipped tiles were noted from the ground, although it appears that the tiles are doubled up, based on the deterioration of the inside of the toilet block, it seems reasonable to assume that this building is no longer watertight where the tiles have slipped and across the building. Although these slipped tiles could offer suitable crevice opportunities for bats, as they are no longer weatherproof, it would be unlikely that they would be suitable for bats.</p>	Negligible
-----------	-----------------------------------------------------------------------------------------------------------------------------------------------------------------------------------------------------------------------------------------------------------------------------------------------------------------------------------------------------------------------------------------------------------------------------------------------------------------------------------------------------------------------------------------------------------------------------------------------------------------------------------------------------------------------	------------

Figure 1 – Breakdown of structure, showing features identified during the preliminary roost assessment.

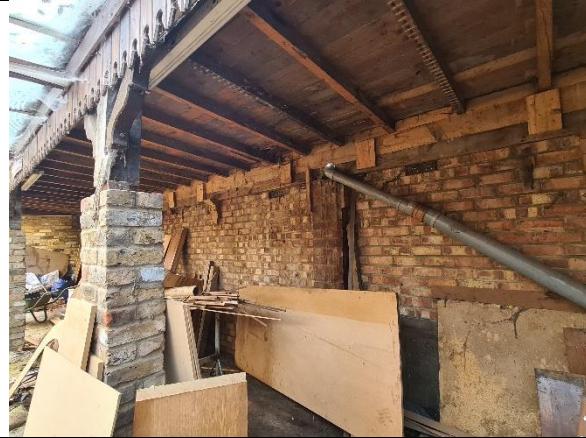
Image 3: Underside of flat timber clad Section 4

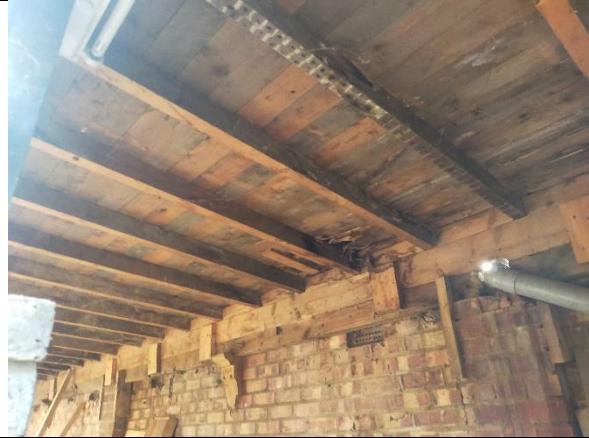
Image 4: Underside of Section 4

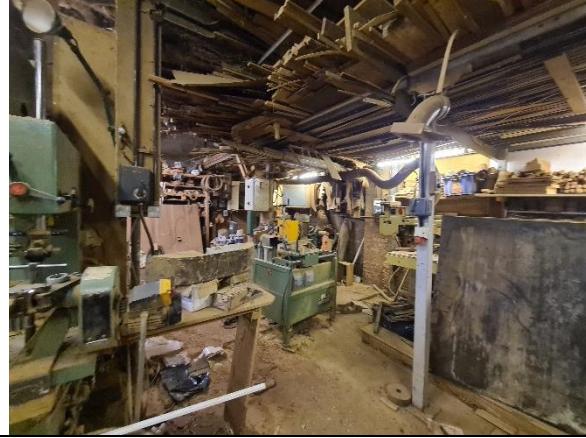
- 5.1.3 Within the false pitch of section one of the building, there were missing tiles observed via photographs. Following inspection of these tiles internally, it is unlikely that these would provide a suitable resting place due to being directly adjacent to the flue for the chimney, which is unencapsulated internally, causing this area to become quite hot. This combined with the regular industrial use of the space and cramped environment would suggest that opportunities for crevice dwelling bats would be significantly hampered due to rigid insulation boards and foam spray being used behind the false pitch roof tiles.

Image 5: Internal view of Section 1 former main workshop area with flat roof.

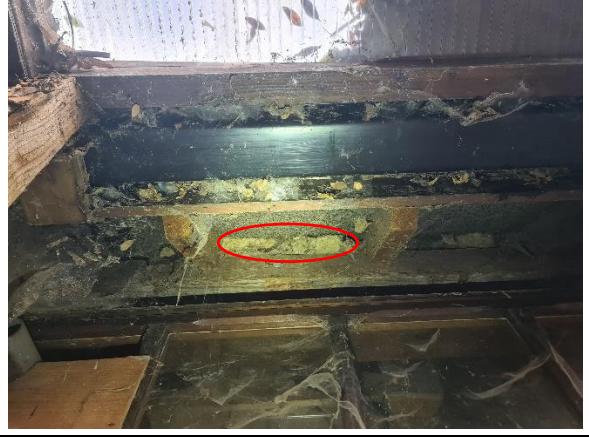
Image 6: Section 2 pitch with expanding foam filling.

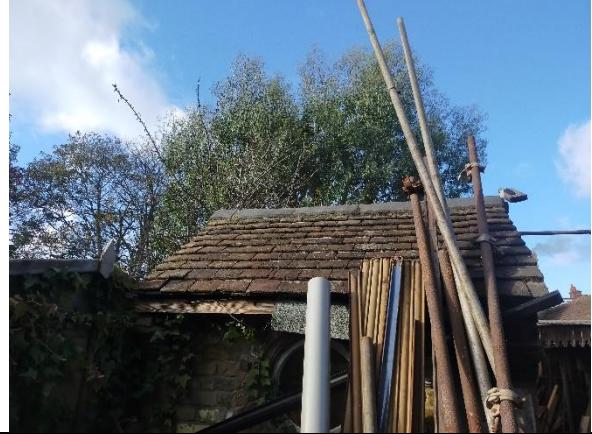
- 5.1.4 The toilet block is in a state of disrepair and is not considered to offer suitable roosting potential for bats, despite having two slipped tiles, these tiles were inspected, and no evidence of bats was noted, such as droppings/staining or obvious crawl pathways. The roof line is leaking, which is causing internal damage, it seems reasonable to conclude that the slipped tiles are no longer watertight, which would significantly reduce the likelihood of bats using them for crevice dwelling purposes.

Image 7: Section 5 toilet block with pitched roof.	Image 8: Internal view of Section 3 metal flat roof component.

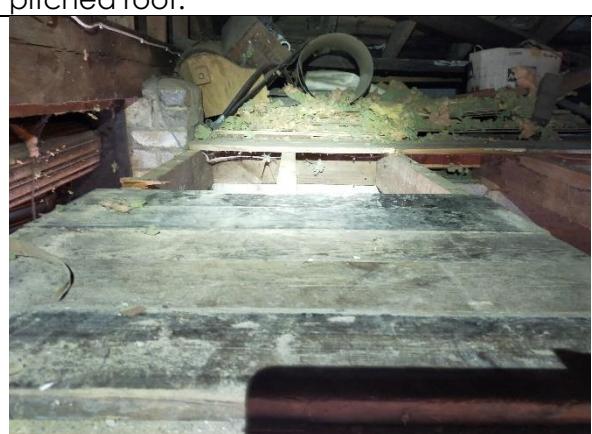
Image 11: Boarding within pitched roof of Section 3 with no droppings observed.	Image 12: Internal view of Section 3 pitched roof.

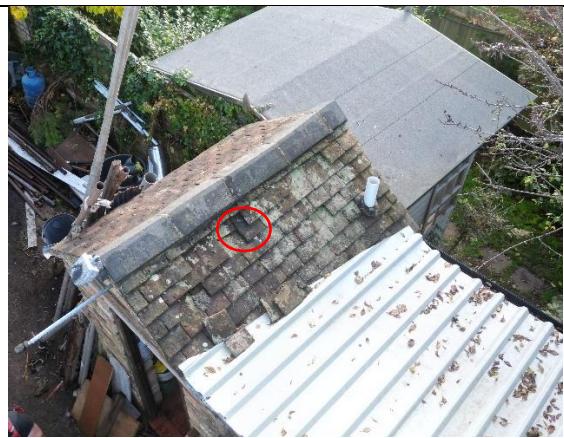
Image 16: View of Section 5 toilet block roof.
