Arboricultural Report

In accordance with BS 5837:2012

For land adjacent to

67 Chiltern View Road

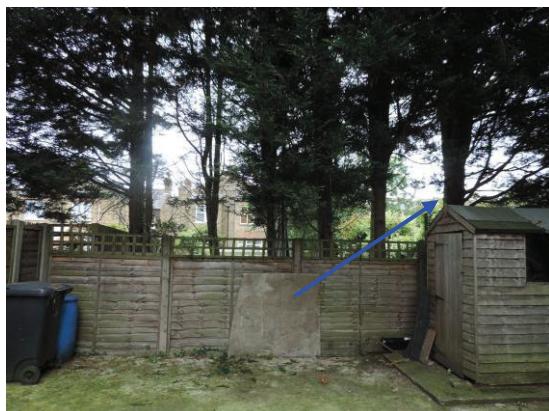
Tree	1
Location	North west corner of the garden of 61 The Greenway
Species	Leyland Cypress
Number stems	1
DBH (cm)	36 – estimated measurement
Height (m)	13.0
Spread (m)	7.5
Age	Semi mature
Condition	Good
Observations	Access not possible to use diameter tape. Westernmost and largest in a line of six trees, probably planted as a hedge. No evidence of previous pruning and could cause shading nuisance in the future
BS 5837 category	B
RPA radius (m)	4.32

T1 Viewed from 67 Chiltern View Rd

4.2 This tree is to be retained and its Root Protection area extends at least 370cm into the proposed worksite. The RPA will need to be protected with a physical barrier and signage as per the recommendations on pages 21 and 22 of BS 5837:2012.

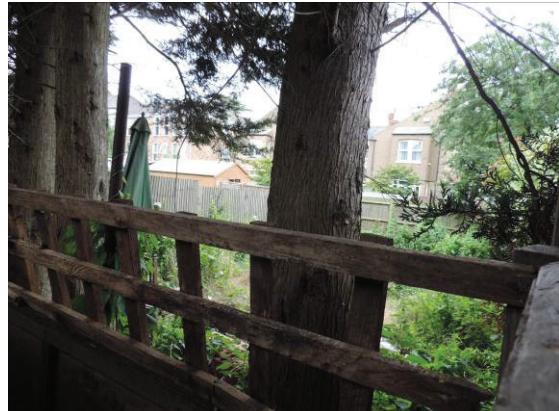
T1 Viewed from the SE corner of the worksite

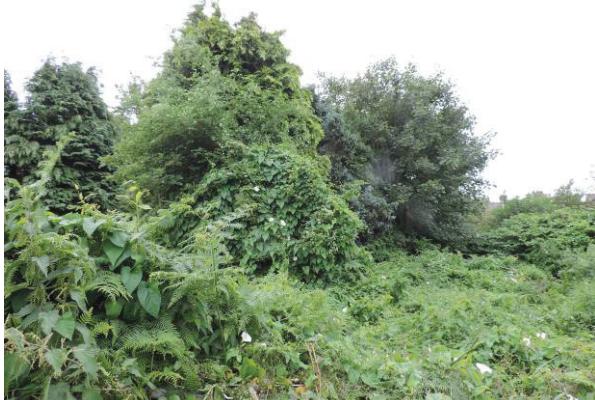
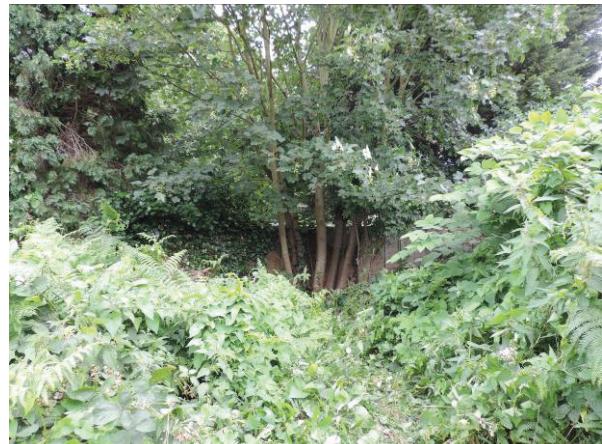
Tree	2
Location	South east corner of the site, 0.6 metres from east boundary and 6.7 metres from south boundary
Species	Sycamore
Number stems	7
DBH (cm)	17.5, 11.5, 11.5, 16.0, 13.5, 16.0, 16.5
Height (m)	12.5
Spread (m)	9.4
Age	Early mature
Condition	Fair
Observations	Seven etiolated stems of regeneration from decayed coppice stool
BS 5837 category	U
RPA radius (m)	4.65

T2 Sycamore behind trees 3-6

Multiple stems from coppice stool

4.1 All the trees on the site have been classified as unsuitable for retention as they are young or early mature regeneration from coppice stools. These are tree numbers 2, 6 and 11. However, tree 2 has a DBH in excess of 7.5 centimetres; therefore a “section 211” request will be necessary before it is felled.

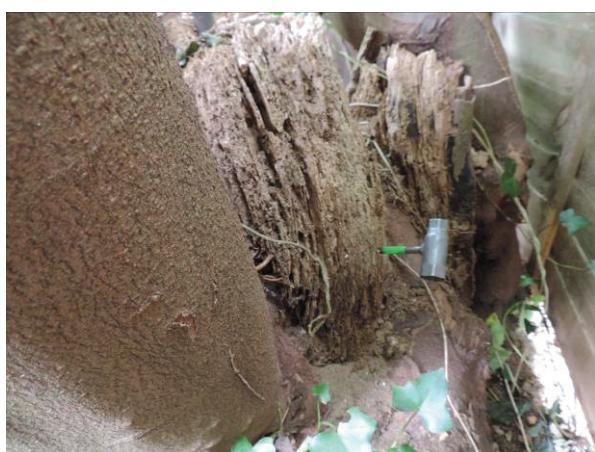
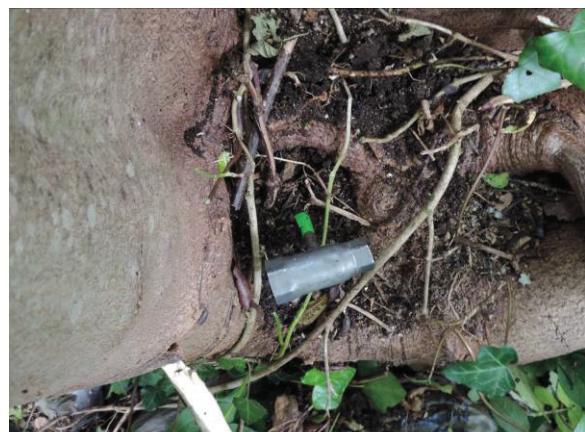
Photos showing decay at coppice stool.
The green tape on the tool shaft is 10cm from the tip

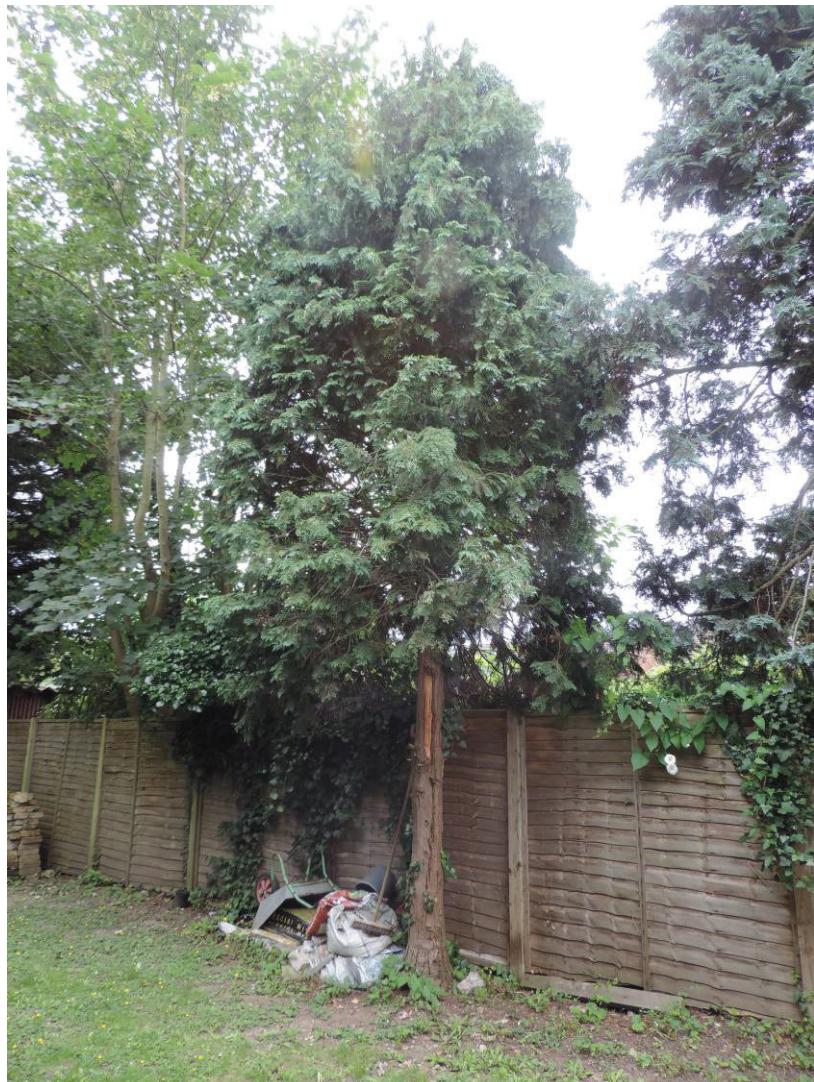
Tree	3
Location	0.6 metres from western boundary of garden of 67 Chiltern View Road
Species	Lawson's Cypress
Number stems	1
DBH (cm)	22
Height (m)	7.5
Spread (m)	3.5
Age	Early mature
Condition	Fair
Observations	Wound on stem at one metre
BS 5837 category	B
RPA radius (m)	2.64

T 3 Photographed from the garden of 67 Chiltern View Road. Note proximity to the fence and the wound on the stem. Approximately 40% of the crown is encroaching over the fence onto the worksite. T2 can be seen to the left.

The trees on the western boundary are within 60cm of the fence and their RPA’s extend 310 centimetres into the worksite. If these trees are retained, a Root Protection area barrier will need to be established on the worksite.

An alternative would be to liaise with the owner of 67 Chiltern View Road with a view to felling these trees prior to the development of the worksite and then replanting suitable replacements once work is completed. The Developer would bear the costs of these operations and the Tree Officers at Hillingdon consulted on suitable replacements and the necessary conditions added to the planning approval.

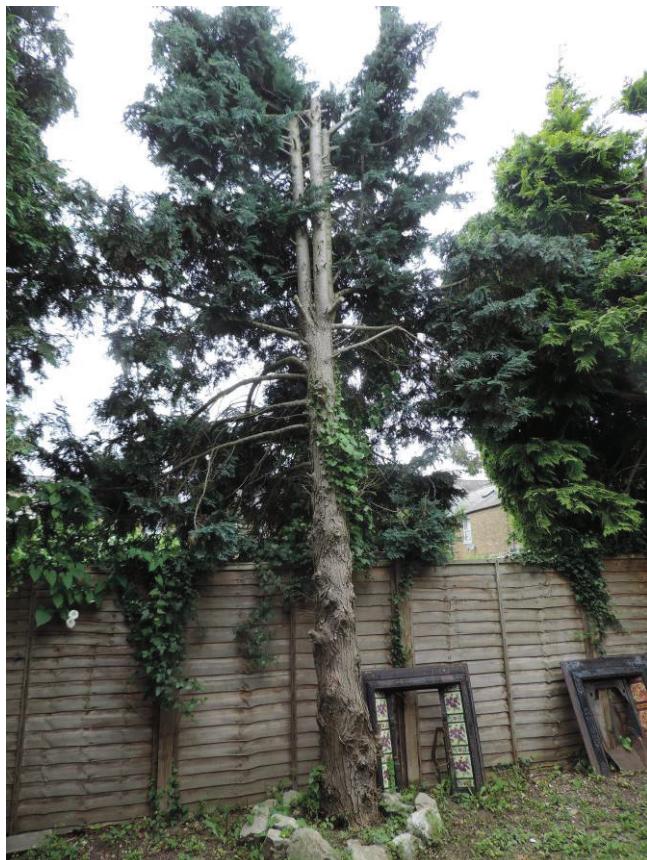
Tree	4
Location	0.6 metres from western boundary of garden of 67 Chiltern View Road
Species	Lawson's Cypress
Number stems	1
DBH (cm)	32
Height (m)	8.2
Spread (m)	4.5
Age	Early mature
Condition	Poor
Observations	Previously topped, crown asymmetric with most leafing over the fence on the worksite side
BS 5837 category	C
RPA radius (m)	3.84

T4 Lawson's Cypress that has been unsympathetically pruned and topped. A poor quality tree with in excess of 80% of the crown encroaching over the fence to the worksite.

However, it has been previously noted that these trees are in poor condition having been unsympathetically pruned leaving the majority of the remaining leafing area encroaching over the boundary fence.

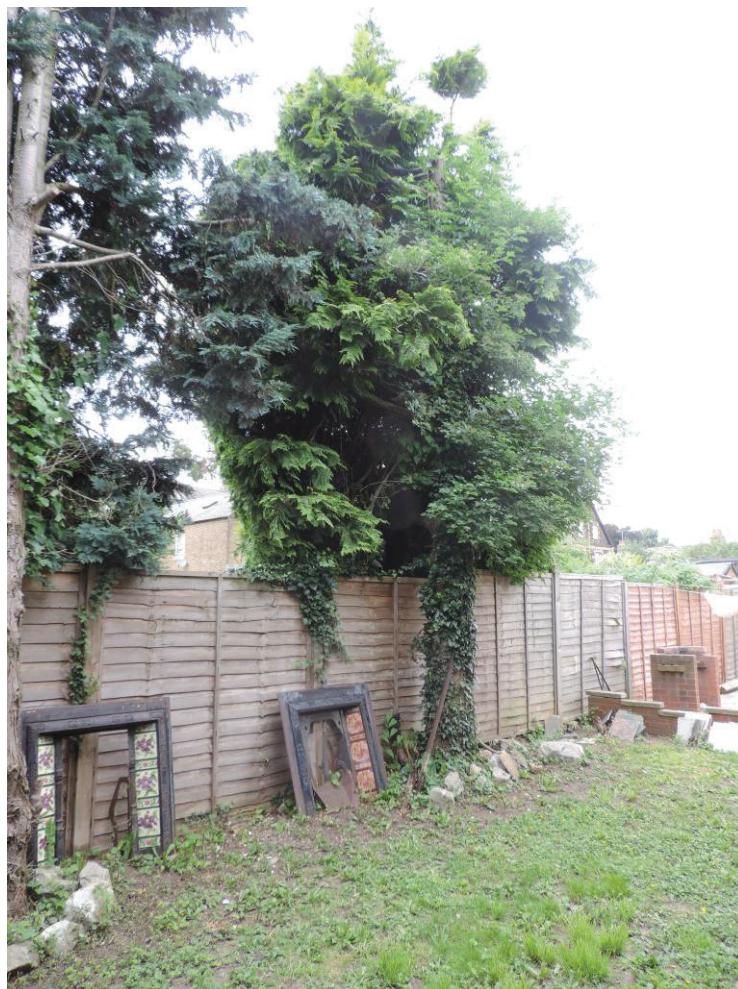
Tree	5
Location	0.6 metres from western boundary of garden of 67 Chiltern View Road
Species	Lawson's Cypress
Number stems	1
DBH (cm)	31
Height (m)	8.2
Spread (m)	4
Age	Early mature
Condition	Poor
Observations	Previously topped, crown asymmetric with most leafing over the fence on the worksite side
BS 5837 category	C
RPA radius (m)	3.72

Tree 5. Lawson's Cypress photographed from the rear garden of 67 Chiltern View Road. The tree has been topped and nearly all branches overhanging this garden have been removed. At least 70% of the canopy of T5 is encroaching over the fence onto the worksite. The bulk of the leafing on the garden side of the fence is from the young Elder (T6) growing on the worksite.

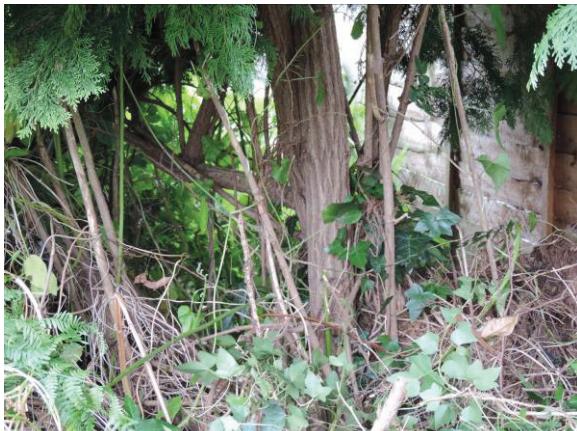
Tree	6
Location	Eastern boundary of the worksite with the canopy of tree 5
Species	Elder
Number stems	2
DBH (cm)	9.0, 5.8
Height (m)	5.0 approximated
Spread (m)	Not measured
Age	Early mature
Condition	Poor
Observations	Suppressed by T5 and canopy smothered with Bindweed and White Bryony
BS 5837 category	U
RPA radius (m)	N/A

Base of T6, early mature Elder

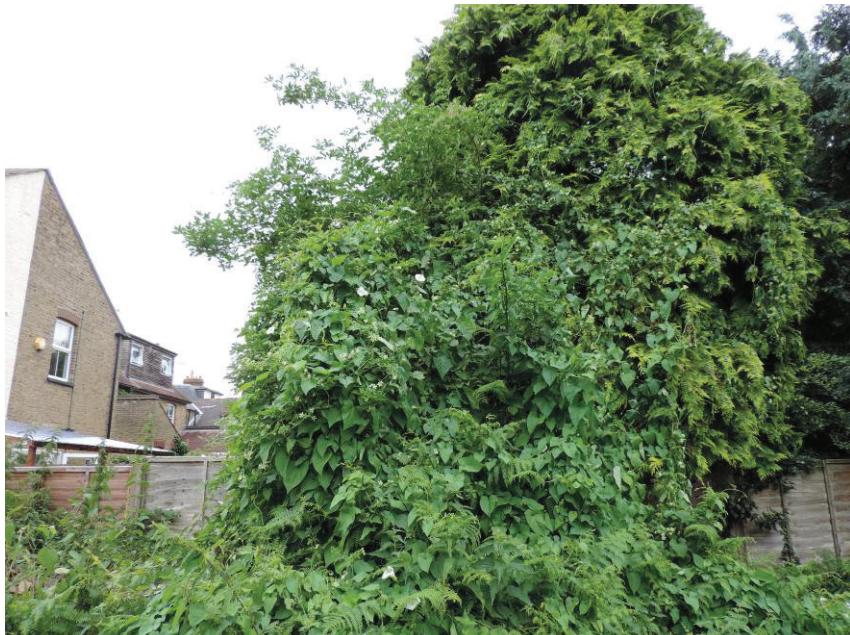
T6 Smothered by Bindweed. This photo illustrates the encroachment over the fence of the canopy of T5

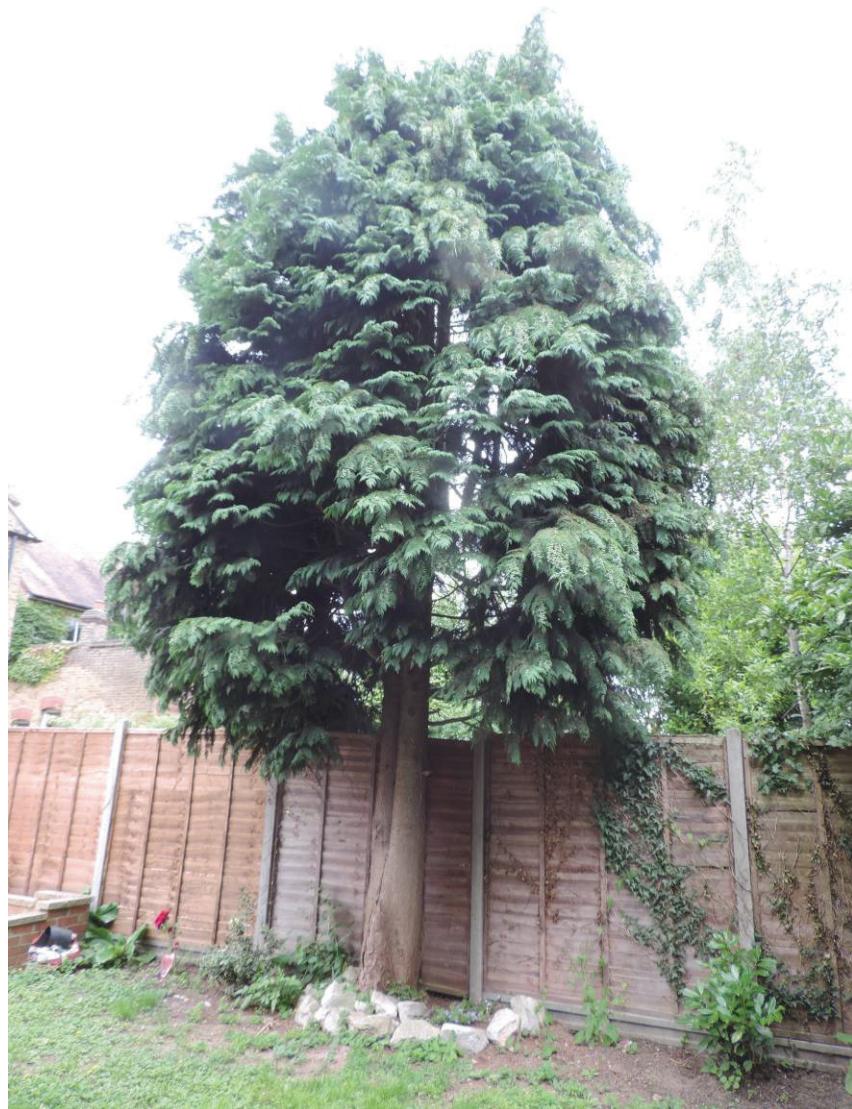
T7 Lawson's Cypress on the eastern boundary of 67 Chiltern View Road. The RPA of this tree does not extend into the proposed worksite.

The RPA of tree 7 does not extend westwards onto the worksite, therefore no action is required in relation to it.

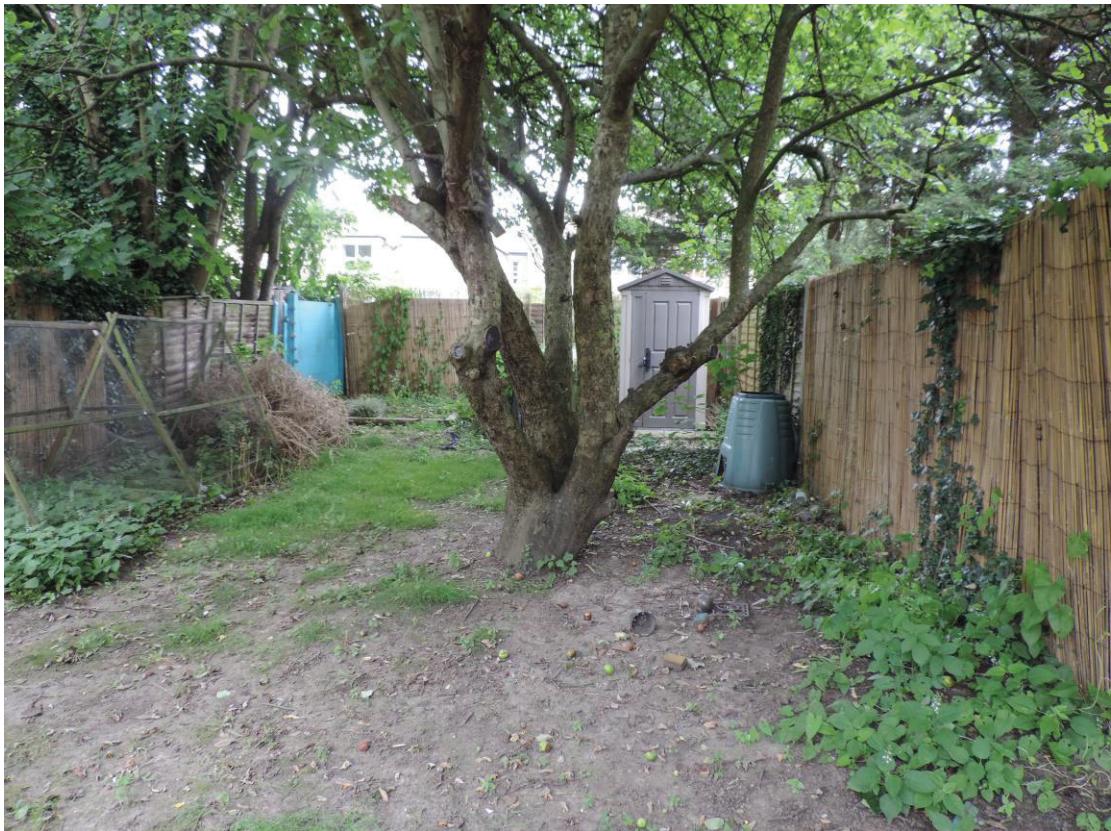
Tree	8
Location	2.0 metres from western boundary of garden of 66 Chiltern View Road
Species	Orchard Apple
Number stems	5
DBH (cm)	24, 23, 23, 25, 19
Height (m)	9
Spread (m)	11.7
Age	Mature
Condition	Fair
Observations	Previous pruning not to BS 3998, congested crown with some deadwood. Shaded by Sycamores in neighbouring garden to the east. Life could be extended by gentle restorative pruning
BS 5837 category	B
RPA radius (m)	6.14

T8 Orchard Apple in the rear garden of 66 Chiltern View Road. The RPA of this tree does not extend into the proposed worksite.

4.4 The Orchard Apple tree in the rear garden (tree 8) of this property is too distant for the works to have any impact on it.

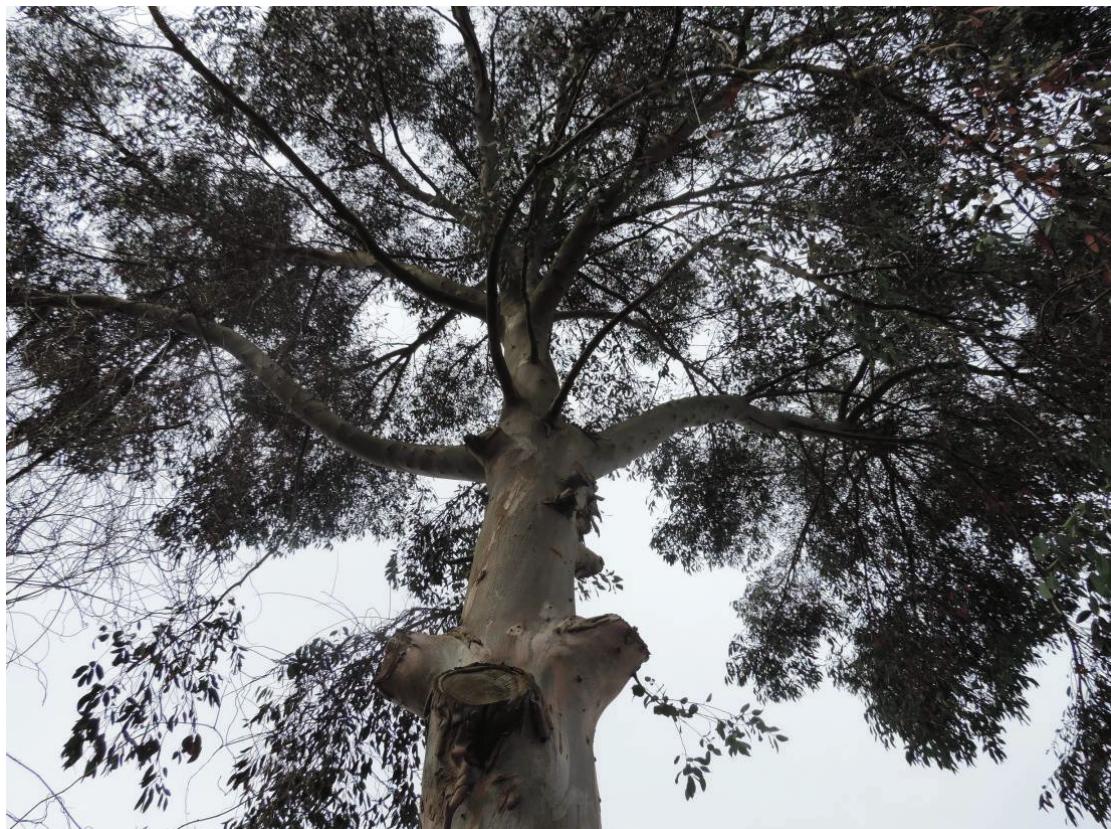
Tree	9
Location	Northern boundary of the rear garden of 17 Alexandra Road – 12 metres from the eastern edge of the house
Species	Eucalyptus
Number stems	1
DBH (cm)	53
Height (m)	18.8
Spread (m)	12.6
Age	Semi Mature
Condition	Fair
Observations	Most significant tree in the vicinity of the worksite. Crown has been raised with large limbs removed, pruning not to BS 3998 – potential for decay around the multiple non-healed pruning wounds. Evidence of shed limb above the pruning wounds. Tree now appears etiolated with thin top-heavy branches with high probability of failure by shedding limb systems. Tree life could be prolonged by pollarding, but failure risk will remain following regrowth
BS 5837 category	C
RPA radius (m)	6.36 Structures within radius so RPA = $6.36^2 \times \pi = 127m^2$

T 9 View into the crown from below showing major pruning wounds not to BS 3998. Decay at the union of these wounds would give potential for complete crown failure.

Whilst this is the most imposing tree in the immediate area, it has been poorly managed in the past and has high potential for structural failure. There are multiple pruning wounds encircling the bole where the crown has been lifted and the remaining crown is etiolated and top heavy.

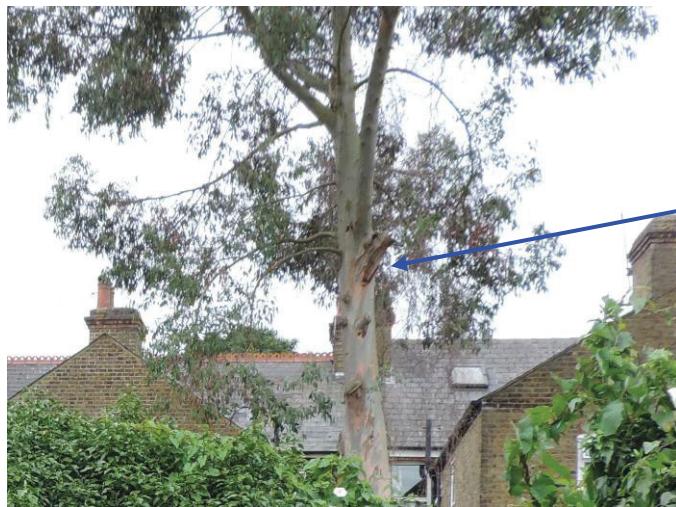
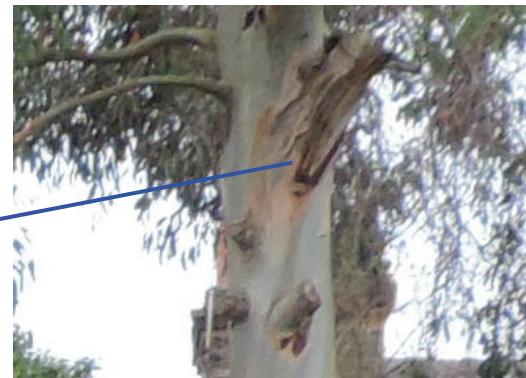
Tear either from poor pruning or snapped out limb

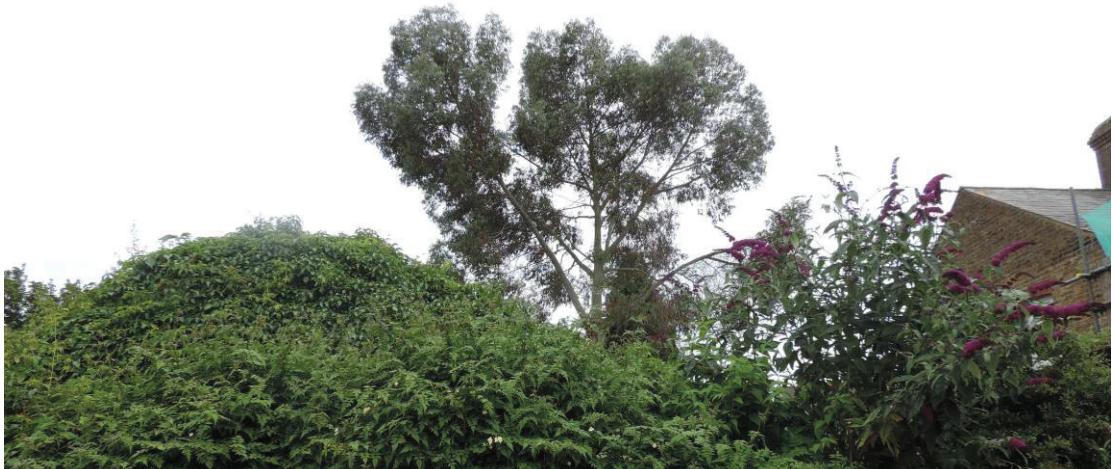
T9 Viewed from Chiltern View Drive. Note the slender branches bearing all of the leafing area.

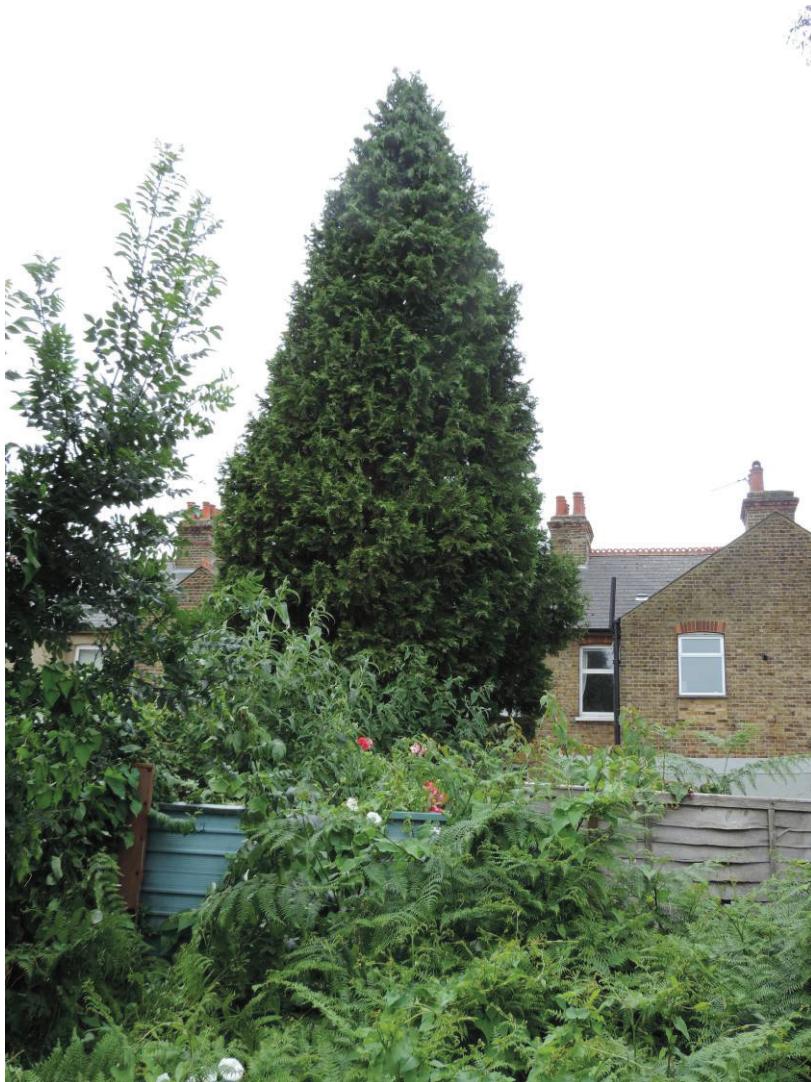
Tree	10
Location	Northern boundary of the rear garden of 19 Alexandra Road – 9.8 metres from the eastern edge of the house
Species	Leyland Cypress
Number stems	2
DBH (cm)	20.0, 22.0
Height (m)	11.0
Spread (m)	4.3
Age	Early mature
Condition	Good
Observations	Inspected from the garden of number 18 so base not seen. Twin stemmed from about 1m. Has potential to reach optimum size, though a 30m tree may be out of keeping with the surroundings and the narrow gardens
BS 5837 category	A
RPA radius (m)	3.57

Tree 10 photographed from the worksite

4.6 The Root Protection Area from this Cypress (tree 10) does not impinge on the worksite, therefore will have no impact on the proposed works.

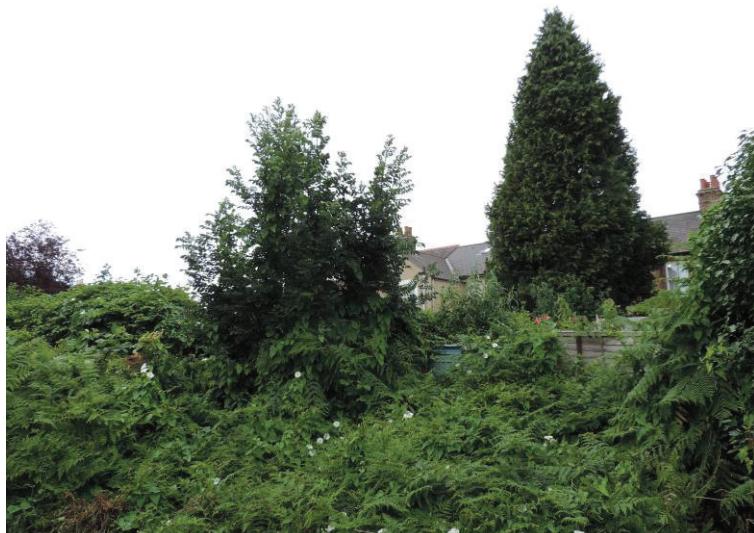
Tree 11.

Tree	11
Location	Western boundary of the worksite adjacent to the eastern boundary of 19 Alexandra Road
Species	Ash
Number stems	Multiple
DBH (cm)	<7
Height (m)	Not recorded
Spread (m)	Not recorded
Age	Young
Condition	Poor
Observations	Young regrowth from coppice stool
BS 5837 category	U
RPA radius (m)	N/A

Ash regeneration from coppice stool with T10 in the background

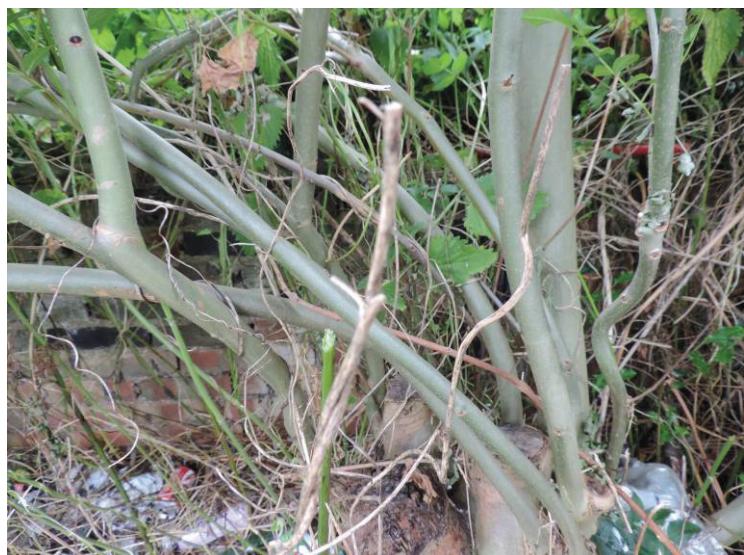
Coppice regrowth from base of T11
