# **Arboricultural Assessment**

**41 Highfield Drive  
Ickenham  
Uxbridge UB10 8AW**

TITLE  
**Tree Protection Plan  
41 Highfield Drive**

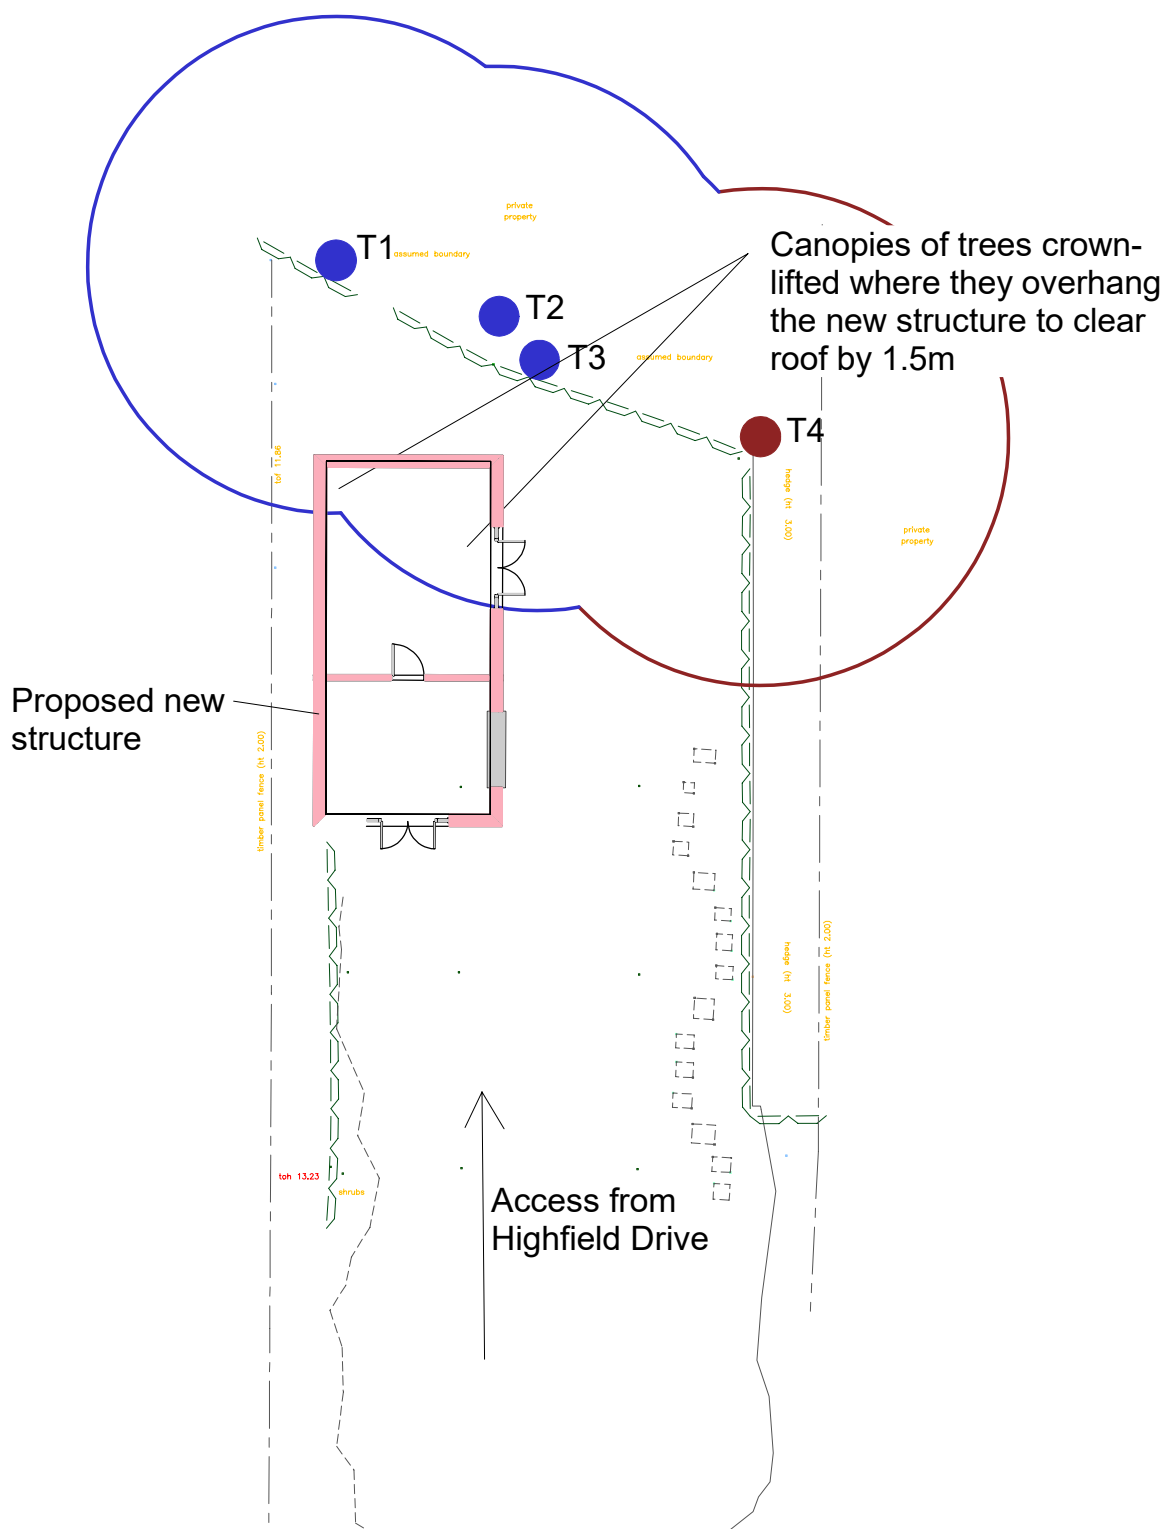
- 7.2 Root protection areas (RPAs) from the trees also extend into the gardens of the subject property.
- 7.3 It is proposed to construct a new building towards the end of the rear garden of 41 Highfield Drive and this new structure encroaches into the RPA of three Beech trees (T1-T3). The extent of encroachment means that if a traditional method of construction involving excavation for foundations is utilised, then a notable portion of the RPAs will be affected.

- 7.4 In order to avoid the need for excavation, and hence root damage, the new building will be of timber construction sited on screw piles. This method of construction is normally accepted within RPAs of retained trees as the likelihood of root damage is minimal. This method of construction also allows for a small void to be retained beneath the floor of the new structure allowing any roots beneath to continue to interact with the air.

The canopies of Beech trees T1-T3 will be crown-lifted to clear the roof of the new structure by 1.5m. Works will be undertaken by persons both qualified and experienced to do so.
