Heritage Impact Assessment Window Schedule

Cannons Bridge Farm
Bury Road
Ruislip
HA4 7TJ

14th November 2023

This report is submitted in support of
listed building consent application for
the replacement of existing single
glazed windows at Cannons Bridge
Farm

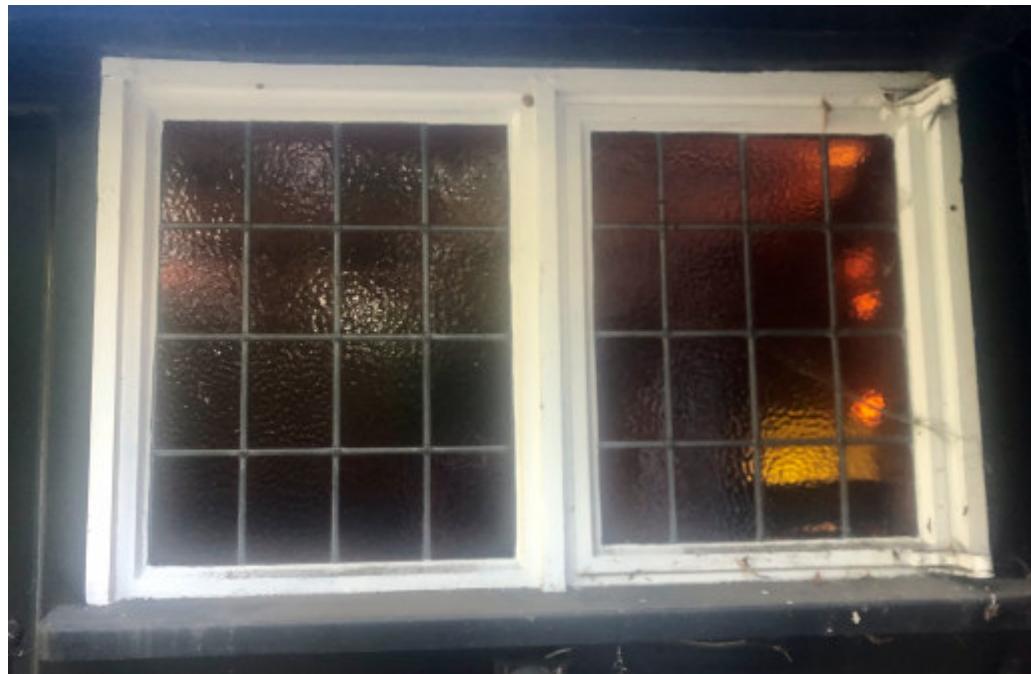
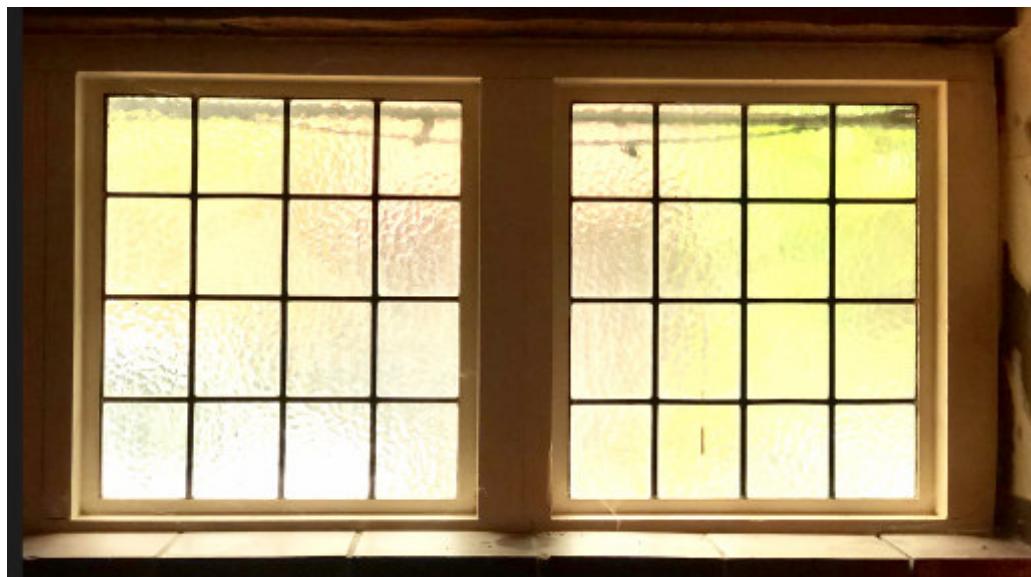
Provenance:	From Early 20 th "Arts and Crafts" restoration works
Condition:	Reasonable/serviceable
Construction:	Softwood timber sub frame in oak structural frame/metal (Cast iron) "Crittall" style casement

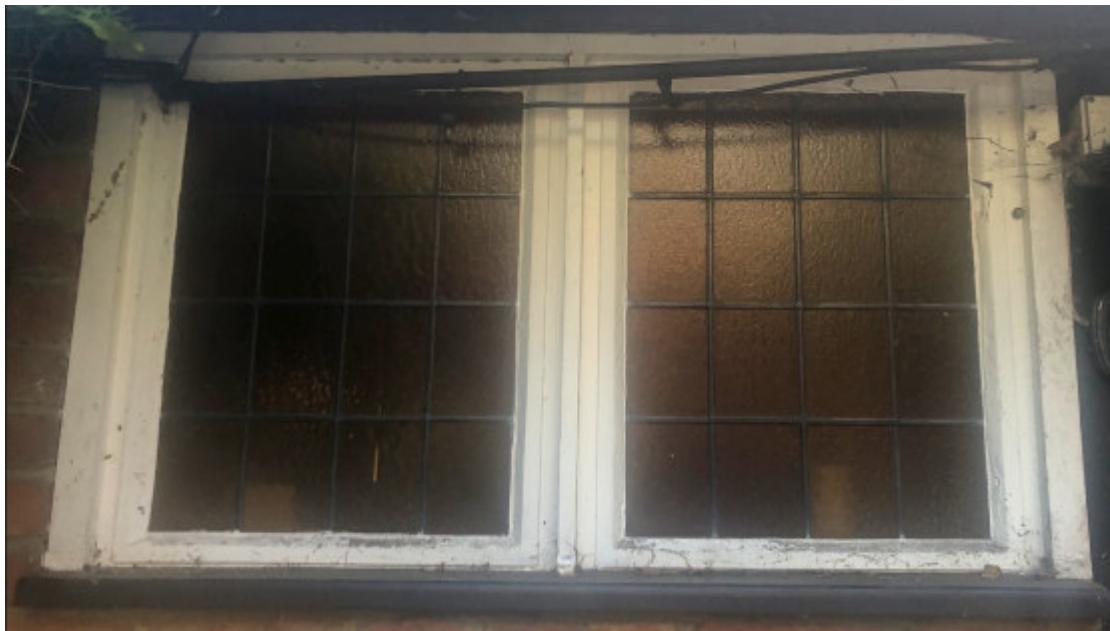
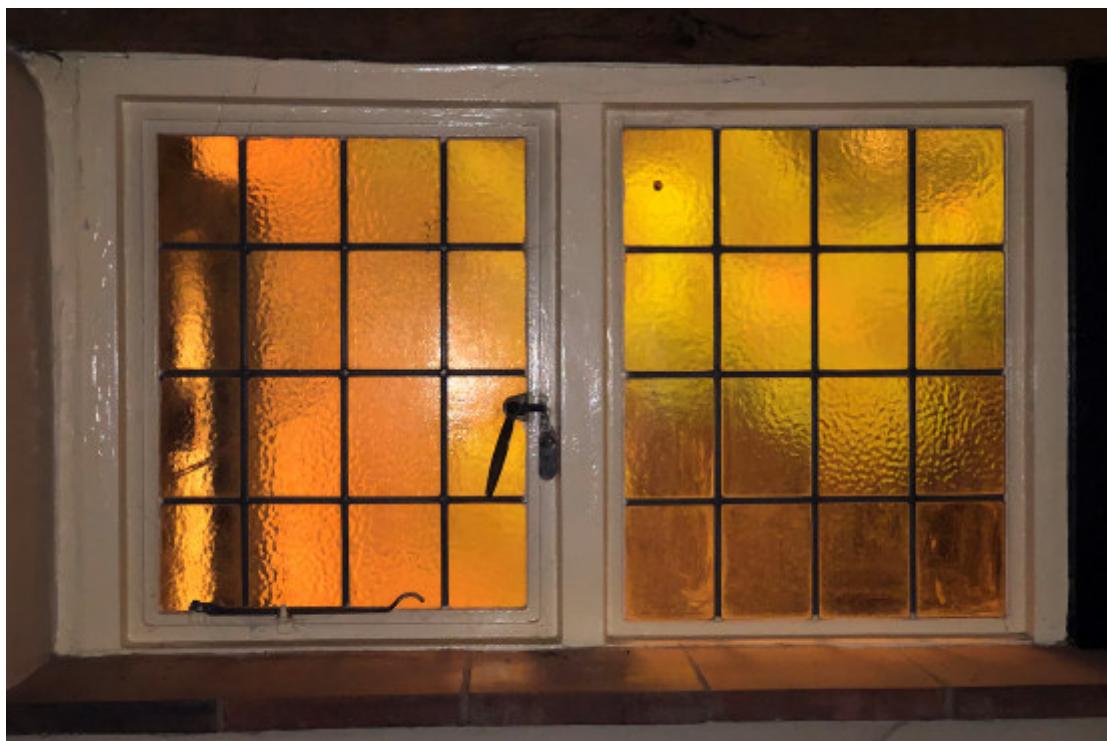
Condition:	Reasonable/serviceable
Construction:	Softwood timber sub frame in oak structural frame/metal (Cast iron) "Crittall" style casement
Provenance:	From Early 20 th "Arts and Crafts" restoration works

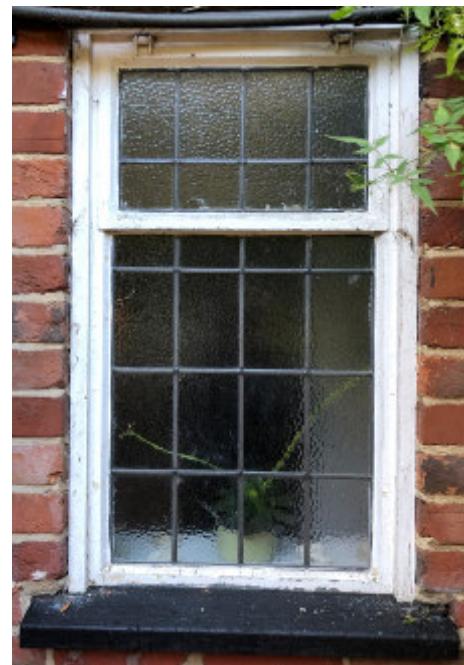
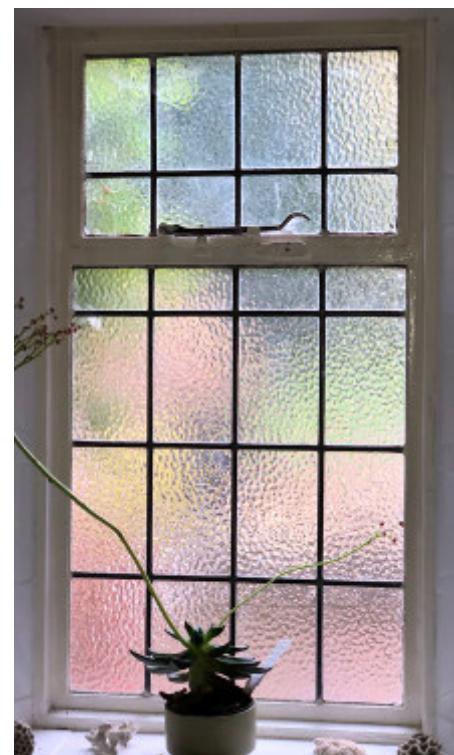
Condition:	Reasonable/serviceable
Construction:	Softwood timber sub frame in structural brick opening/metal (Cast iron) "Crittall" style casement
Provenance:	From Early 20 th "Arts and Crafts" restoration works

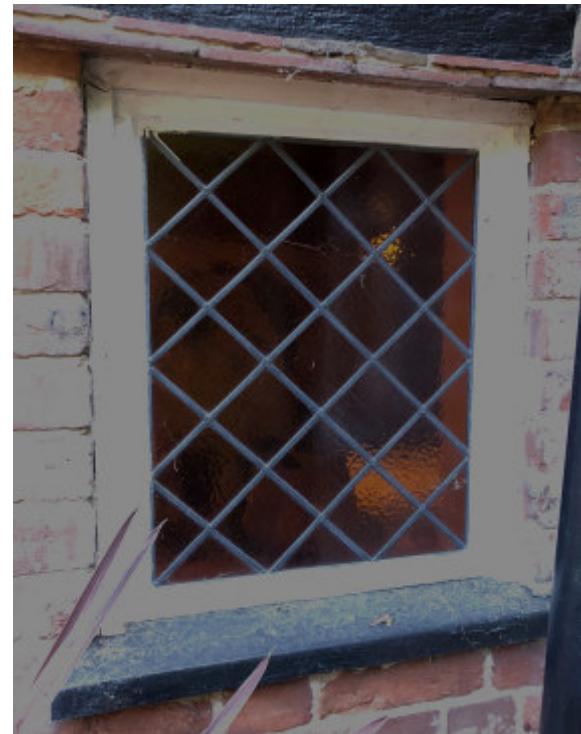
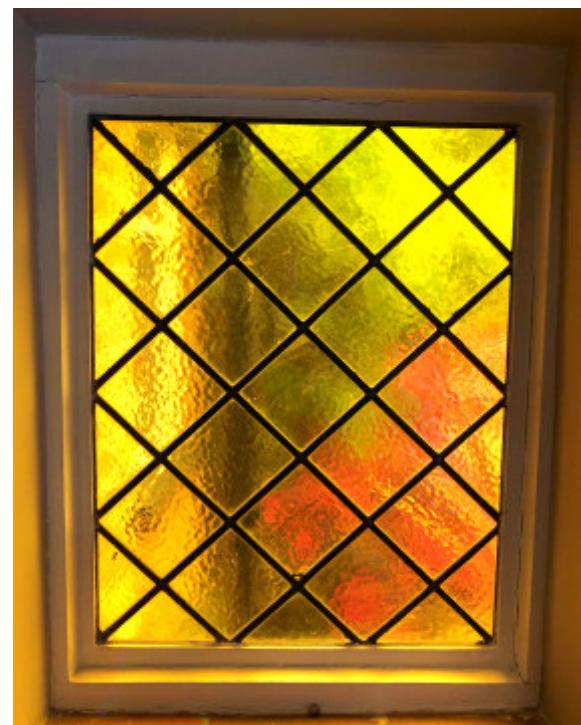
Condition:	Reasonable/serviceable
Construction:	Softwood timber sub frame in structural brick opening/metal (Cast iron) "Crittall" style casement
Provenance:	From Early 20 th "Arts and Crafts" restoration works

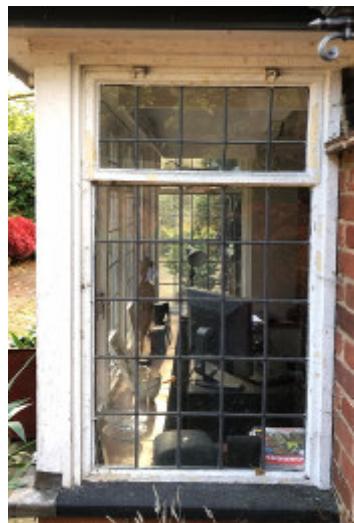
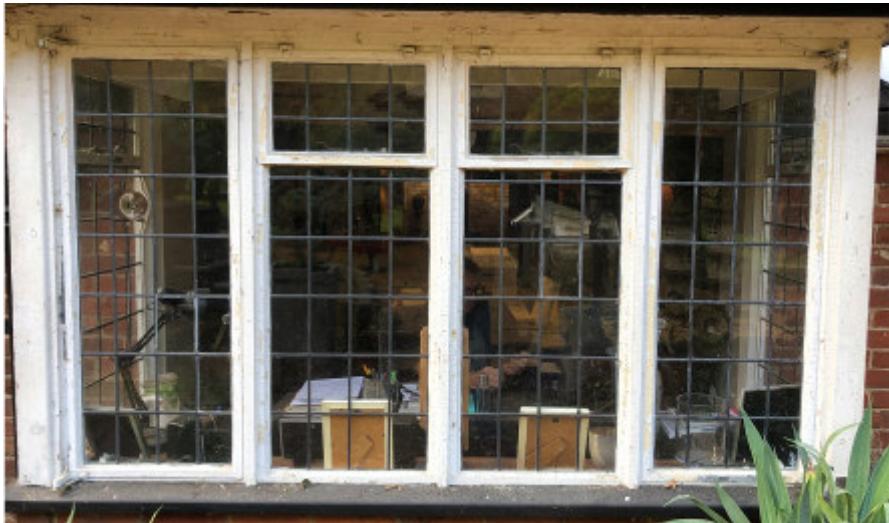
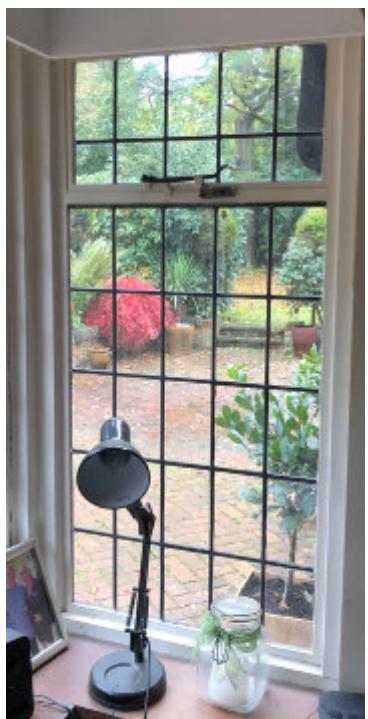
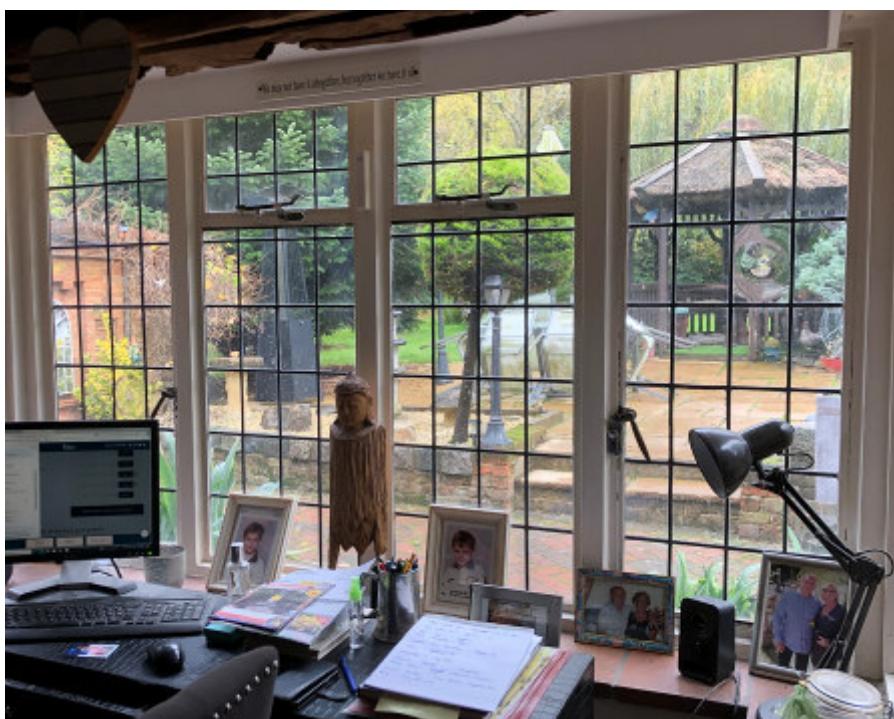
Condition:	Reasonable/serviceable
Construction:	Softwood timber sub frame in softwood bay window frame /metal (Cast iron) "Crittall" style casement
Provenance:	From Early 20 th "Arts and Crafts" restoration works

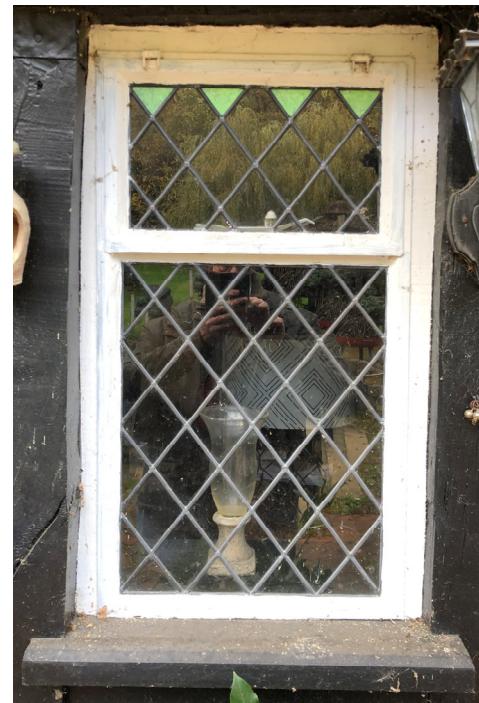
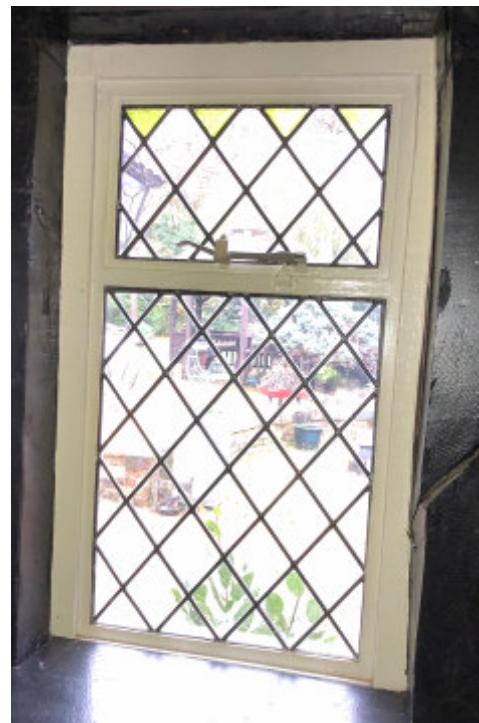
Condition:	Reasonable/serviceable
Construction:	Softwood timber sub frame in oak structural frame/metal (Cast iron) "Crittall" style casement
Provenance:	From Early 20 th "Arts and Crafts" restoration/ extension works

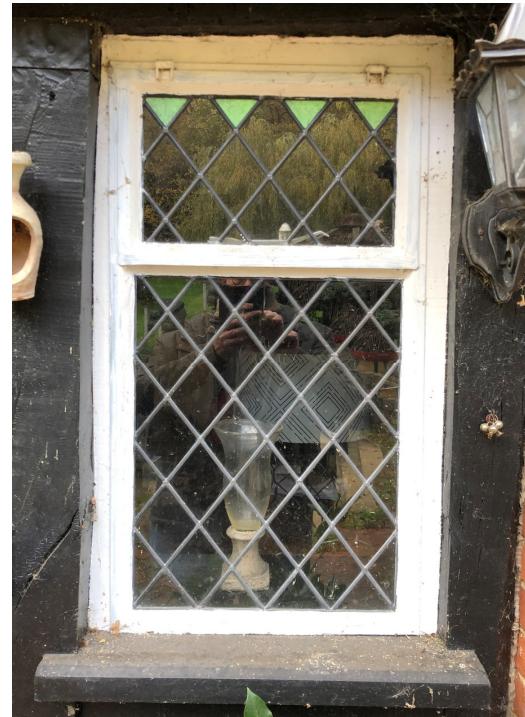
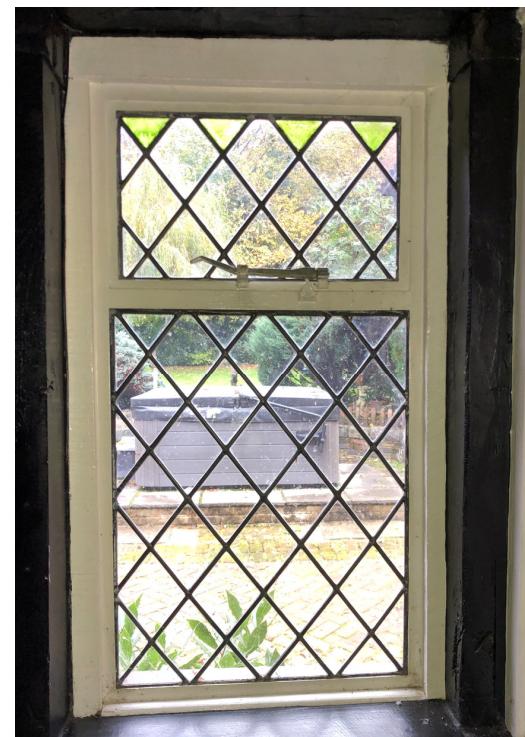
Condition:	Reasonable/serviceable
Construction:	Softwood timber sub frame in oak structural frame/metal (Cast iron) "Crittall" style casement
Provenance:	From Early 20 th "Arts and Crafts" restoration/ extension works

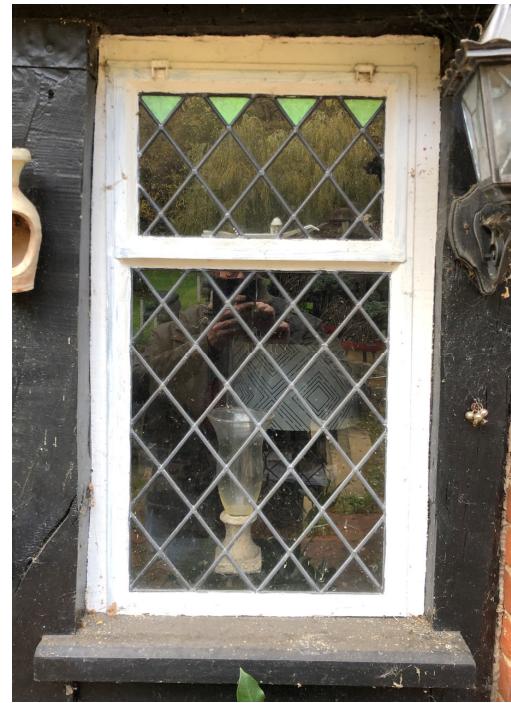
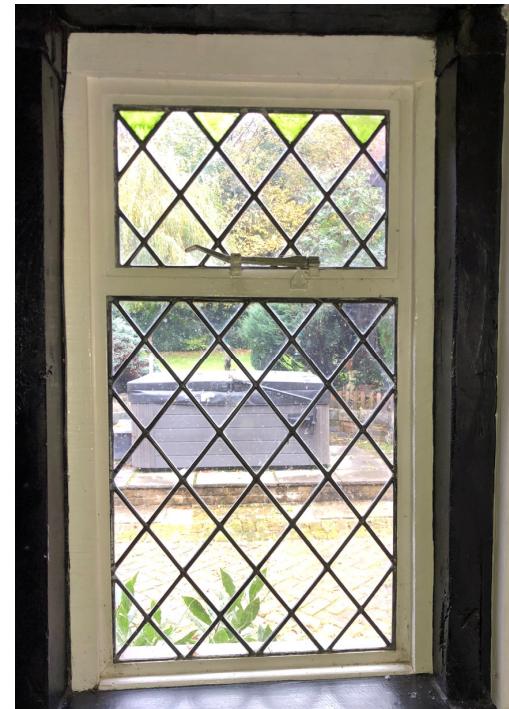
Condition:	Reasonable/serviceable
Construction:	Softwood timber sub frame in oak structural frame/metal (Cast iron) "Crittall" style casement
Provenance:	From Early 20 th "Arts and Crafts" restoration works

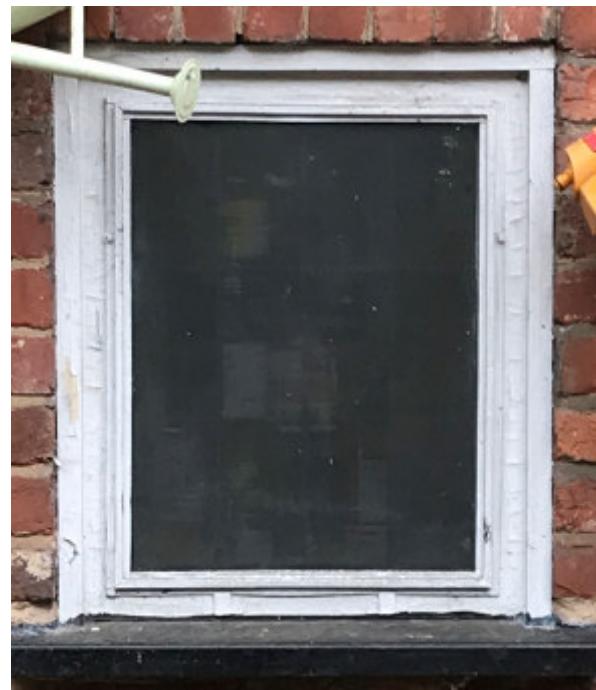
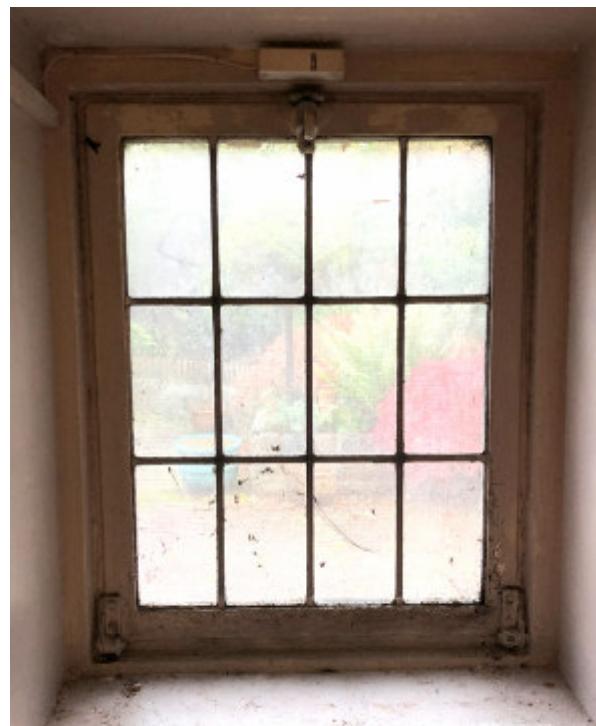
Condition:	Reasonable/serviceable
Construction:	Softwood timber sub frame in structural brickwork /metal (Cast iron) "Crittall" style casement
Provenance:	From Early 20 th "Arts and Crafts" extension works

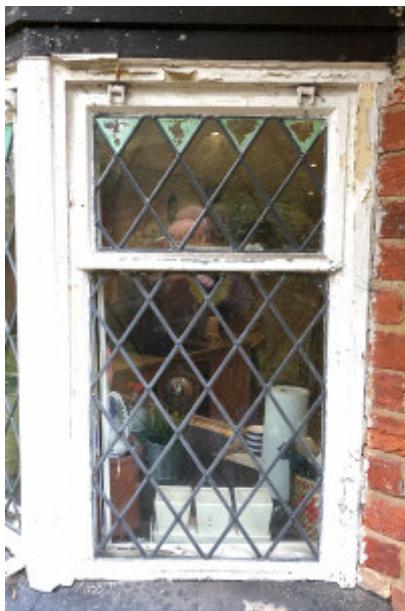
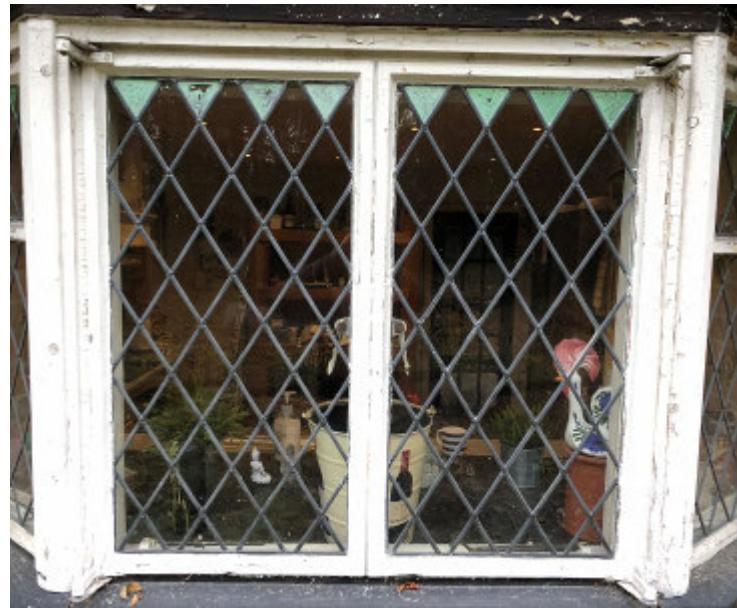
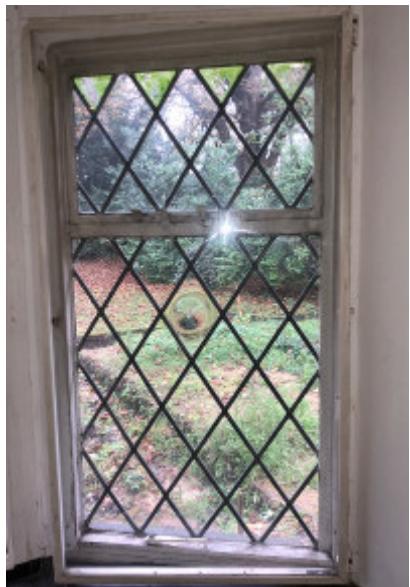
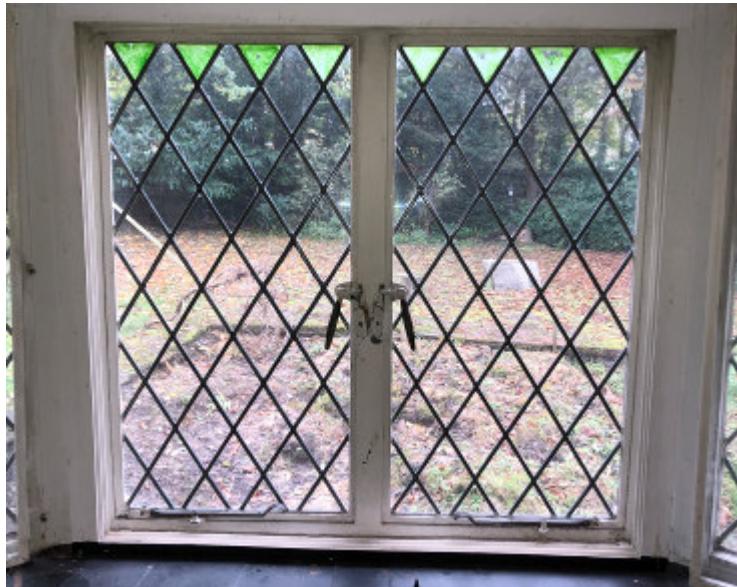
Condition:	Reasonable/serviceable
Construction:	Softwood timber sub frame in softwood bay window frame /metal (Cast iron) "Crittall" style casement
Provenance:	From Early 20 th "Arts and Crafts" extension works

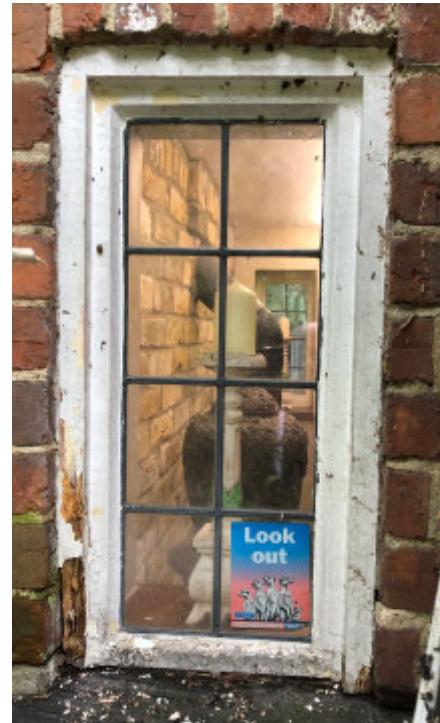
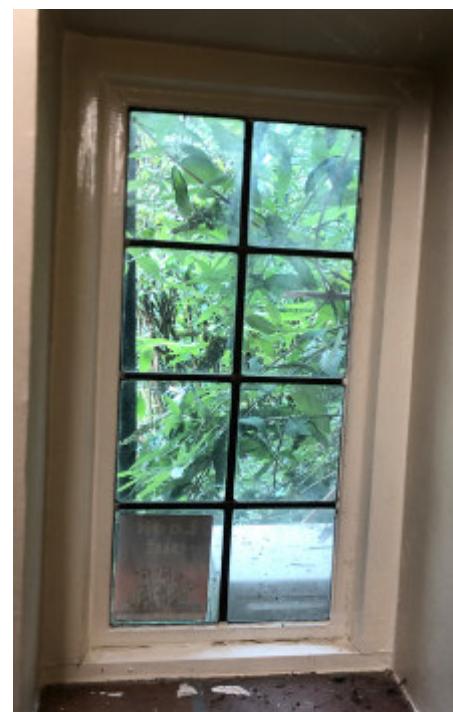
Condition:	Poor Wet rot evident
Construction:	Softwood timber sub frame in C20th Brick Chimney stack/metal (Cast iron) "Crittall" style casement
Provenance:	From Early 20 th "Arts and Crafts" extension works

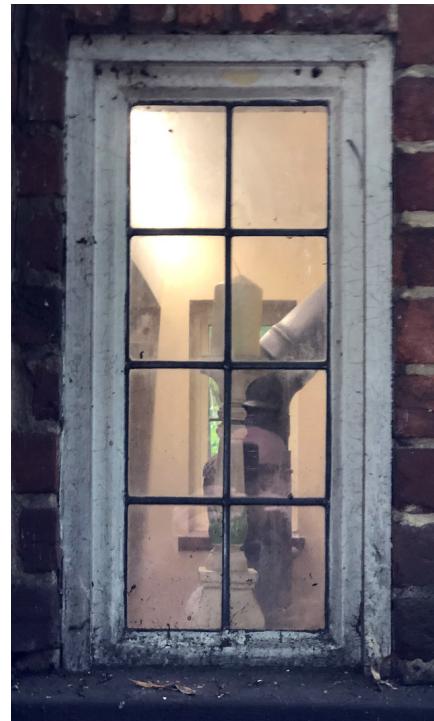
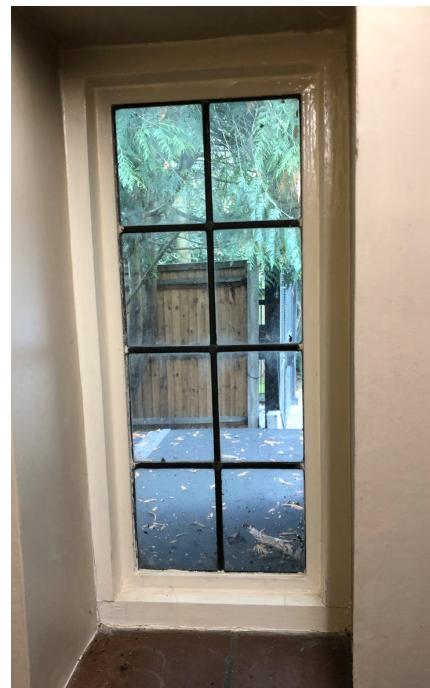
Condition:	Poor/ Wet Rot evident
Construction:	Softwood timber sub frame in C20th Brick Chimney stack/metal (Cast iron) "Crittall" style casement
Provenance:	From Early 20 th "Arts and Crafts" extension works

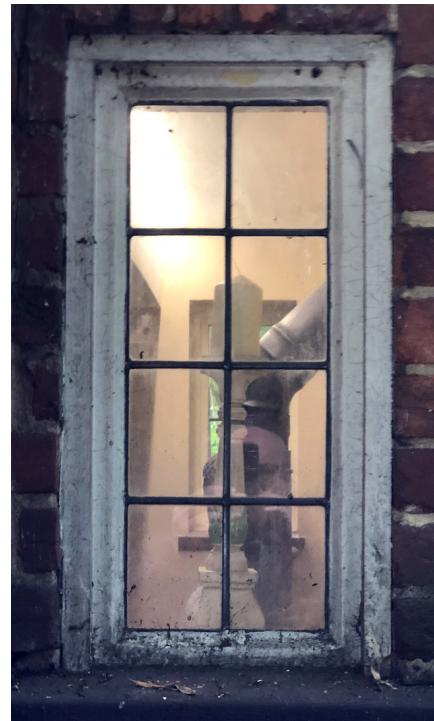
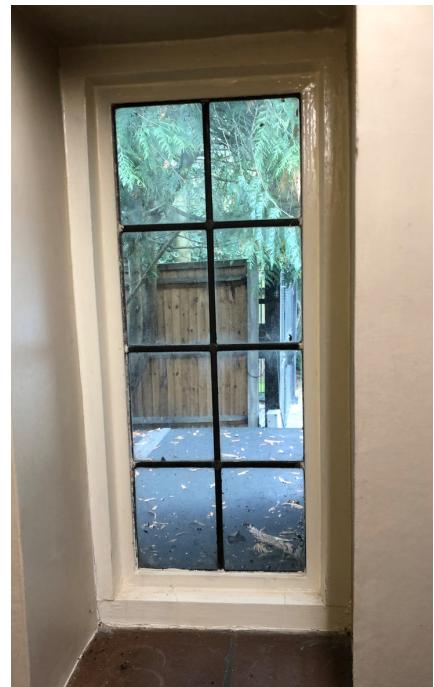
Condition:	Poor/ Wet Rot evident
Construction:	Softwood timber sub frame in C20th Brick Chimney stack/metal (Cast iron) "Crittall" style casement
Provenance:	From Early 20 th "Arts and Crafts" extension works

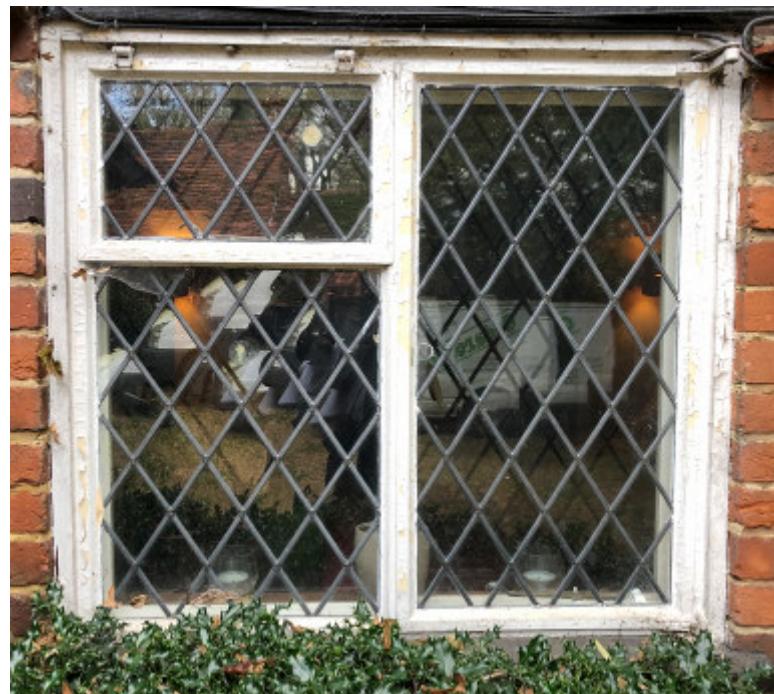
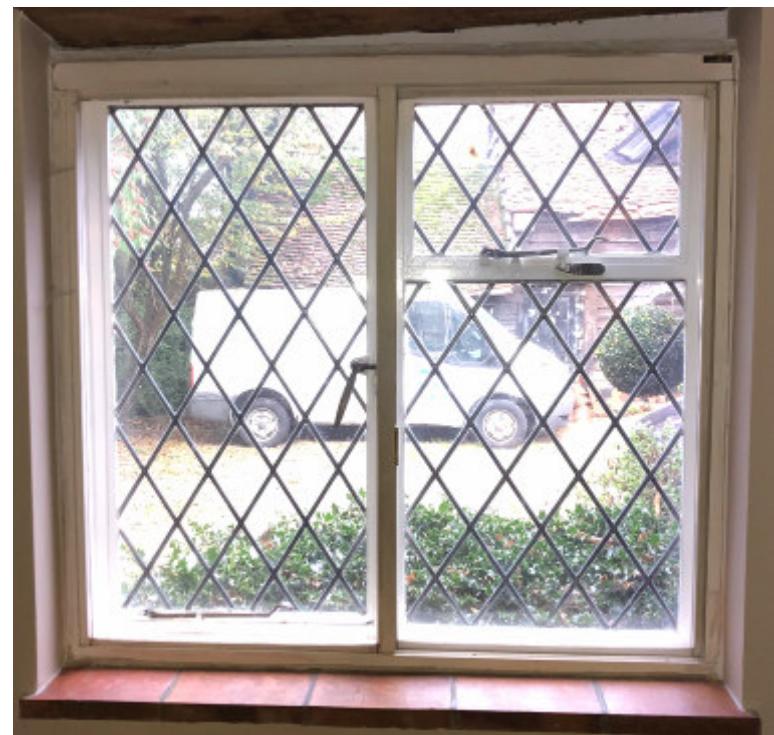
Condition:	Poor/ Wet Rot evident
Construction:	Softwood timber sub frame in Structural brick opening /metal (Cast iron) "Crittall" style casement
Provenance:	From Early 20 th "Arts and Crafts" extension works

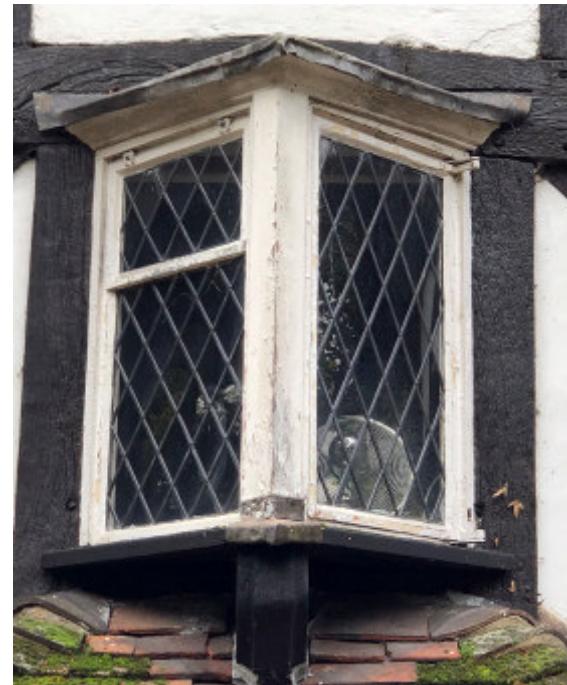
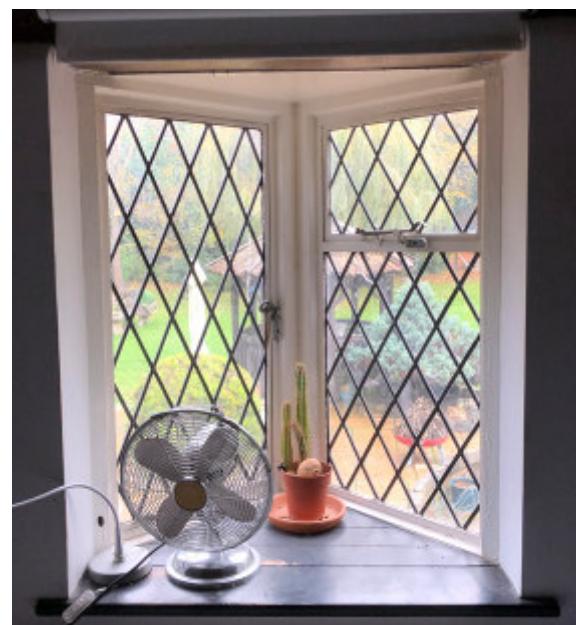
Condition:	Poor/ Wet Rot evident
Construction:	Softwood timber sub frame in C20th Softwood Oriel Frame /metal (Cast iron) "Crittall" style casement
Provenance:	From Early 20 th "Arts and Crafts" extension works

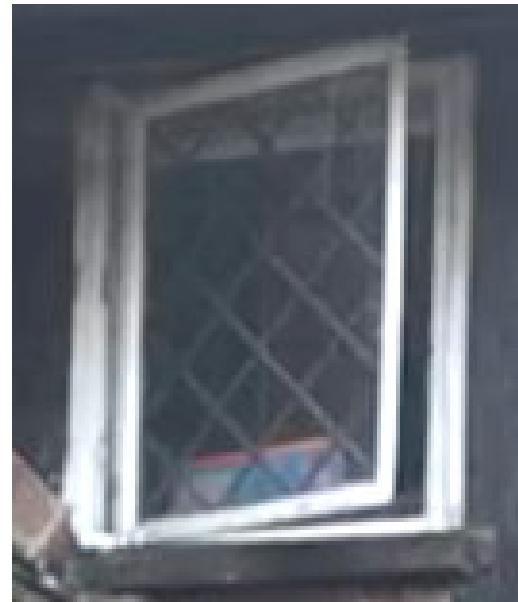
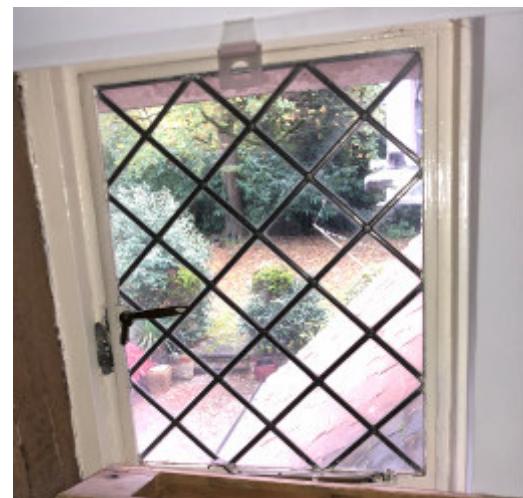
Condition:	Poor/Serviceable
Construction:	Softwood timber sub frame in structural timber frame /metal (Cast iron) "Crittall" style casement
Provenance:	From Early 20 th "Arts and Crafts" extension works

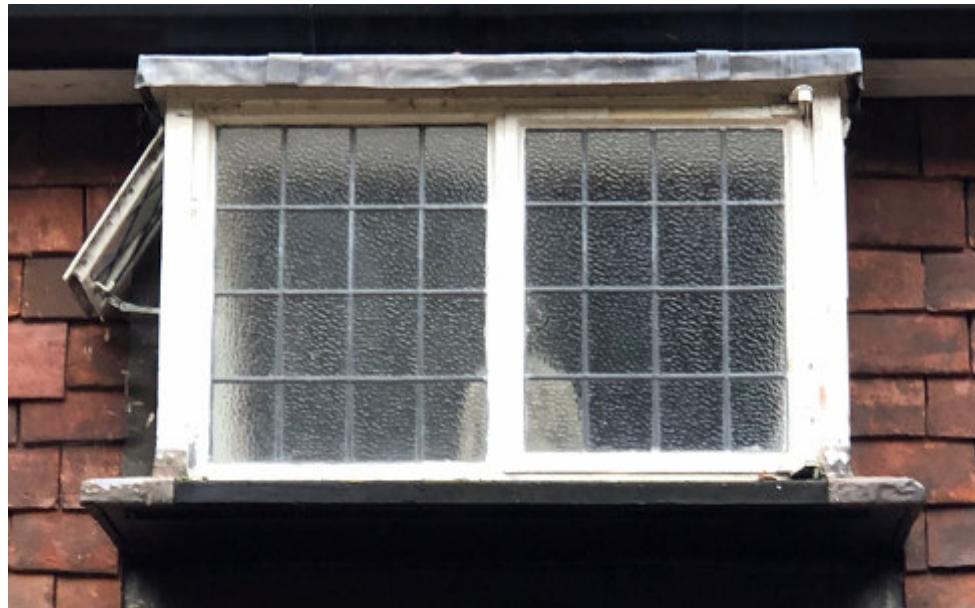
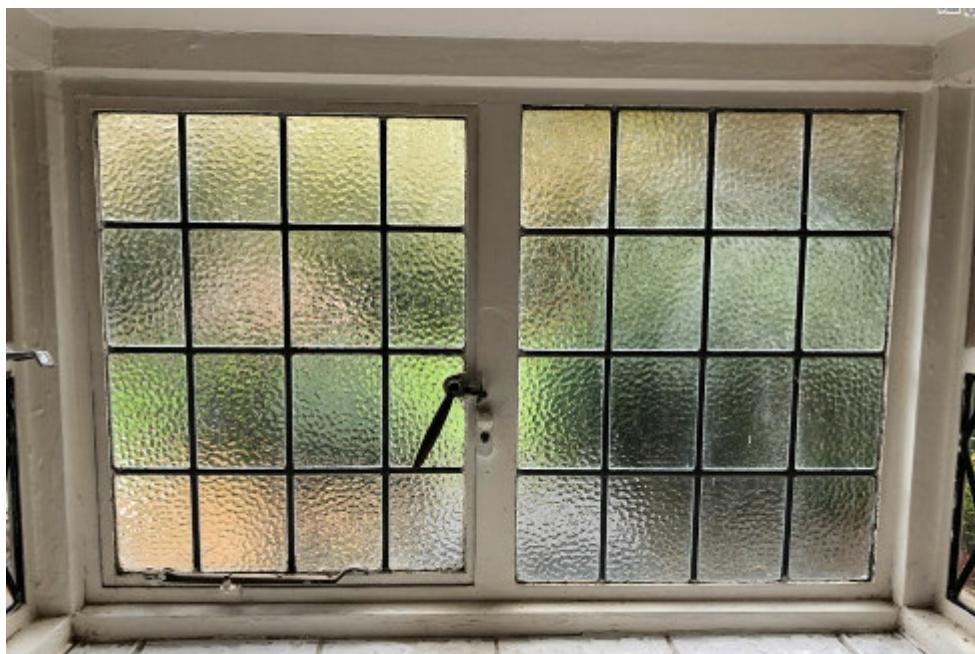
Condition:	Poor/ Wet Rot evident
Construction:	Softwood timber sub frame in C20th Softwood Oriel Frame /metal (Cast iron) "Crittall" style casement
Provenance:	From Early 20 th "Arts and Crafts" extension works

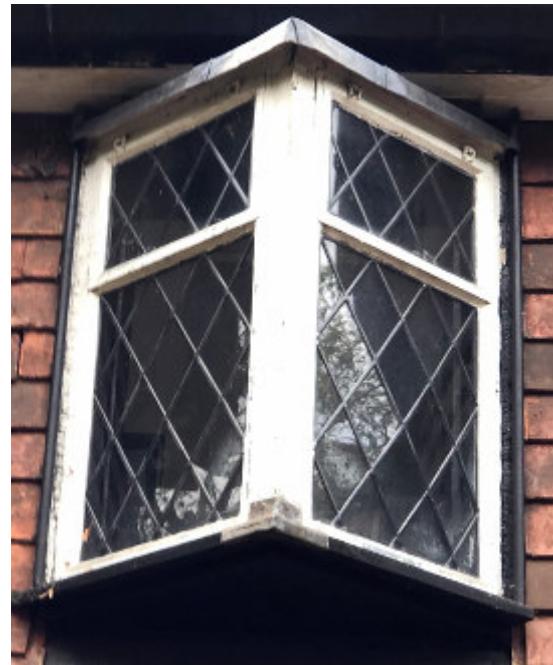
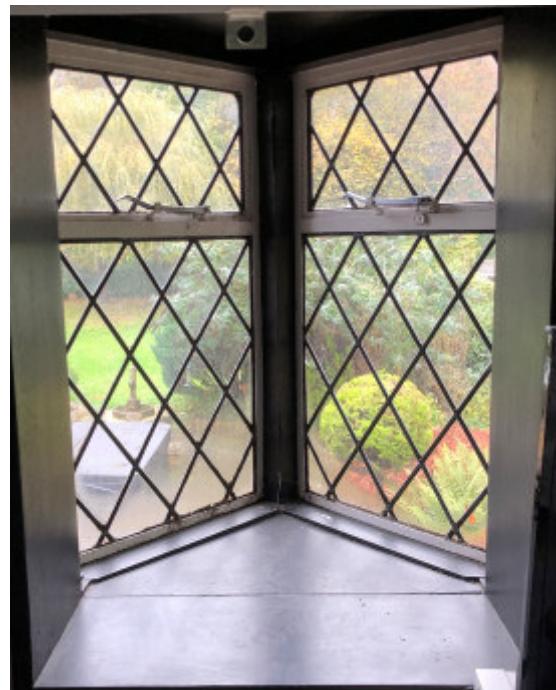
Condition:	Poor/ Wet Rot evident
Construction:	Softwood timber sub frame in C20th Softwood Oriel Frame /metal (Cast iron) "Crittall" style casement
Provenance:	From Early 20 th "Arts and Crafts" extension works

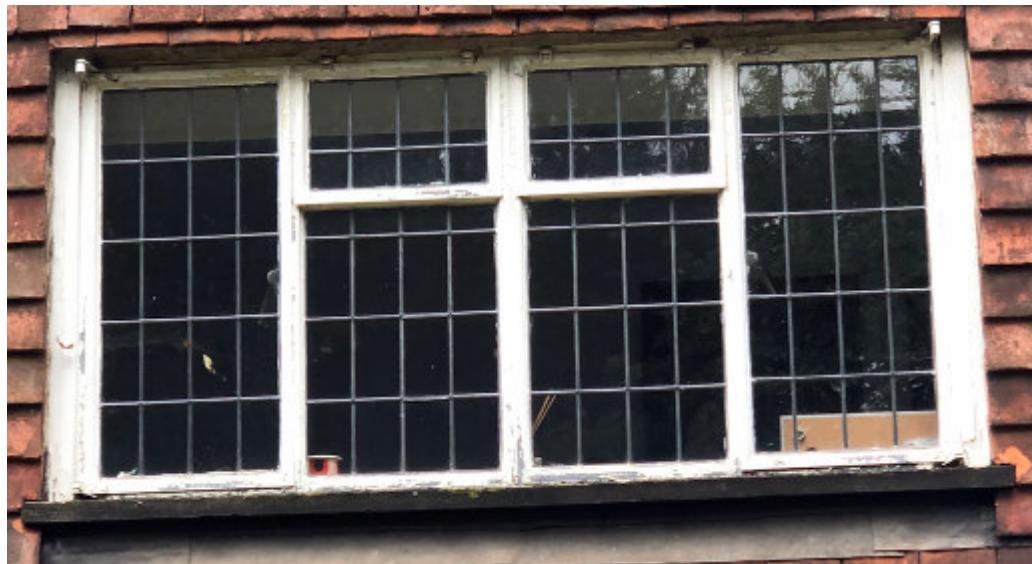
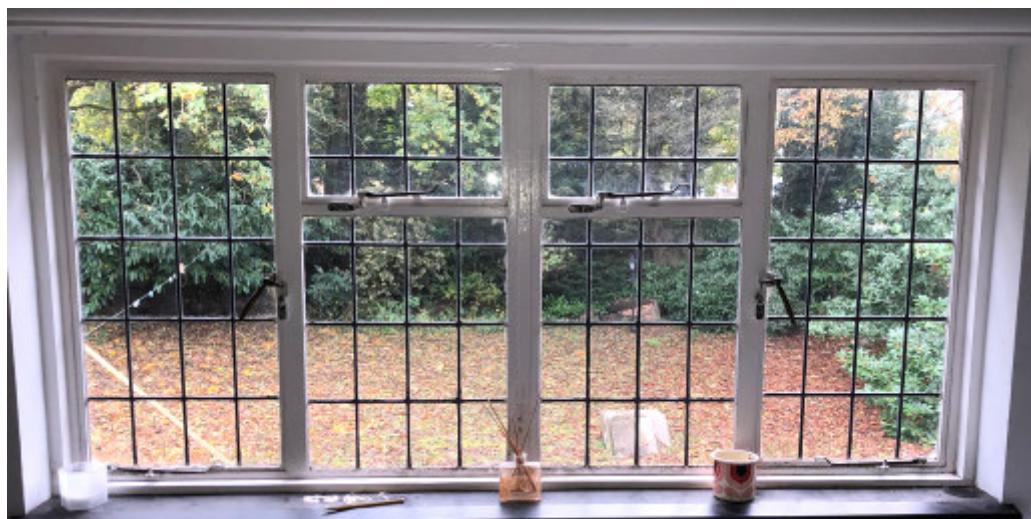
Condition:	Poor/ Wet Rot evident
Construction:	Softwood timber sub frame in C20th Softwood Tile Hung Frame /metal (Cast iron) "Crittall" style casement
Provenance:	From Early 20 th "Arts and Crafts" extension works

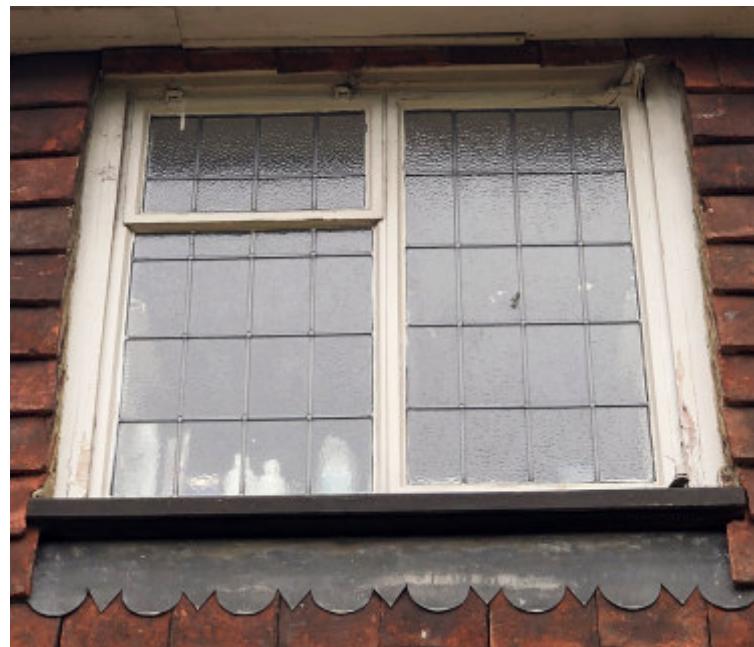
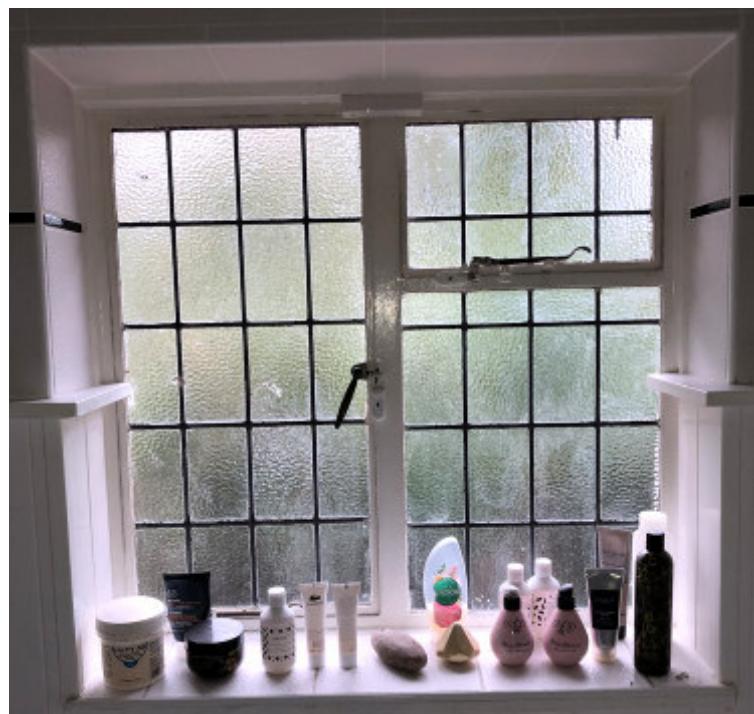
Condition:	Poor/ Wet Rot evident
Construction:	Softwood timber sub frame in C20th Softwood Tile Hung Frame /metal (Cast iron) "Crittall" style casement
Provenance:	From Early 20 th "Arts and Crafts" extension works

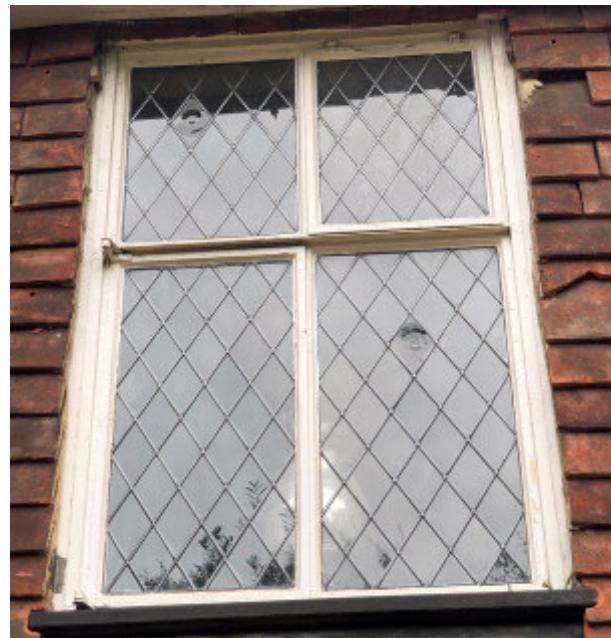
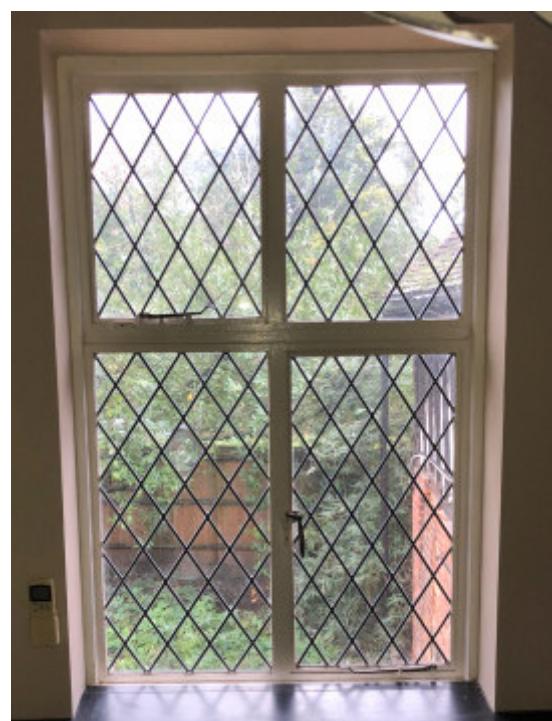
Condition:	Poor/ Wet Rot evident
Construction:	Softwood timber sub frame in C20th Softwood Tile Hung Frame /metal (Cast iron) "Crittall" style casement
Provenance:	From Early 20 th "Arts and Crafts" extension works

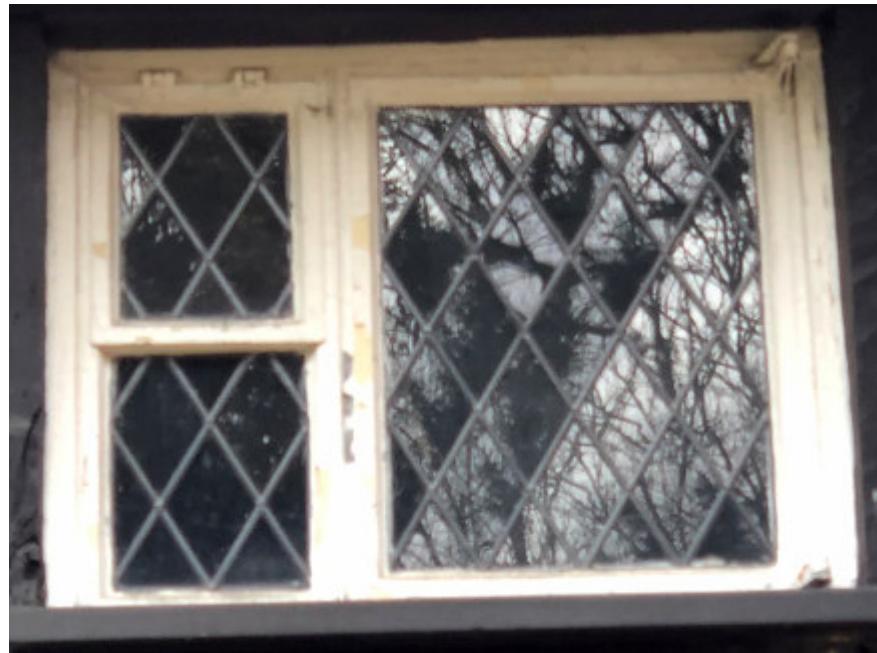
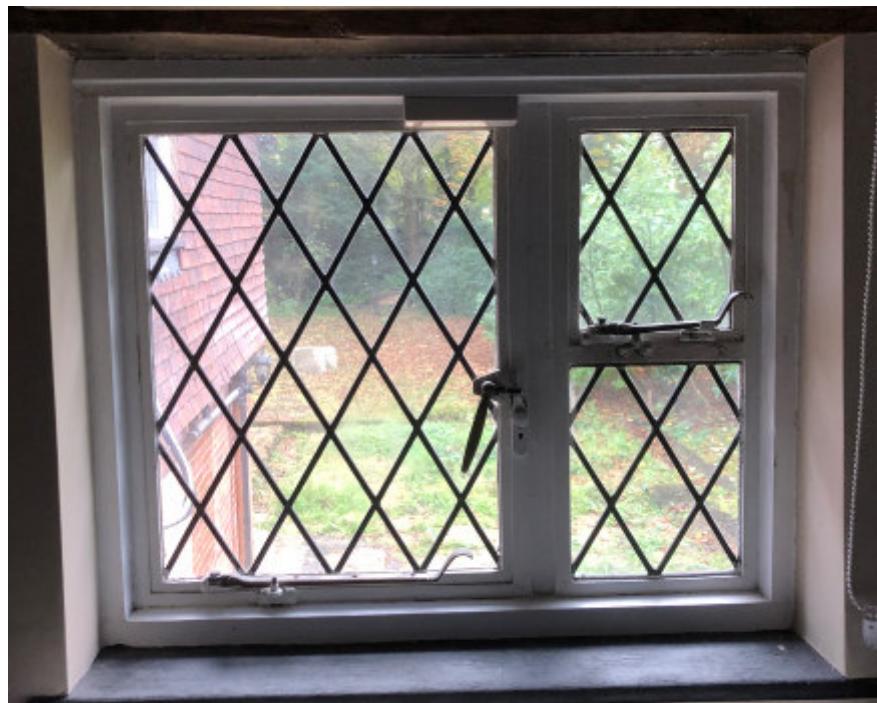
Condition:	Poor/ Wet Rot evident
Construction:	Softwood timber sub frame in C16th structural timber frame /metal (Cast iron) "Crittall" style casement
Provenance:	From Early 20 th "Arts and Crafts" extension works

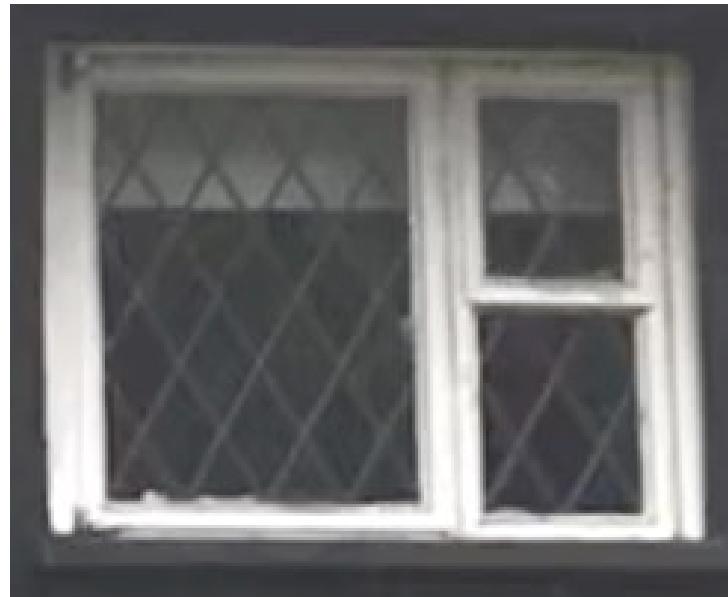
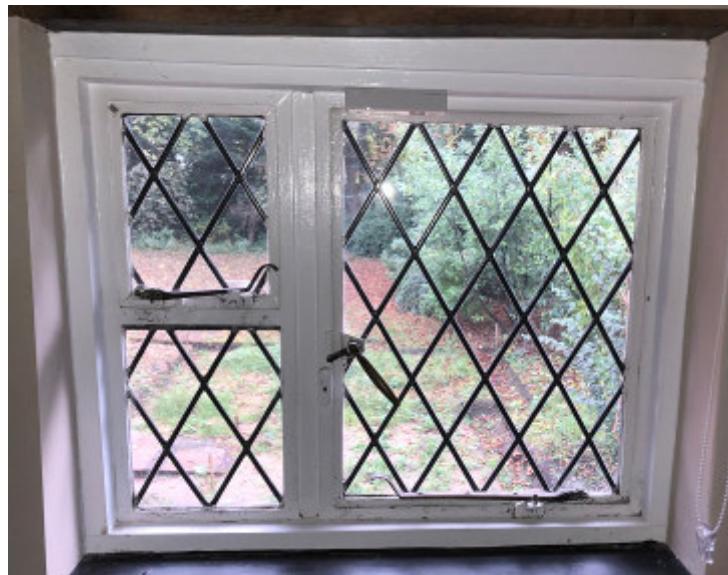
Condition:	Poor/Serviceable
Construction:	Softwood timber sub frame in C16th structural timber frame /metal (Cast iron) "Crittall" style casement
Provenance:	From Early 20 th "Arts and Crafts" extension works
