Heritage Impact Assessment Window Schedule

Cannons Bridge Farm
Bury Road
Ruislip
HA4 7TJ

14th November 2023

This report is submitted in support of
listed building consent application for
the replacement of existing single
glazed windows at Cannons Bridge
Farm

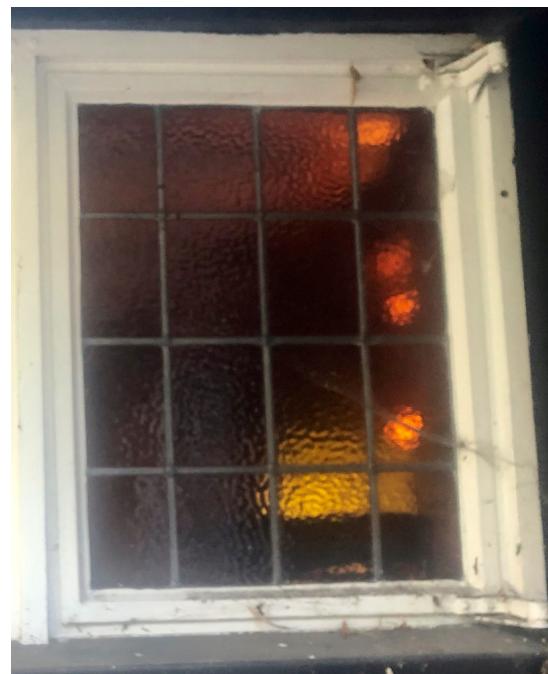
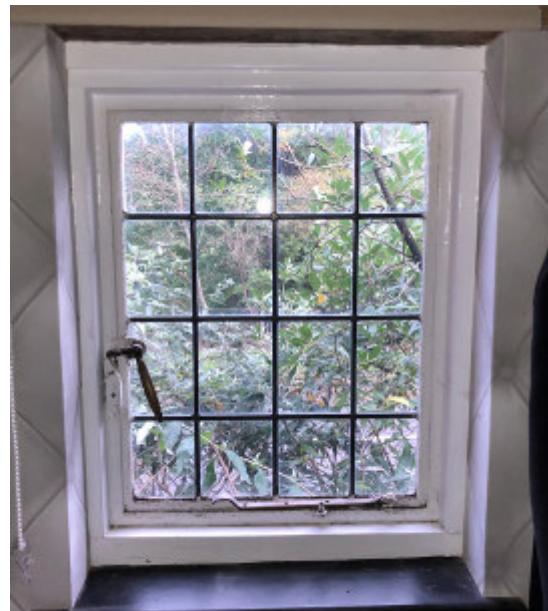
2.3.10 Window 23 (W23)

Condition:	Poor/Serviceable
Construction:	Softwood timber sub frame in C16th structural timber frame /metal (Cast iron) "Crittall" style casement
Provenance:	From Early 20 th "Arts and Crafts" extension works

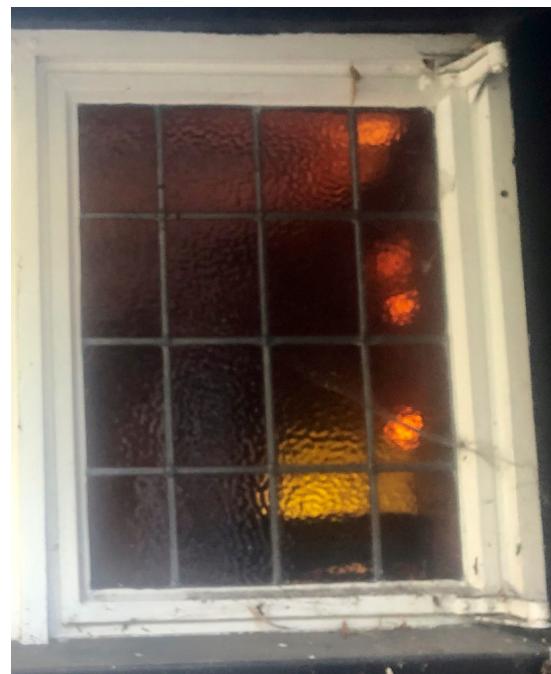
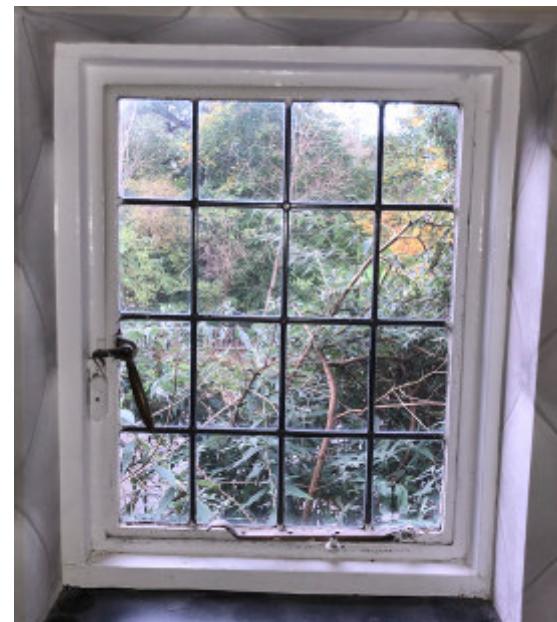
2.3.11 Window 24 (W24)

Condition:	Poor/Serviceable
Construction:	Softwood timber sub frame in C16th structural timber frame /metal (Cast iron) "Crittall" style casement
Provenance:	From Early 20 th "Arts and Crafts" extension works

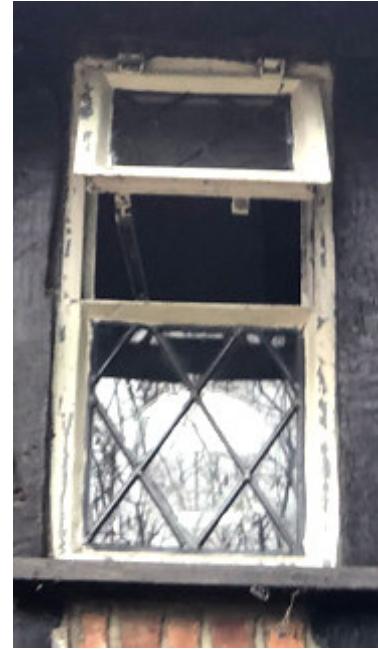
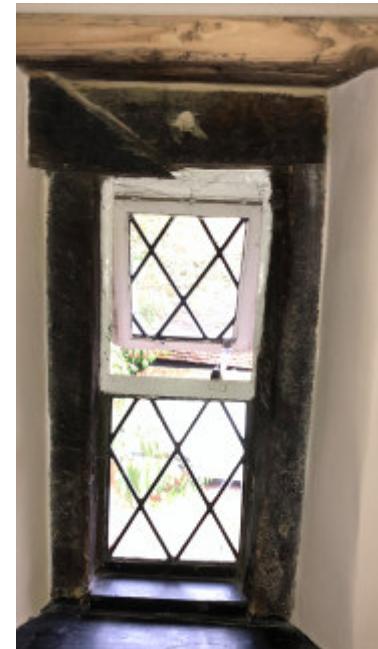
2.3.12 Window 25 (W25)

Condition:	Poor/Serviceable
Construction:	Softwood timber sub frame in C16th structural timber frame /metal (Cast iron) "Crittall" style casement
Provenance:	From Early 20 th "Arts and Crafts" extension works
