**Tree Survey and Arboricultural Impact Assessment  
In Accordance with BS 5837:2012**

| Project No<br><b>12311</b> | <b>Mercure Hotel Heathrow, Shepiston Lane, Hayes, UB3 1LP</b> | | |
| Date of Report: | 11/03/2026 | Revision: | Original |

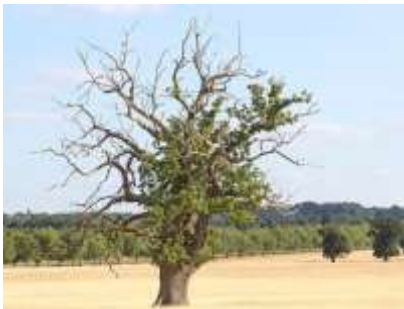
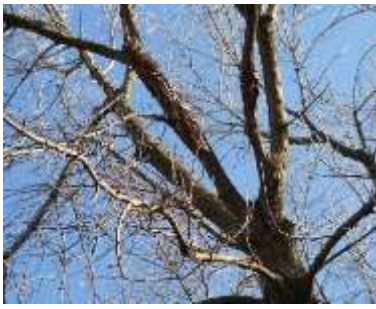
| <b>Name: Deadwood</b> | |
| <b>Symptoms/damage type and cause:</b> | This relates to dead branches in the crown of the tree. In most cases, this is caused by the natural ageing process of the tree or shading due to its close proximity to neighbouring trees. However, in some situations, it may be related to fungal, bacterial or viral infection. |
| <b>Consequence:</b> | Depending upon the location and mass of dead wood removal of the affected tissue may be necessary to prevent harm to persons or property as the wood will become unstable as it decays and in some circumstances is likely to fall from the tree with little or no warning. |

| <b>Name: Deadwood</b> | |
|---|---|
| <b>Control:</b> | Detailed monitoring should be undertaken on those trees showing signs of excessive deadwood production to identify the underlying cause. |

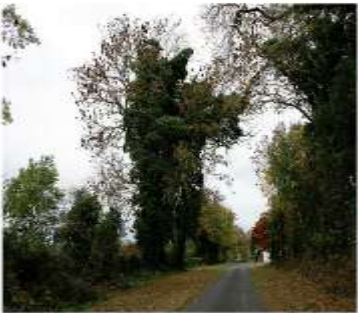
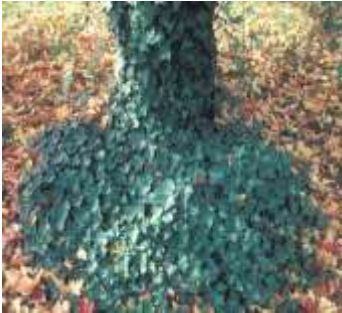
| <b>Name:</b> <i>Hedera helix</i> (Ivy) | |
| <b>Symptoms/damage type and cause:</b> | Ivy may grow to varying degrees on all areas of a tree from the base to the upper crown. It is possible that in doing so it will out-compete the host tree for available light thereby suppressing the host. |
| <b>Consequence:</b> | This is generally only harmful to the tree on already unhealthy specimens which may be constricted by large ivy stems around the trunk or may have their top growth suppressed by a mass of flowering shoots in the crown. Ivy can also mask potentially dangerous faults on a tree. |

| <b>Control:</b> | Ivy should only be removed if absolutely necessary because it provides abundant cover to wildlife and then by severing twice close to the ground and removing a length of stem thereby causing the gradual dying away of the aerial parts of the plant providing extended benefit to wildlife whilst relieving the pressure on the tree. |
