#### TREE CONSTRAINTS REPORT:

The Hillingdon Hospitals NHS Foundation Trust  
Pield Heath Roadd  
Uxbridge  
UB8 3NN

Ref: HFT/THH/TCR/01

Date: 5<sup>th</sup> February 2021

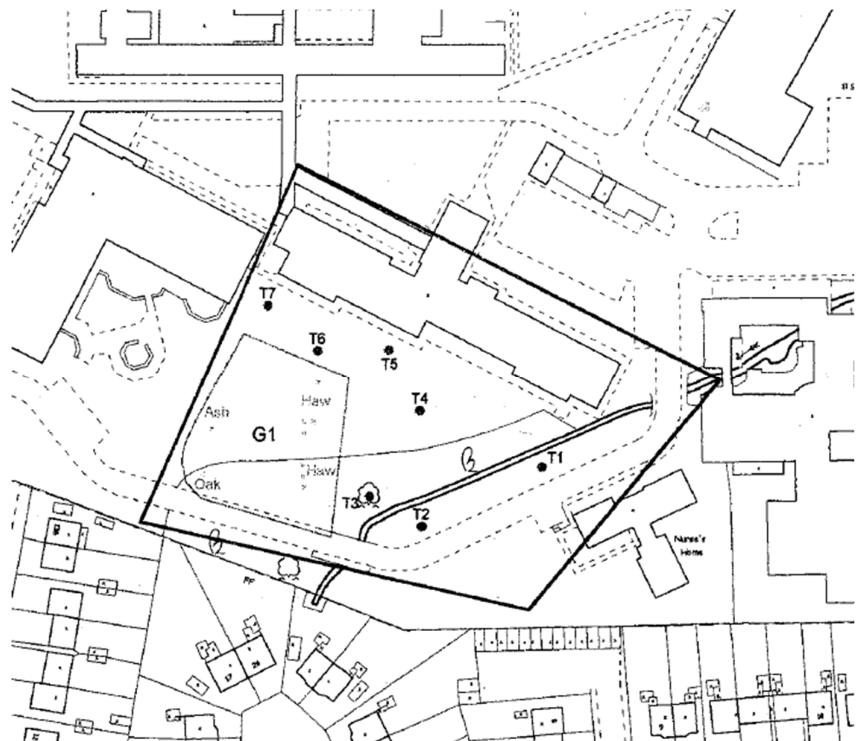
Figure 1: Trees on site protected by TPO 625
