# BS5837 Arboricultural Impact Assessment

NCP Car Park, Terminals 2-3 Heathrow, West Drayton, UB7  
0DU

Client: **Aprirose Real Estate Investment**

**March 2021**

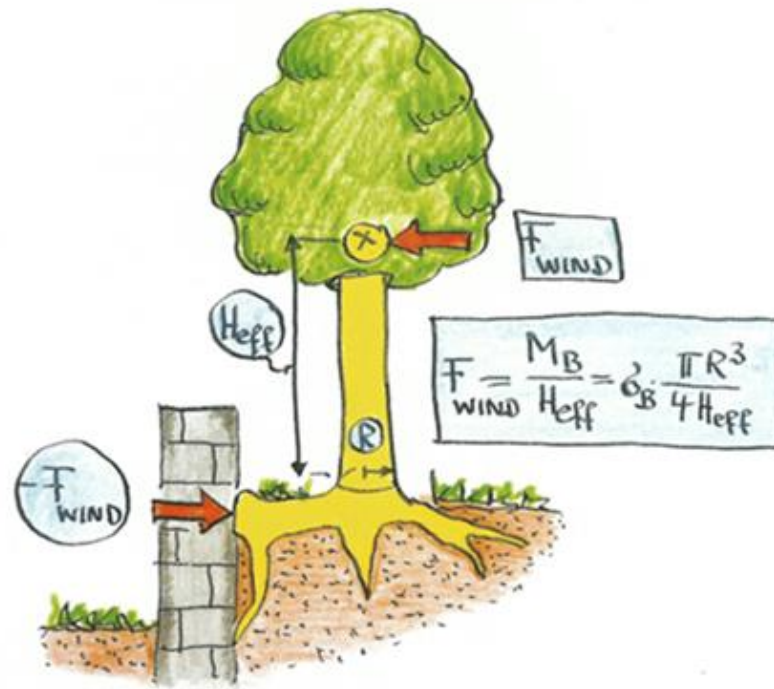
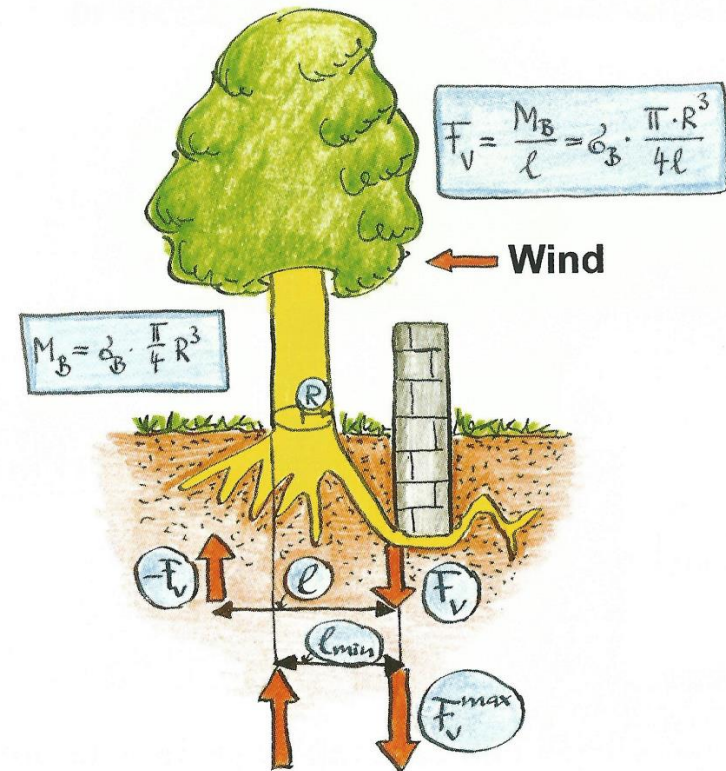
5.1.11 In this instance there is an established brick boundary wall affecting trees within TG1. Depending on the depth of foundation there is a risk that roots are both bracing against and below. Where trees within TG1 are removed a corresponding section of wall is also removed but where trees remain this wall will also remain to reflect the likely relationship with retained trees.

Fig 6 – Roots are likely braced against the face of the wall given the proximity of trees (above left) with some roots also likely extending below the wall (above right). Where TG1 is retained the wall also remains.

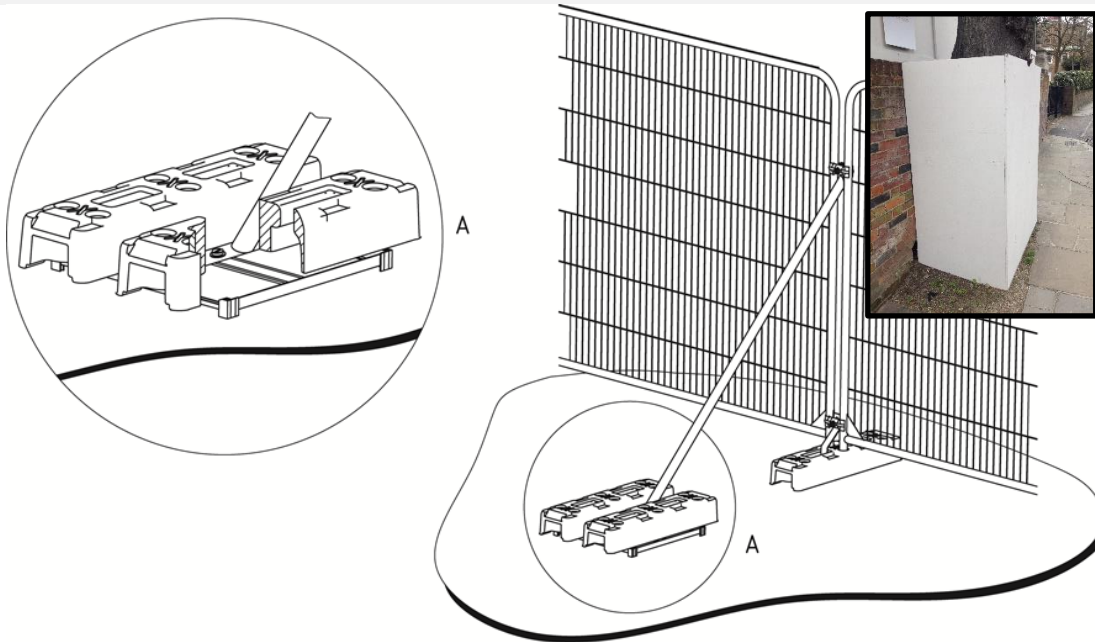
- *Tree protection required internally to site following removal of section of TG1.*
- *To tie in to retained boundary wall features (north and south)*
- *Note: To be marked with signs (inset) and purpose to be briefed to all ground workers.*
- *Maintained for duration of the works.*
- *T1 & T2 basally shuttered (inset).*

5.4.2 High quality BS5837 compliant tree protection will be installed following the removal of the section of TG1 indicated.

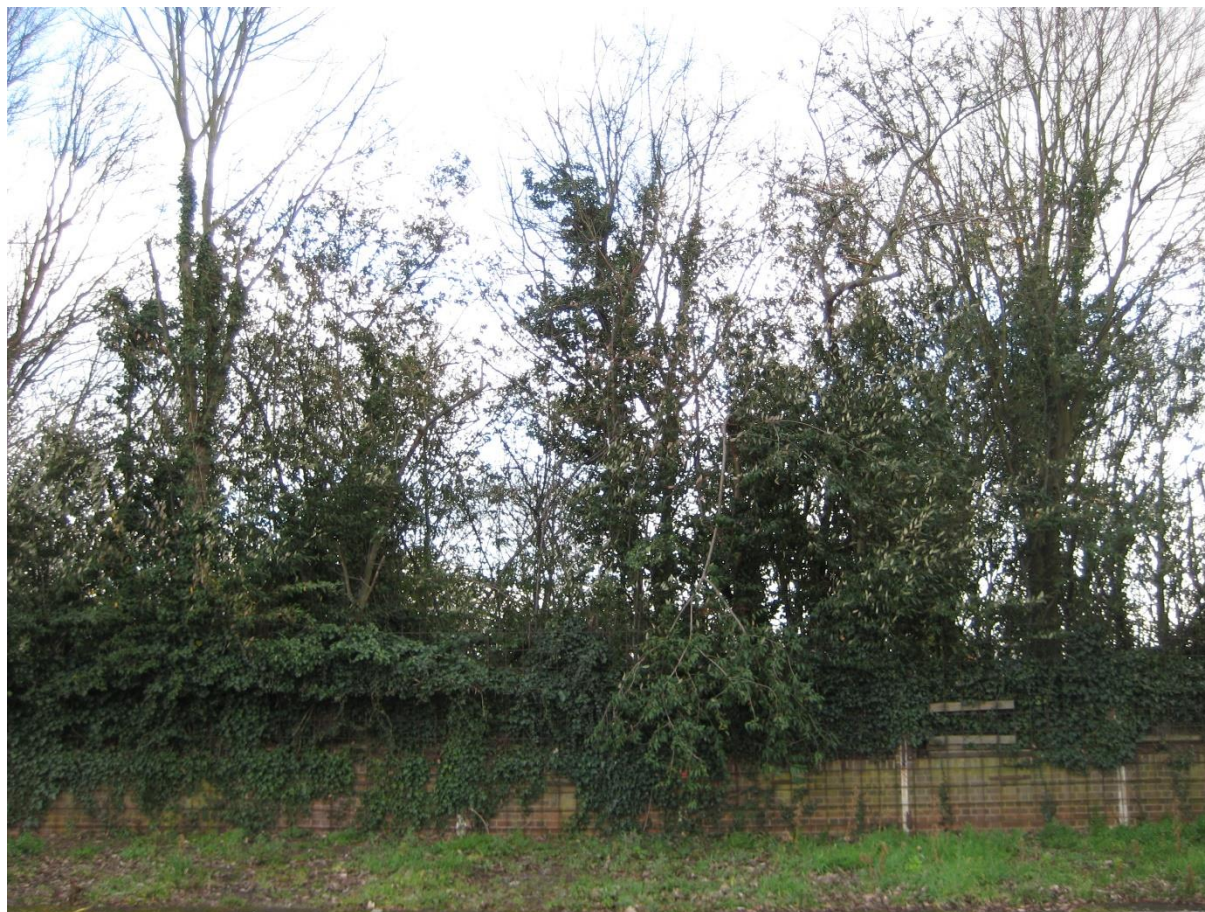
**Image 1** – looking south towards section of TG1 to be removed.

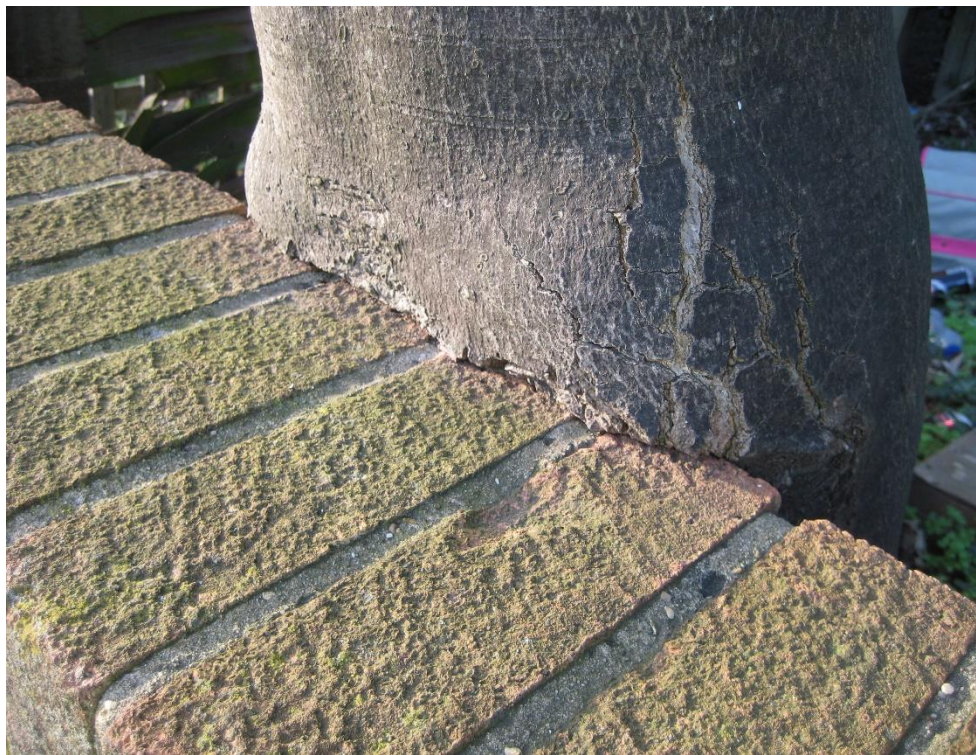
**Image 2** – In places trees are in direct contact with the boundary wall and these trees should be considered for removal on health and safety grounds.

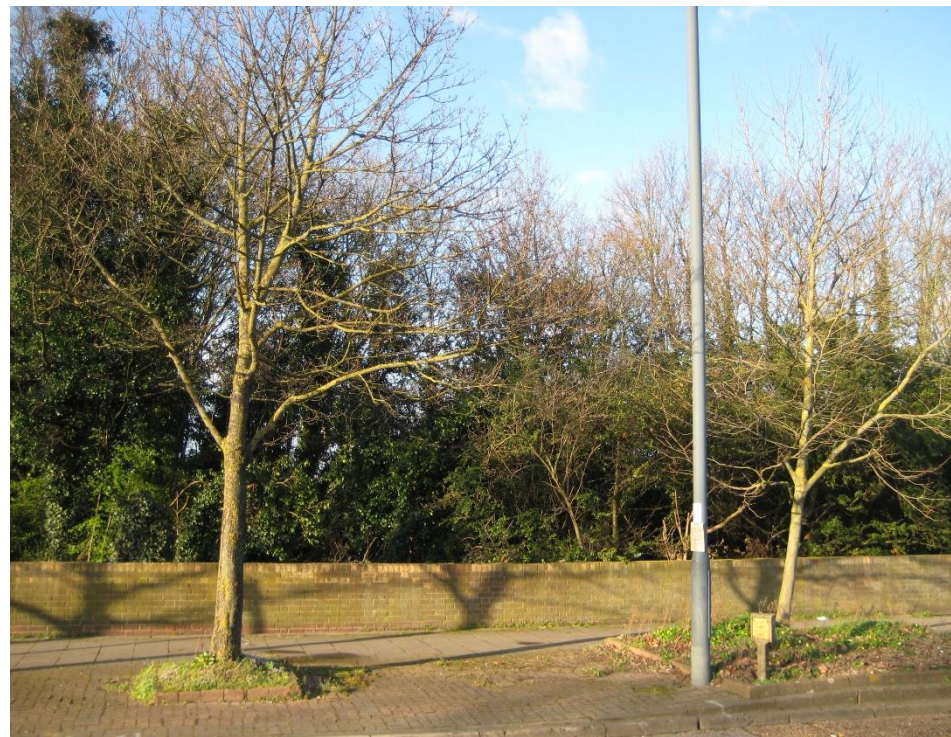
- 1.3 Highway verge trees T3 (Norway Maple) and T4 (London Plane) require removal to facilitate the access point and visibility splay. A section of TG1 (Mixed Species) will be removed to facilitate the link access road to the care park site.

**Image 3** – Looking towards T3 (left) and T4 (right) with TG1 beyond.
