Tree Protection Plan (TPP)

Project: Terminals 2-3 Heathrow Heathrow Flightpath, West Drayton UB7 0DU

Client: Apriose Real Estate Investment

Appendix 7 – Site Photographs

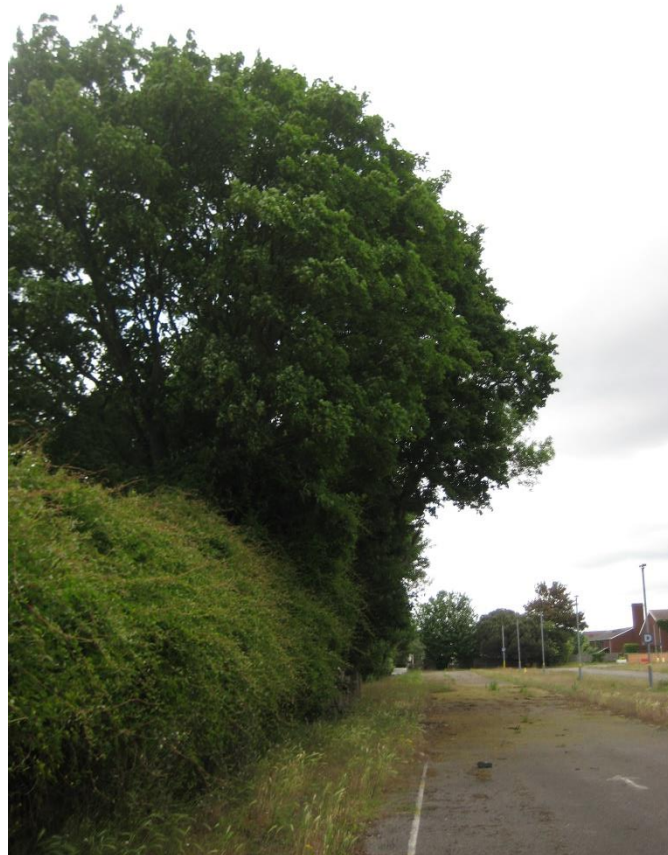
Image 1 – Looking north past TG2 with existing hard surfacing visible

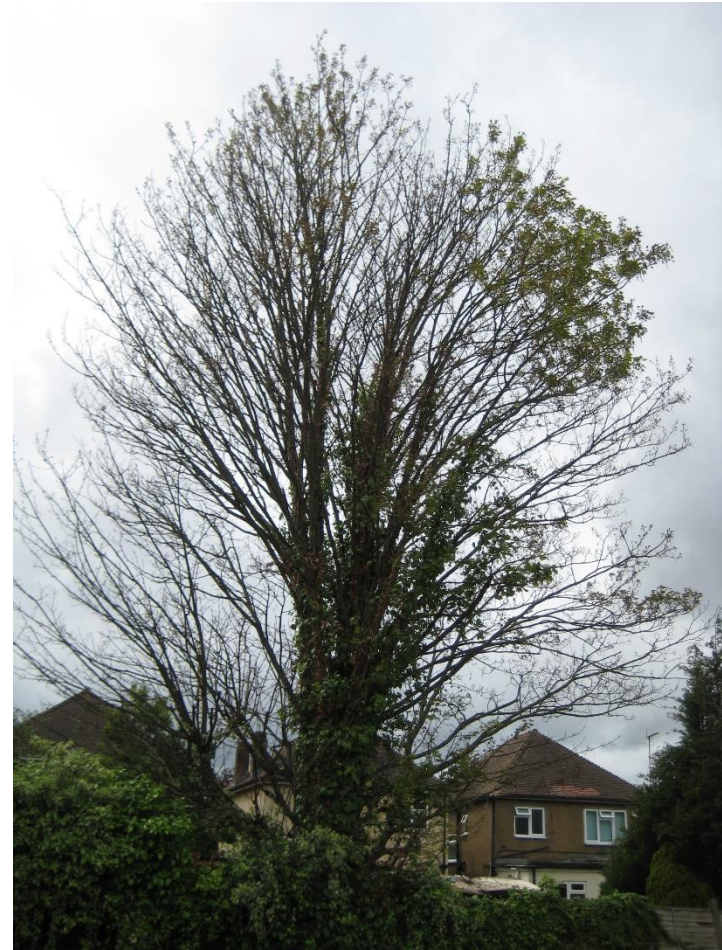
Image 3 –T6 Sycamore - remove
