Arboricultural Report

Maple Road, Hayes, Road, UB4 9NG

London Borough of Hillingdon

Author	Tom Izod FdSc Arboriculture M.Arbor.A
Reviewer	Gary Meadowcroft DIP. Arb RFS ABC L6 M.Arbor.A
Report Status	Arboricultural Impact Assessment Rev A – Movement of proposed north block
Date of Issue	01.11.2022

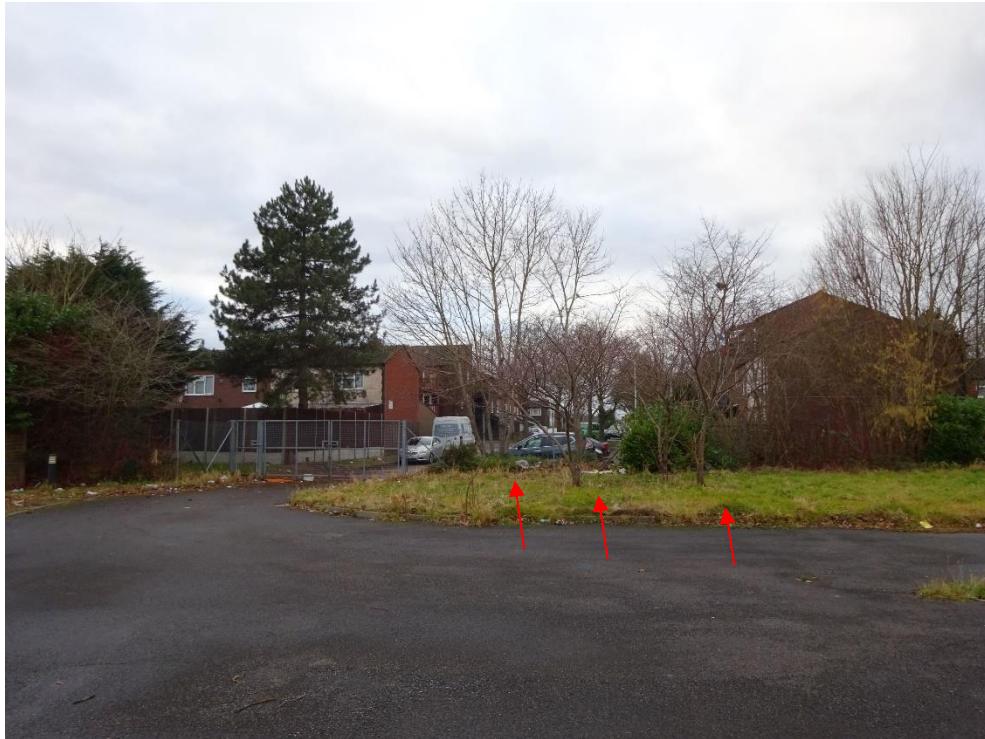
T1-T3 cherry (*Prunus kanzan*) (Category C and U)

5.7 These trees are located just inside the site entrance; T2 is in poor condition.

*Photo 2. Cherry trees (*Prunus kanzan*) T1-T3 looking west from within the site, larger off site Norway maple (*Acer platanoides*) trees T57-T58 in the background will be retained*

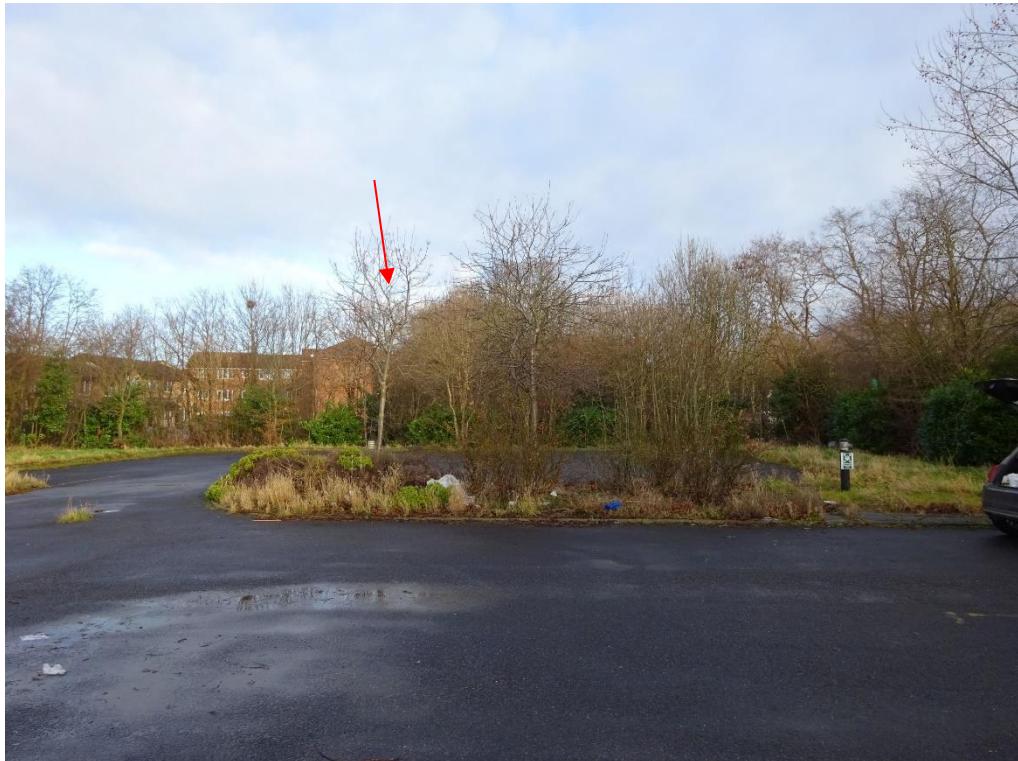
T20-T27 (Category C trees), T49 and T50 (Category C trees in the foreground)

5.9 T20-T27 these trees are internal to the site, but existing in a row running west to east and close to the northern boundary. The rowan (*Sorbus aucuparia*) trees T49 and T50 are within a landscape bed between two existing car parking tarmac areas.

Photo 3. T20-T27 G22, looking north, with T49 and T50 in the foreground looking north

5.10 T20-T25 will need to be removed due to the incompatibility of the existing and future growth with the proposed northern block of flats. There are several dead elms (*Ulmus sp.*) within G22, a group of mixed trees and shrubs growing closer to the northern boundary fencing, and are recommended for removal. Appropriate better quality, new tree planting in this area would be feasible.

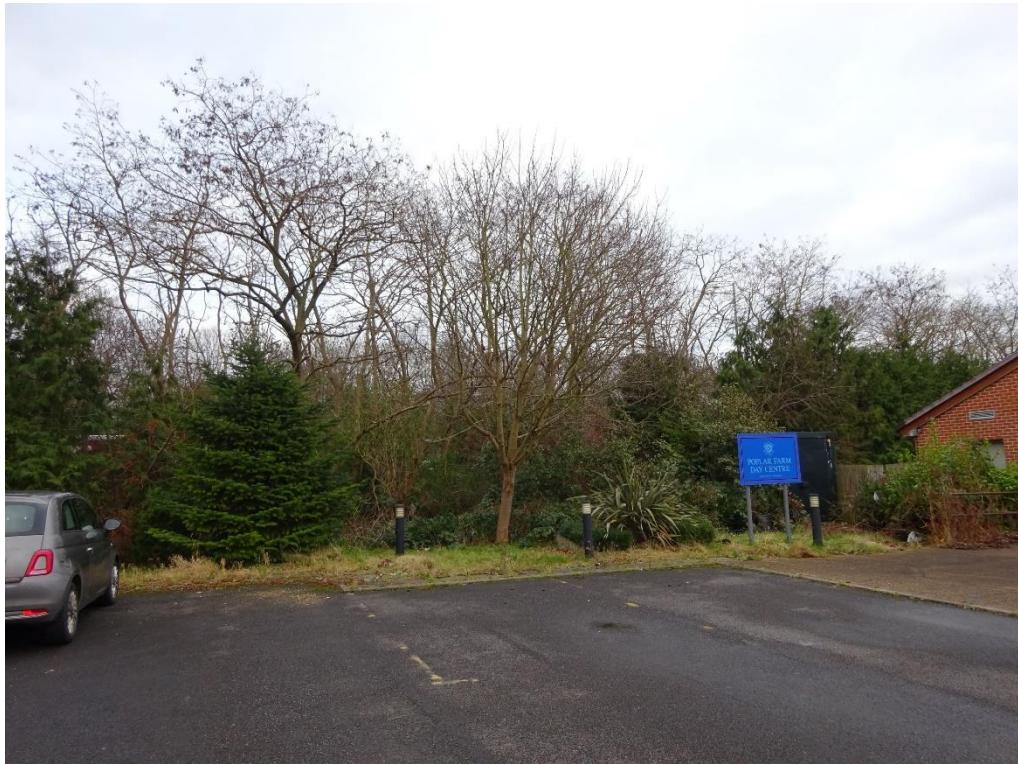
T33, T34, T35, G36 (Category C trees within the site eastern boundary)

5.11 T33 a fir (Abies sp.), T35 Norway maple (Acer platanoides) and G36 a group of shrubs and western red cedar are within the site; these are low value trees, sheltered from wider views by the landscape strip of trees along the Parkway.

Photo 4. T33, T34, G36 looking east

5.13 The proposed car parking bays within the eastern boundary landscape strip adjacent Parkway dual carriageway fall within an area that has not been surveyed as part of the topographical survey. However, T34 has been identified as a poor quality willow (*Salix fragilis*) tree which has significant deadwood and a crack in the main fork, and therefore should not be a constraint to this proposal. Impact on levels and other existing trees in this location can be reviewed in detail during detailed design and appropriate mitigation provided within an arboricultural method statement for the contractor.

5.12 These trees are all to be removed to facilitate the car parking bays proposed in this location.

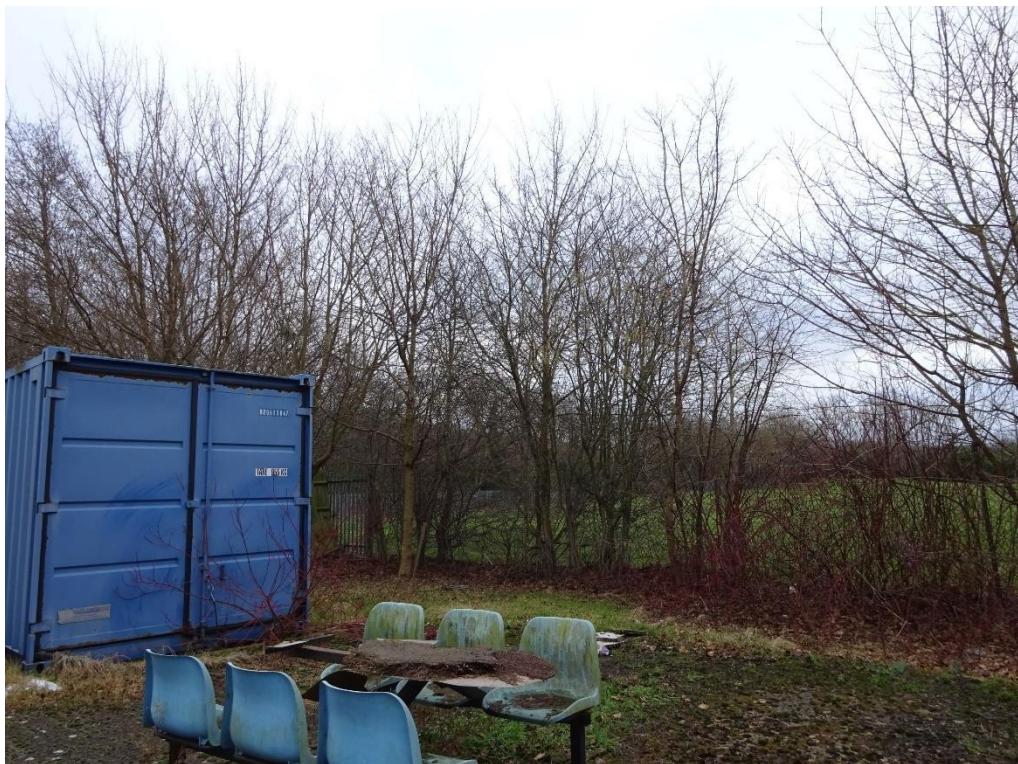
G54 Southern boundary (Category C group of mixed native species)

5.14 This group of trees are again typical of the boundary character generally around the site, consisting of unmanaged native species, developing into young trees.

Photo 6. G54 southern boundary looking south from within the site

5.15 G54 group will be retained, and protected during development works, some crown management will be required in the future to ensure ongoing compatibility with the flats. As an existing feature, it is recommended that the group are formally managed as a tall hedge to integrate the development with the park to the south and protected by tree protection fencing during site works.

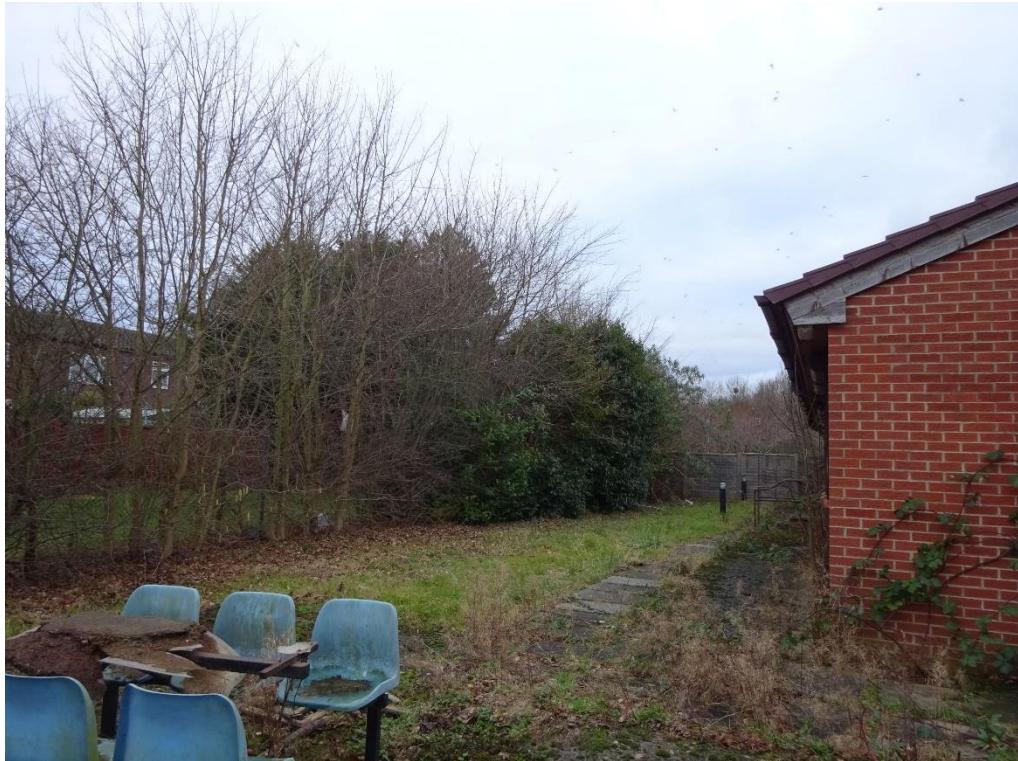
G55 – south west boundary (Category C group)

5.16 Early mature group of mixed trees and shrubs, an unmanaged hedge which has developed into small trees, maximum stem diameter 150mm.

Photo 7. G55 looking north

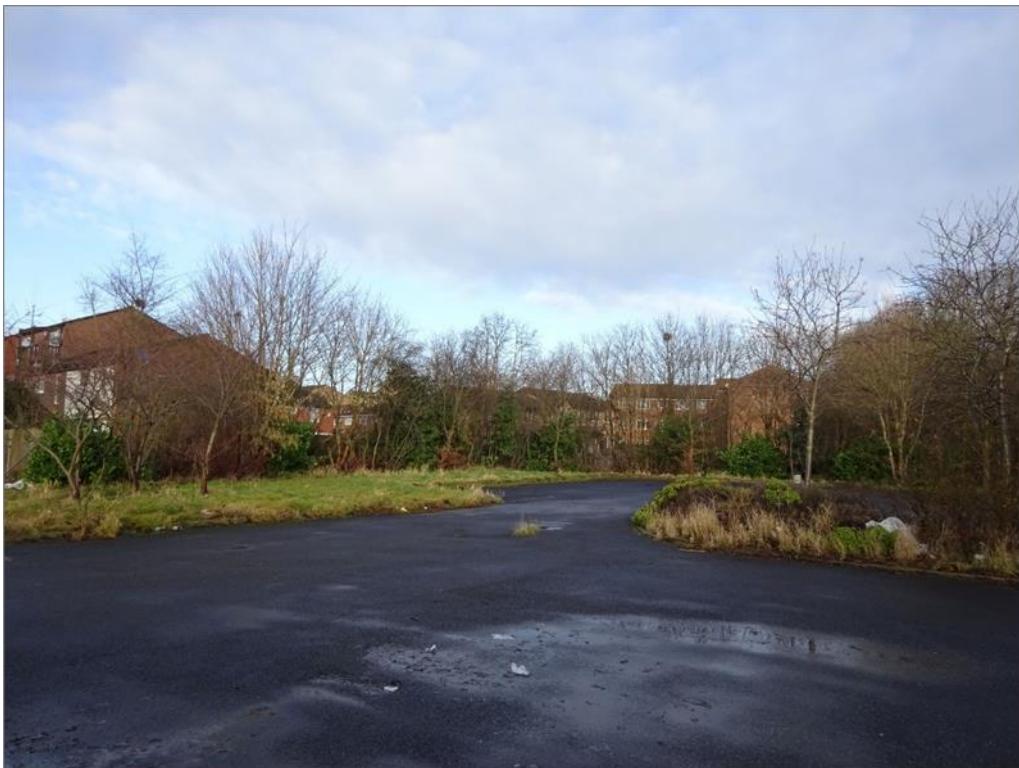
G19 – western boundary (Category C group)

5.18 This group of trees along the western boundary are again typical of the boundary character generally around the site, consisting of unmanaged native species, that are developing into small trees.

Photo 8. G19 and individual trees T5-T16 looking north west from within the site

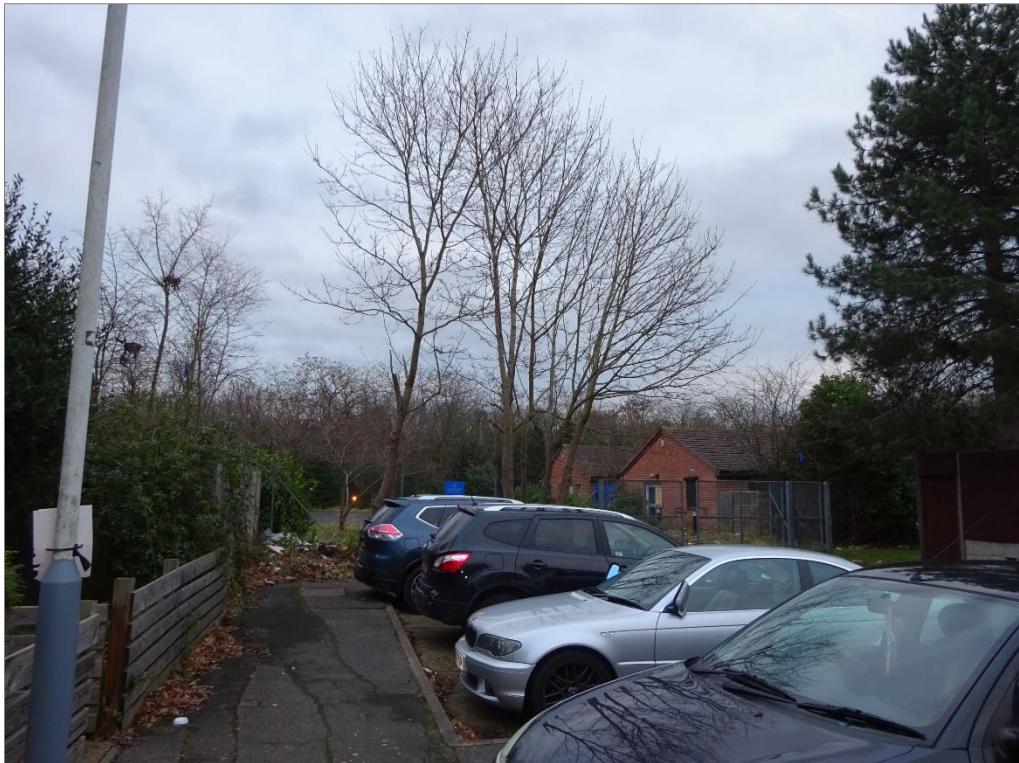
T57 and T58 – off site trees western boundary (Category C trees)

5.20 T57 and T58 are off site trees that need to be retained. They are mature Norway maple trees (*Acer platanoides*), in fair structural and physiological condition, but have been poorly pruned historically, T58 in particular has an unbalanced crown.

Photo 9. T58 and T57 (left to right) looking east from the residential street

5.21 The proposed car parking will be within the RPAs of T58 and T57. To avoid root damage, the hard surfacing (and kerbs) will need to be constructed above existing soil levels and constructed using a permeable, three dimensional and load-bearing material to protect the roots of this tree. The impact on finished levels for this no-dig area will need to be considered when designing the finished levels for the rest of the road construction to ensure it all ties in together and no-dig will work. The area proposed for no-dig is identified on the tree protection plan at Appendix 3, and its specification and installation will need to follow an agreed method statement and be installed under arboricultural supervision. The crowns will be protected by tree protection fencing during works.
