Arboricultural Assessment

**50 Rodney Gardens
Pinner HA5 2RP**

Prepared by
Tim Pursey

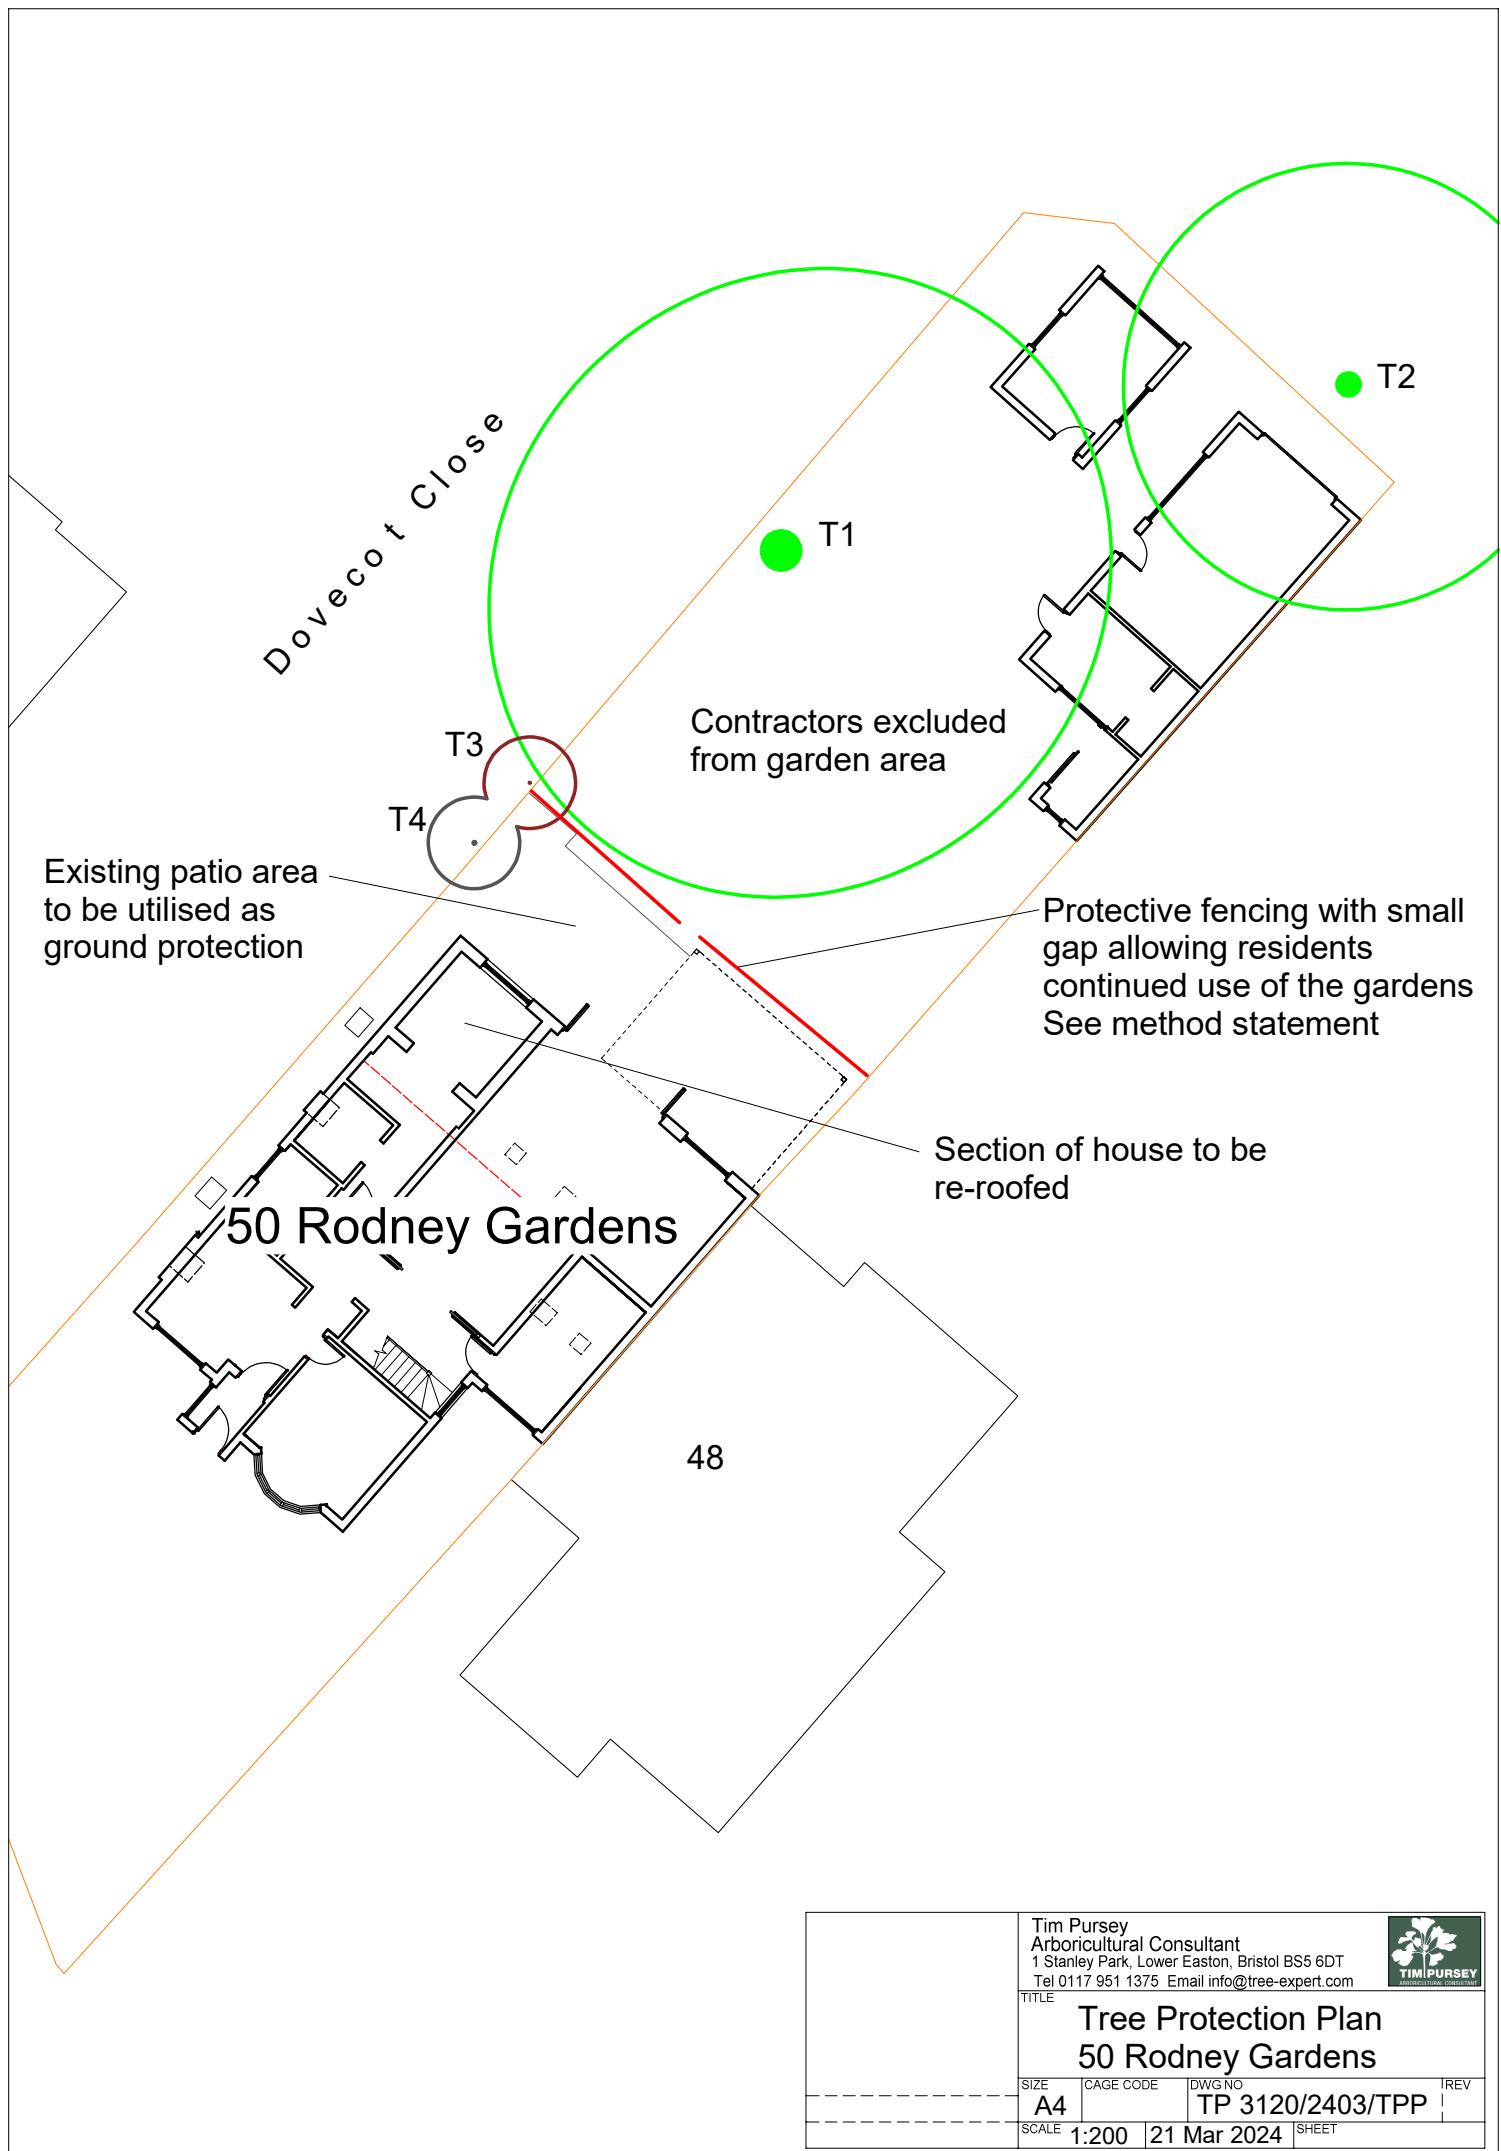
Tree Constraints Plan 50 Rodney Gardens

Root protection area modified due to road
