### Arboricultural Impact Assessment Method Statement & Tree Protection Plan (to BS:5837 2012)

55 The Greenway, Ickenham  
UB10 8LU

Prepared by Trevor Heaps BSc, MICFor, RC. Arbor. A

Ref: TH 5917

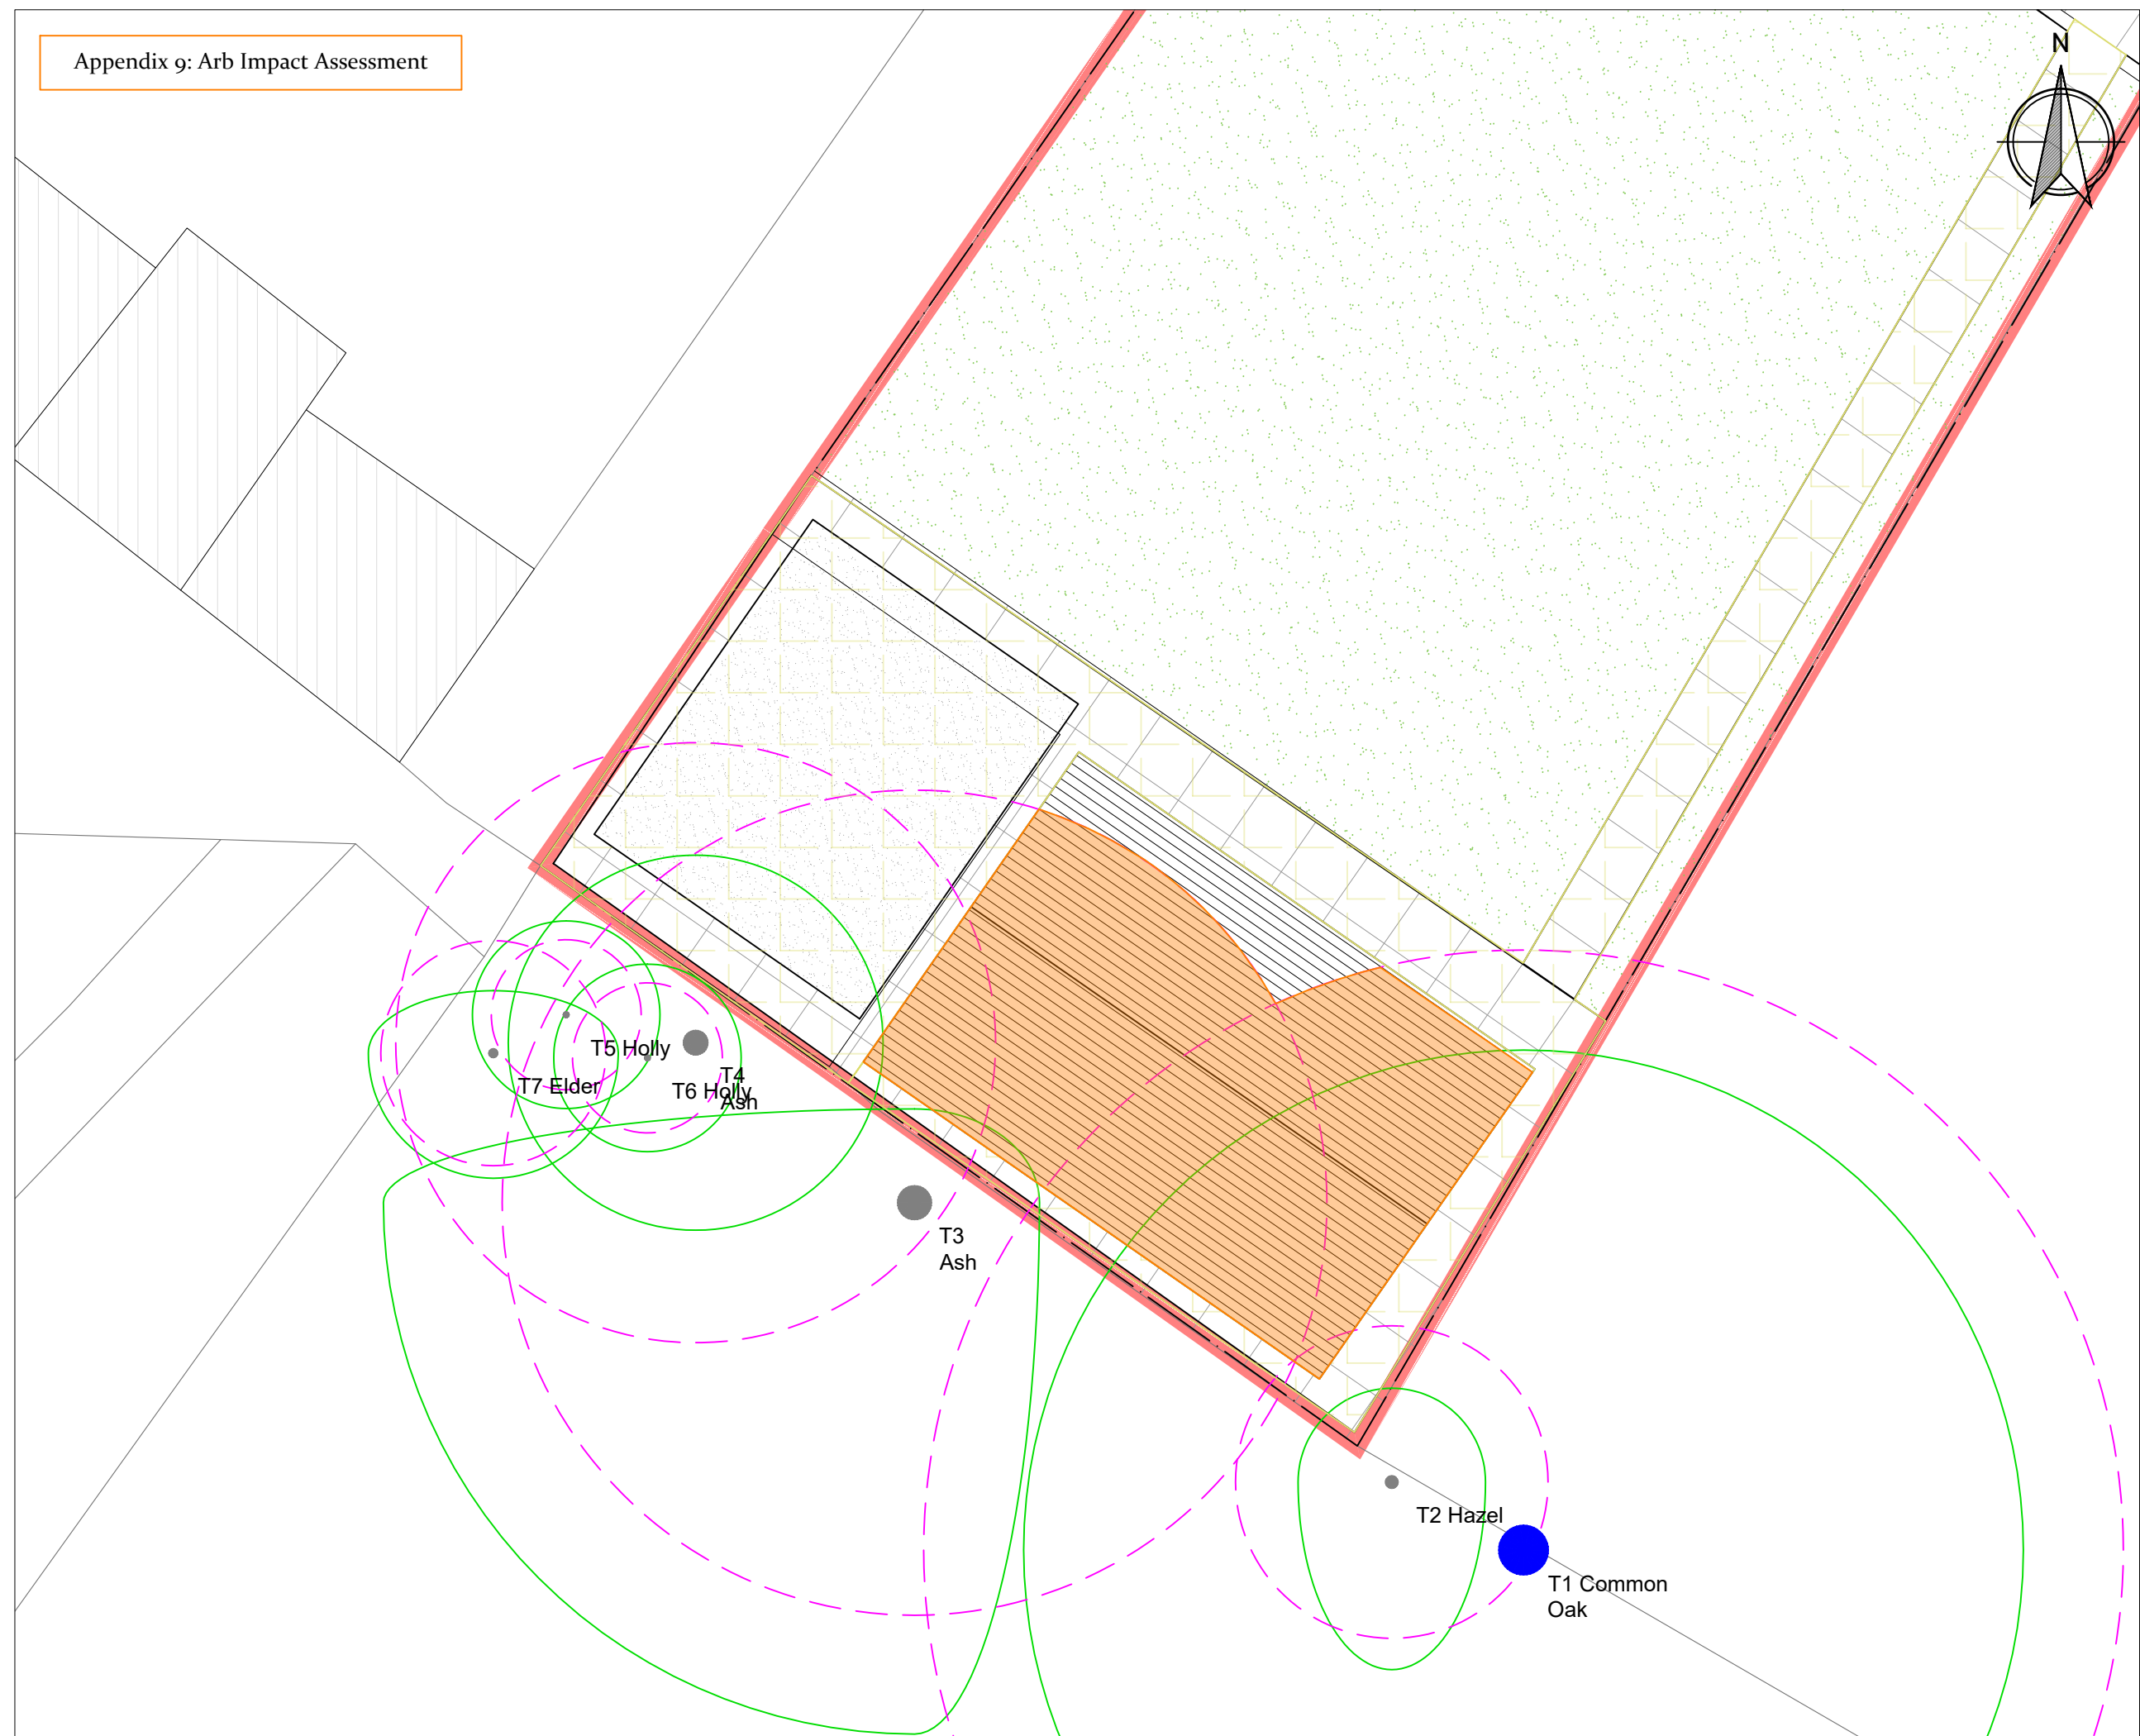
Oak T1 – 26m of 290m<sup>2</sup> = 9%      Ash T3 – 34m of 137m<sup>2</sup> = 25%

9.4.8 The Oak is healthy, but the Ash appears to be suffering from Ash die-back (and so might need management from the Council).
