**Arboricultural Implications
Assessment
for a proposed development
at
10 The Broadwalk
Northwood
HA6 2XD**

**Client: Chirangi Ruparelia
10 The Broadwalk
Northwood
HA6 2XD**

Date
29/03/2022

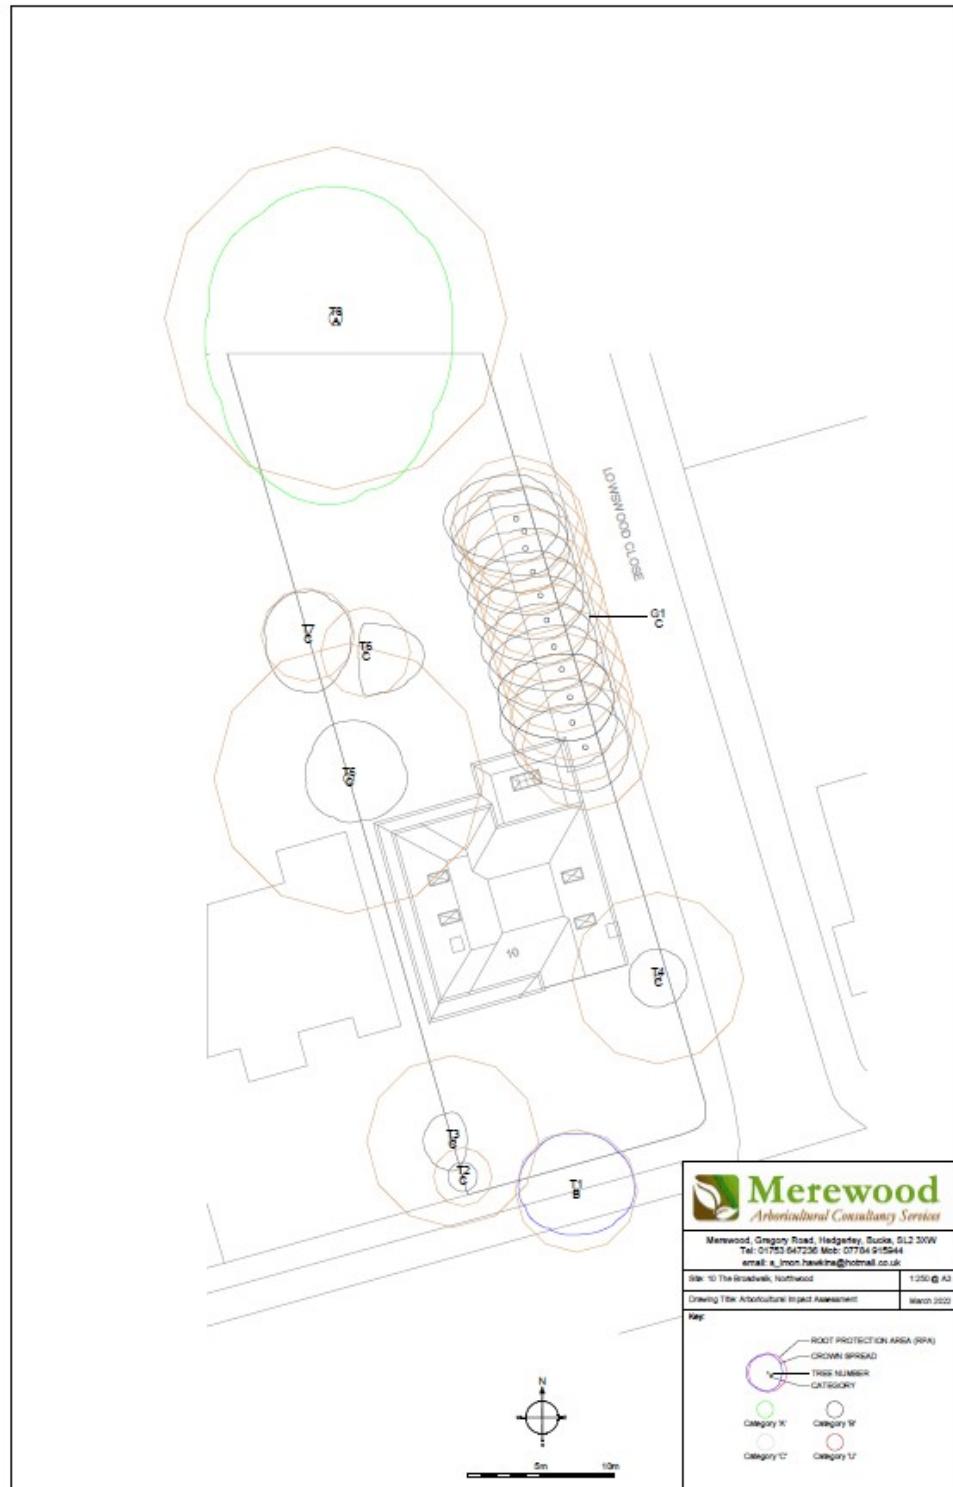
Impact Assessment Plan

3.4.1 The tree protection plan (see method statement) shows that there is a pinch point at the corner of the house alongside the cypress (T4). This tree will have to be fenced off close to the stem to allow pedestrian access down the side, but for machinery to be able to reach the back garden a section of the rear fence will have to be removed, accessing from Lowswood Close.

3.2.1 The proposed development would not require the removal of some of the western red cedars from the group (G1). In order to accommodate the extension it is recommended that 3 of the trees from the group are removed, although the removal of the whole group should also be considered, with replacement planting taking place.
