Tree Survey and Arboricultural Impact Assessment

BS5837:2012 Format

A report and Arboricultural Method Statement to support the demolition of existing and construction of six new properties.

Manor Lodge, Rickmansworth Rd, Northwood HA6 2QW

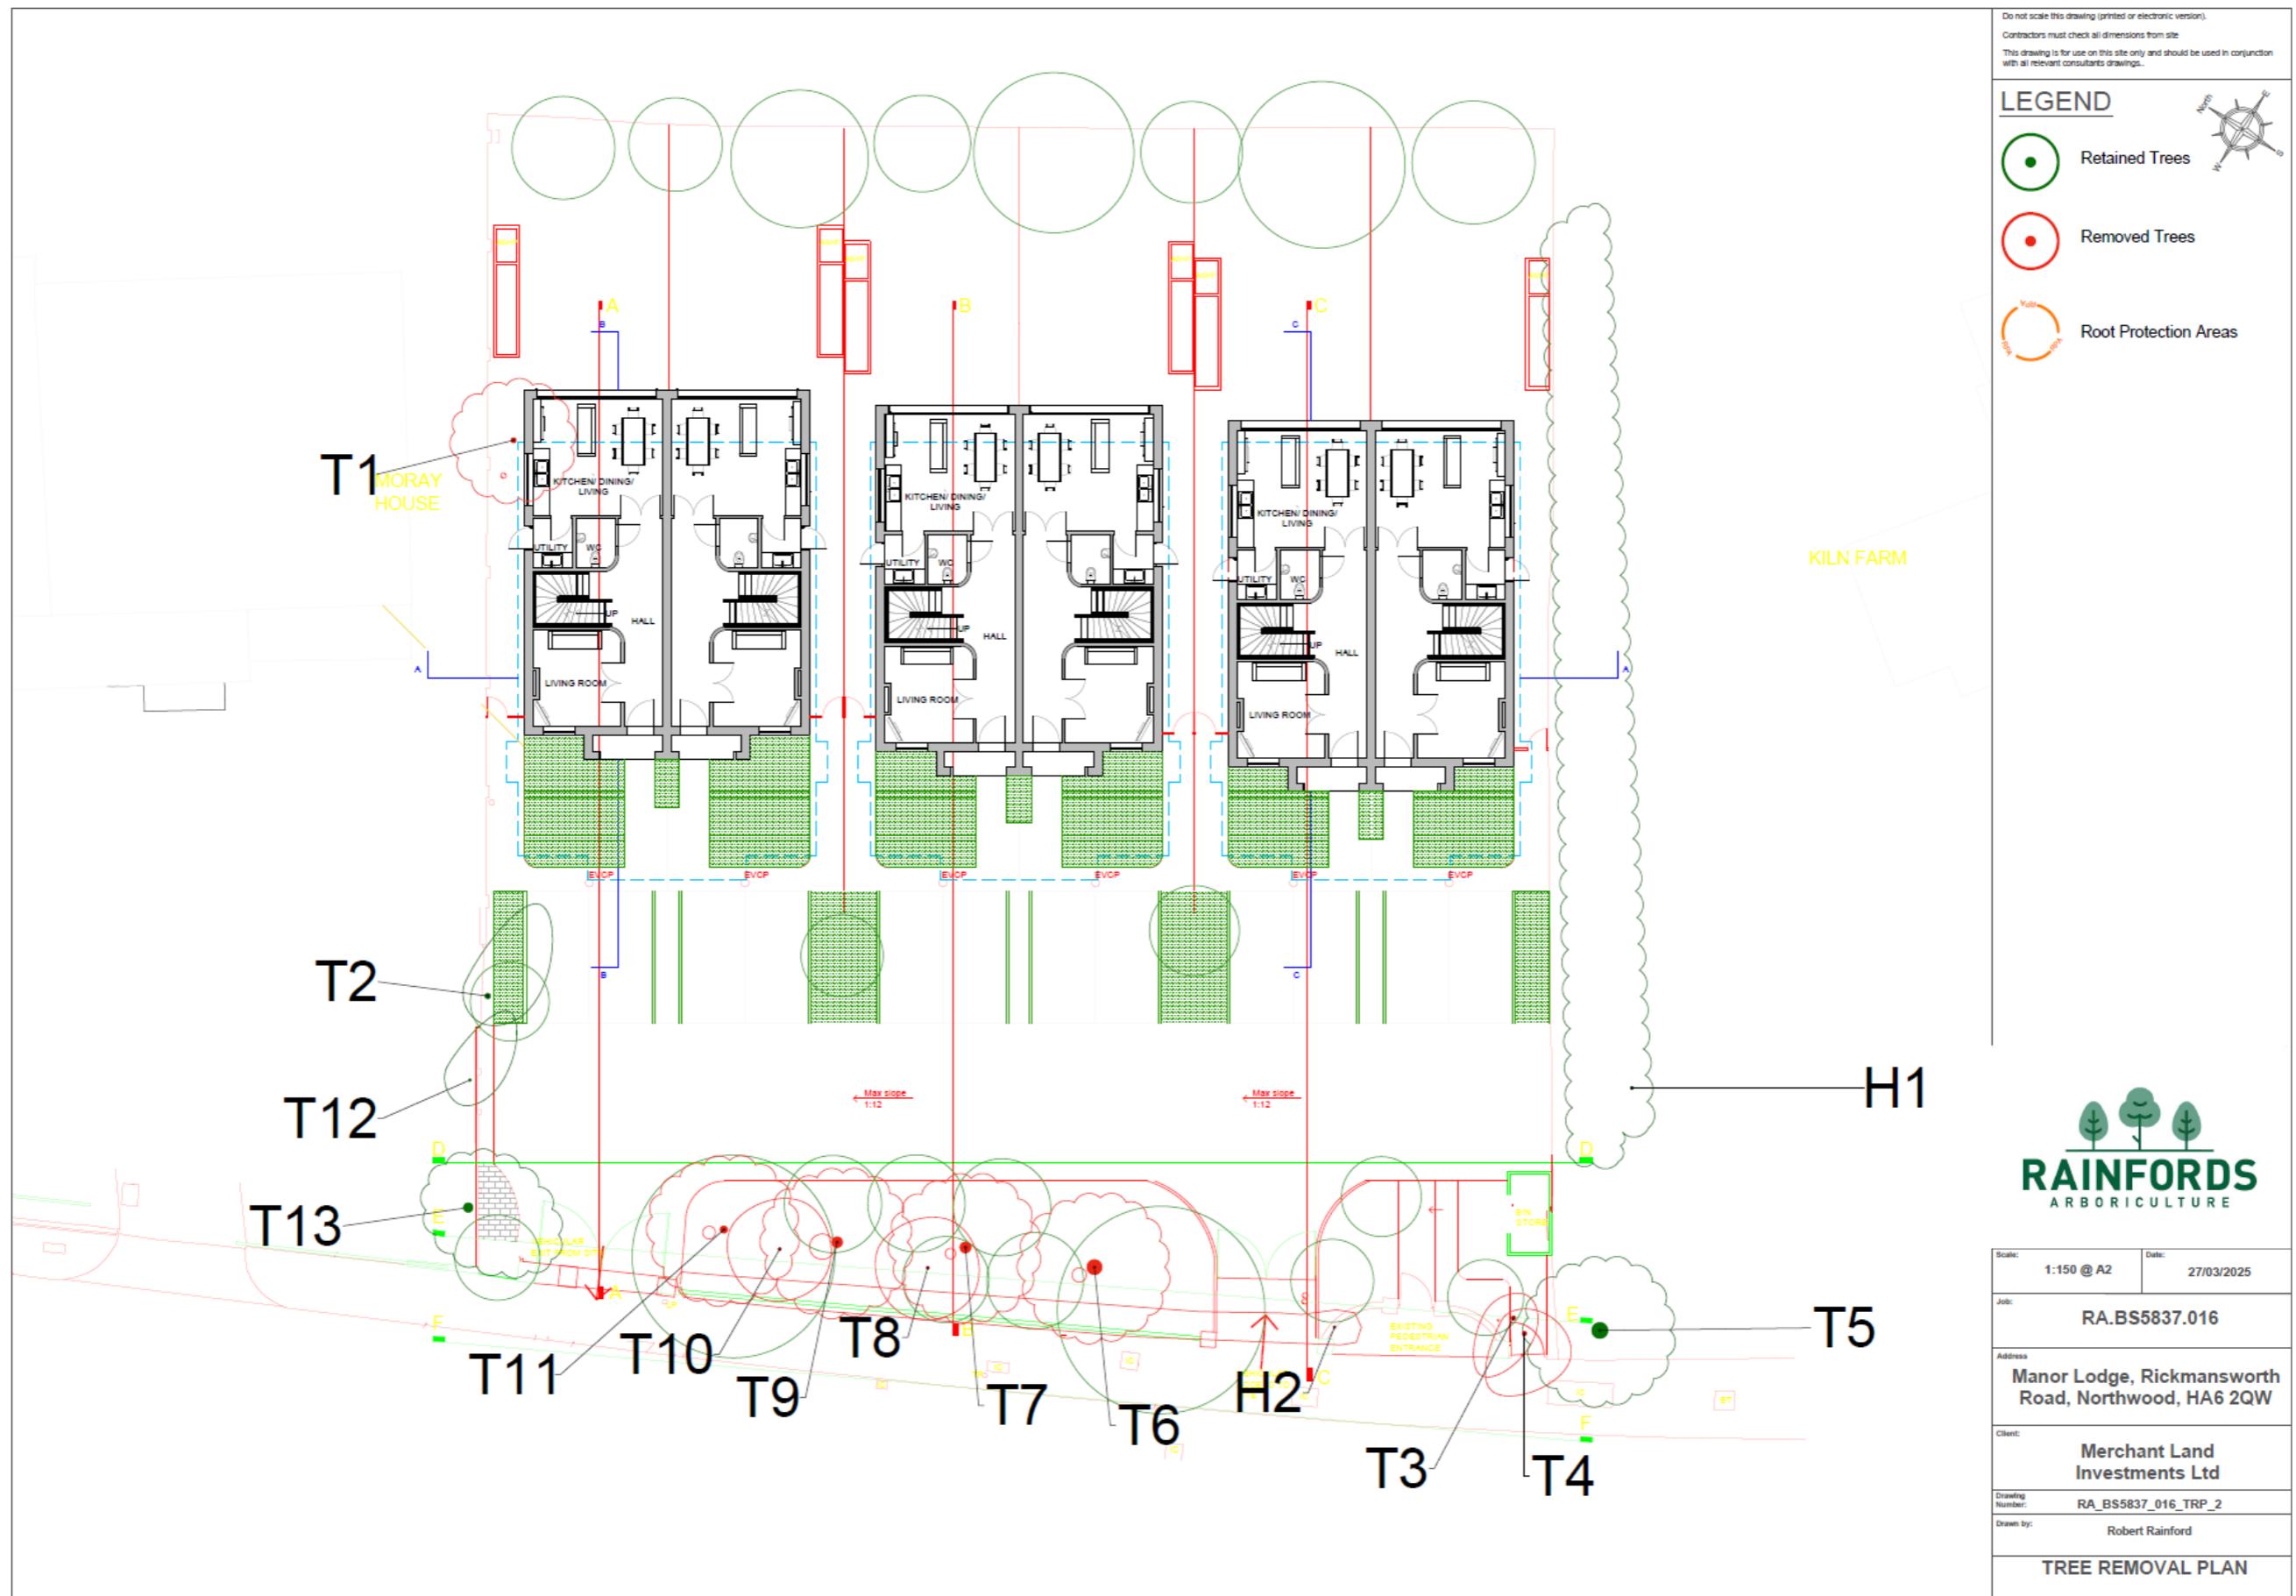
9 APPENDIX C - Tree Removal Plan

- 10 Category **U** trees or groups require work. T1, T3, T4, T6, T7 T8, T9, T10, and T11 all require felling to facilitate the development. T12 is recommended for removal due to its significant overhang to facilitate access.

- 1 Category **U** trees or groups require work. T2 has been categorised as unsuitable for retention however is not scoped to be removed under this scheme at this time.

Remaining trees situated within Manor Lodge boundaries are recommended to be removed to facilitate the proposed designs and allow seamless implementation and scope for improvement where trees currently reside.

T1 is in an unsuitable position and will be infringing on a building if retained.

T3 and T4 are both low quality and require removal to allow the statutory pedestrian Access into the site.

T6-T11, whilst larger trees on site, are of low quality and likely to receive future pressure for severe reduction or removal. Their removal can be mitigated by planting species which will add longevity and biodiversity to the site.

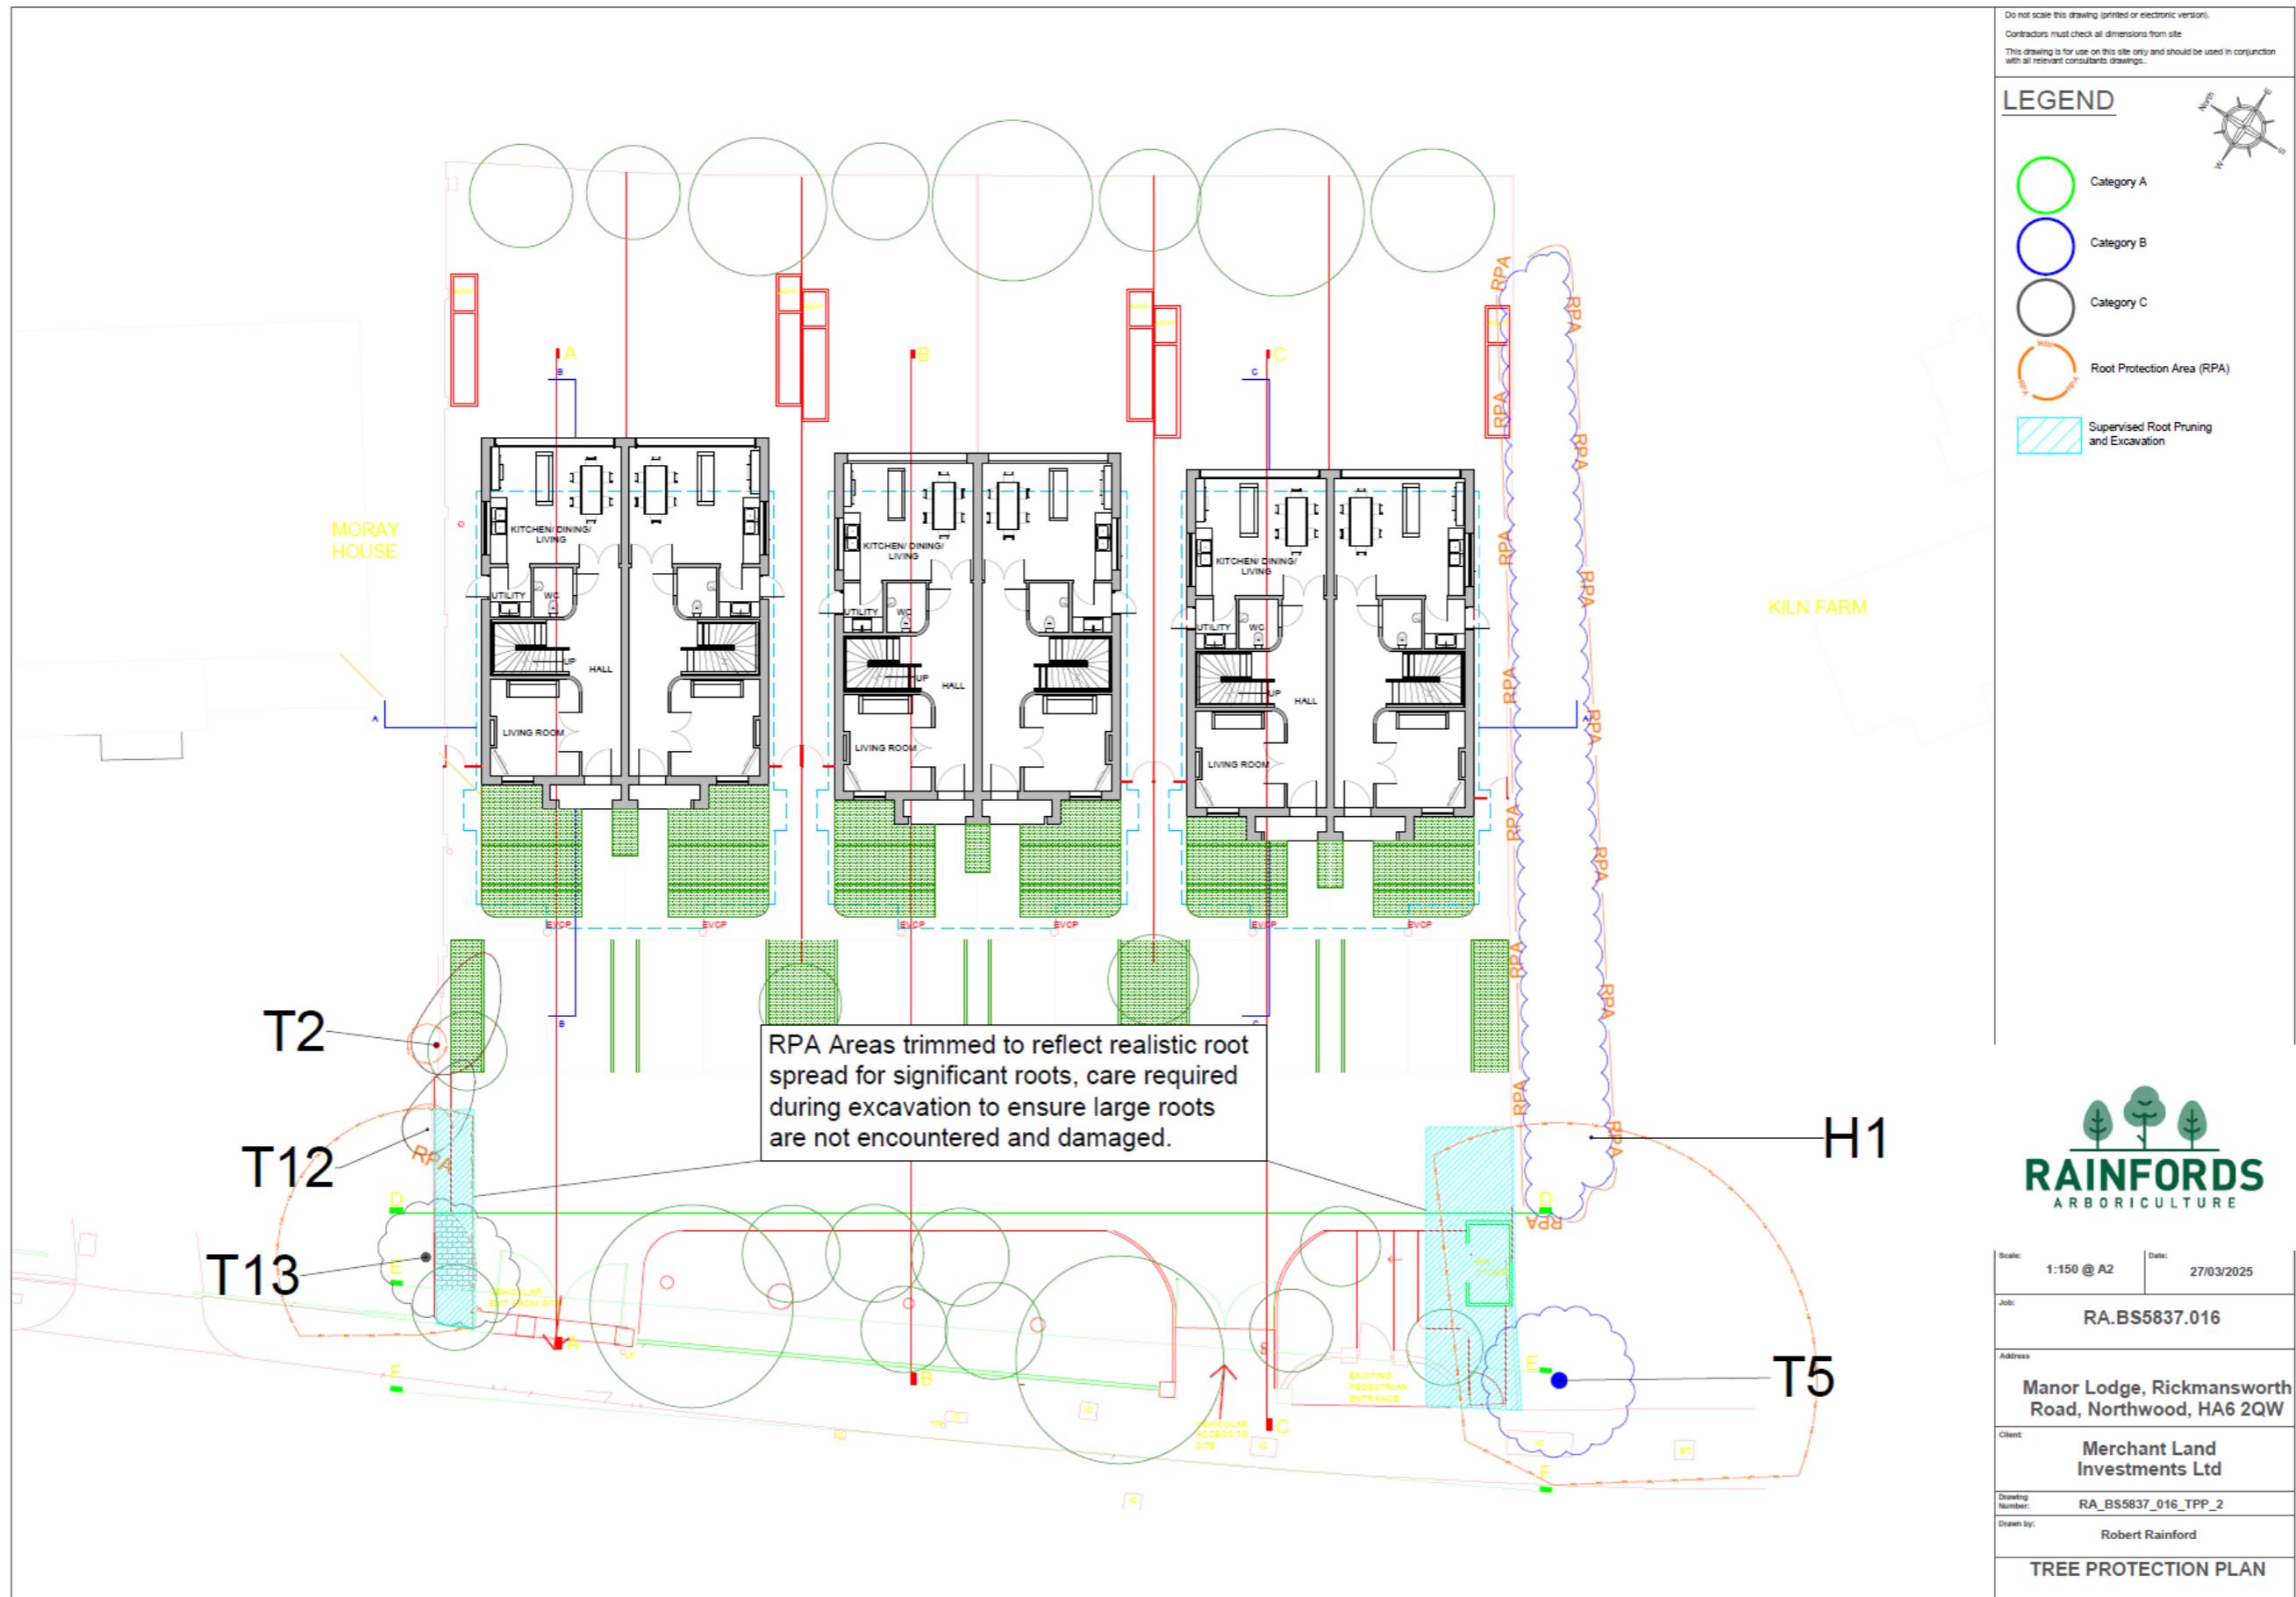
11 APPENDIX E - Tree Protection Plan

Remaining trees under potential pressure during works are primarily third party trees, T2, T5, T12 and T13. Under the Arboricultural Method Statement all tree works should be carried out before building work commences, leaving no trees proposed for removal under pressure or impact from demolition works.

Where surfaces are proposed to be changed, there are potential conflicts to third party trees, T13 is marked to have some slight encroachment into Manor Lodge and will require careful excavation around the site exit. T5 has a substantial root zone within the garden it is situated, so is possible to have roots pruned where possible to prevent future surface damage or uplift, plus allow the installation of the necessary surfacing and support.

Where roots from T5 are likely to be encountered at the existing pedestrian entrance, roots that are unable to be pruned sufficiently should be adequately protected with an engineered solution. A cellular confinement system is a suitable system for this and would allow for final surfacing over the rooting area, while maintaining low levels of compaction and root damage.
