# BS5837 Arboricultural Impact Assessment & Method Statement

46 Sweetcroft, Lane, Uxbridge, UB10 9LE

Job Reference: 04075R

## October 2023

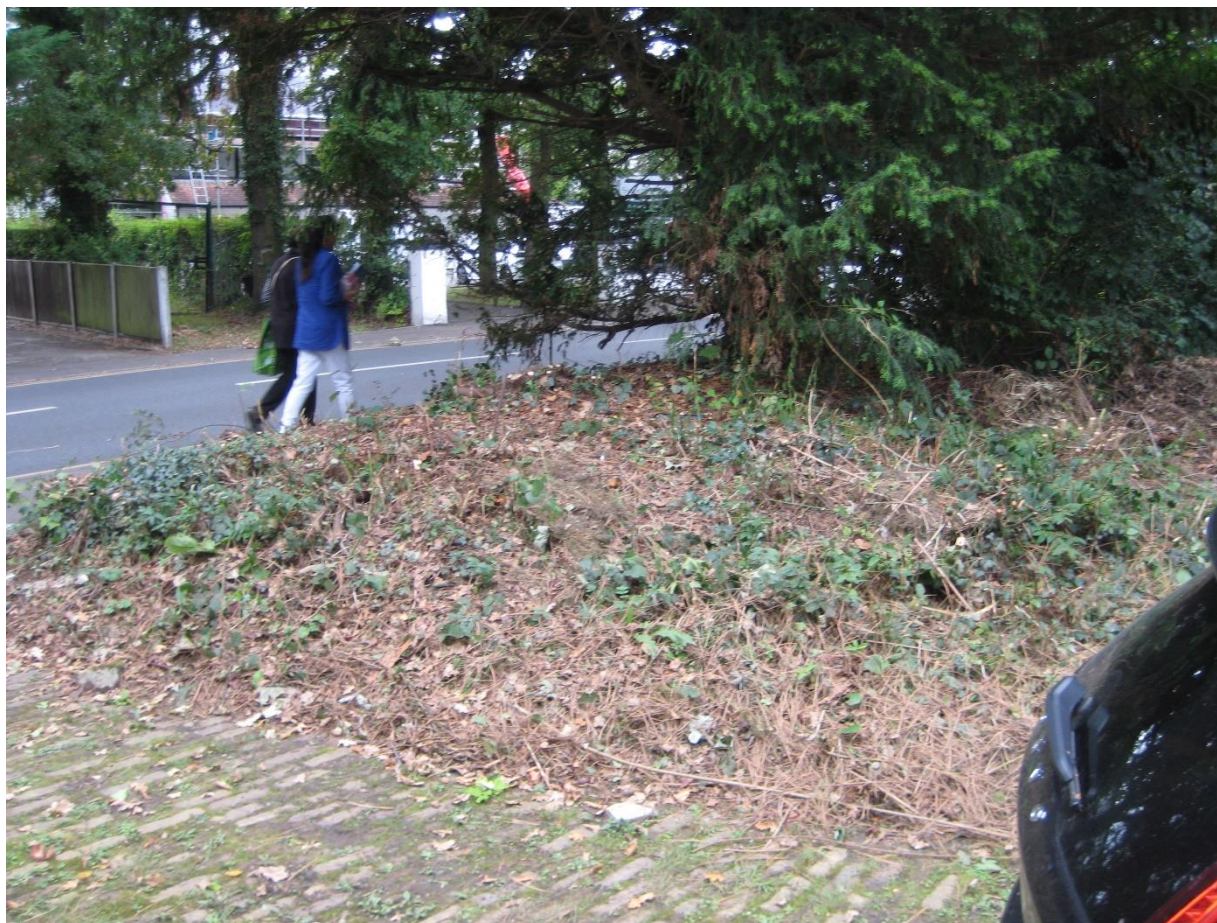
**Image 1** – Looking towards T1 – the mounding in this area must not be removed.

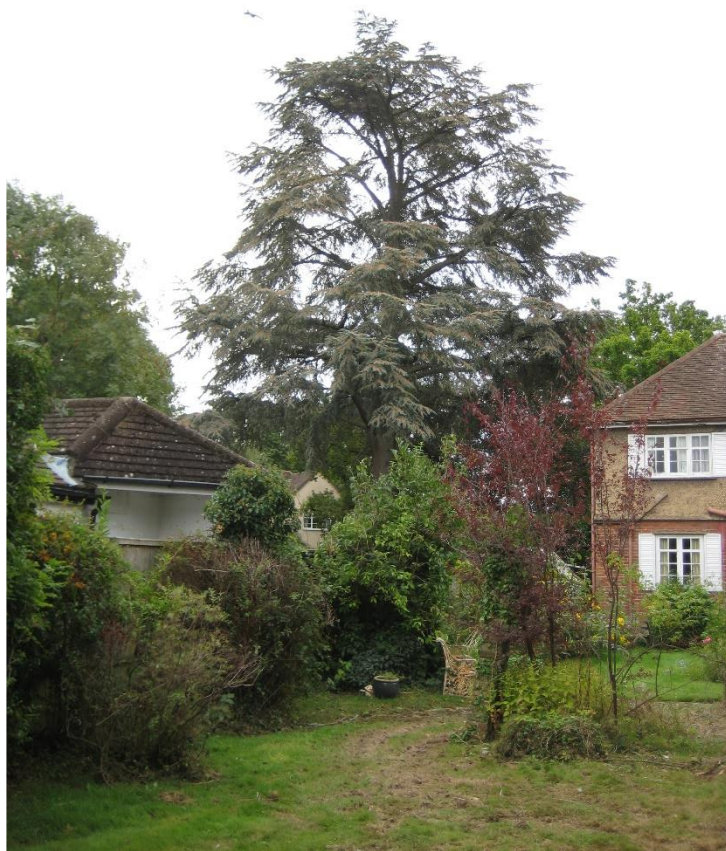
**Image 2 – T12 (Cedar) viewed from the rear with the property visible (right)**

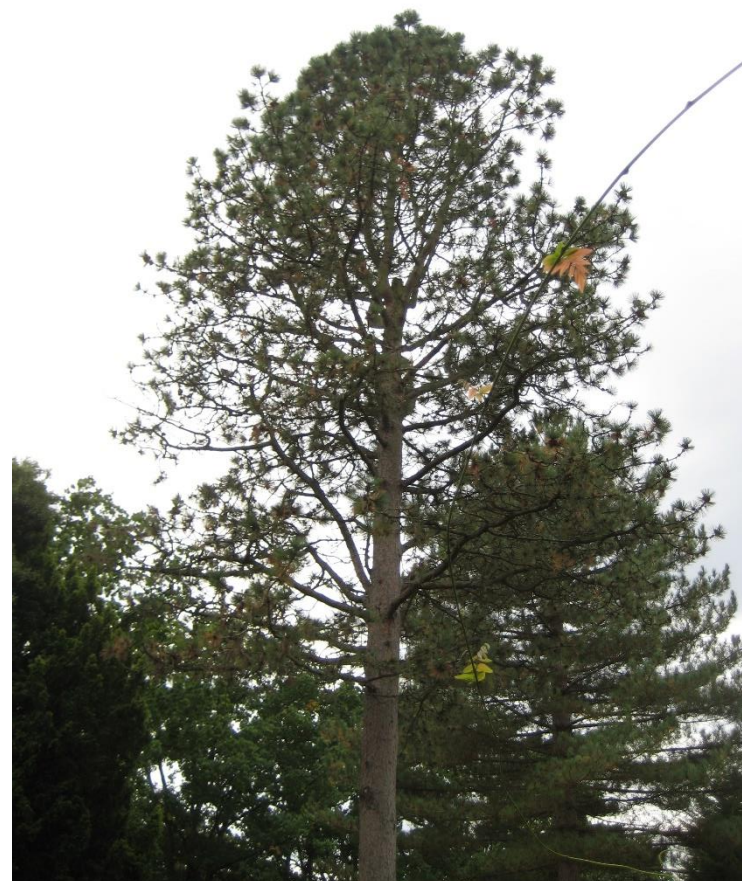
**Image 3 –T2 (Corsican Pine) Oct 2023 – Monitor this tree closely**
