BS5837 Arboricultural Impact Assessment & Method Statement

46 Sweetcroft, Lane, Uxbridge, UB10 9LE

Job Reference: **04075R**

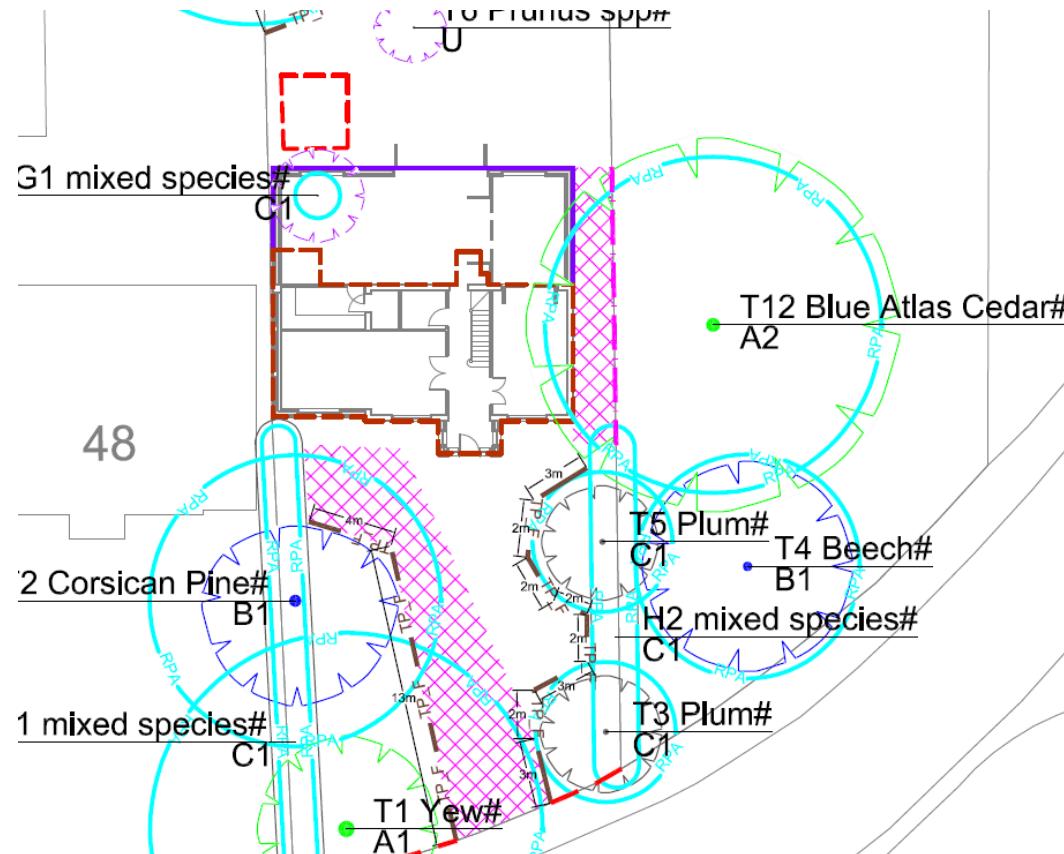
Fig 8 – Temporary Ground Protection allows operative parking/ material storage and movement around the eastern end of the building.

5.4.5 Temporary ground protection should be laid prior to any on site activity and be to a suitable specification relative to the access requirements/ machinery/ personnel movements.

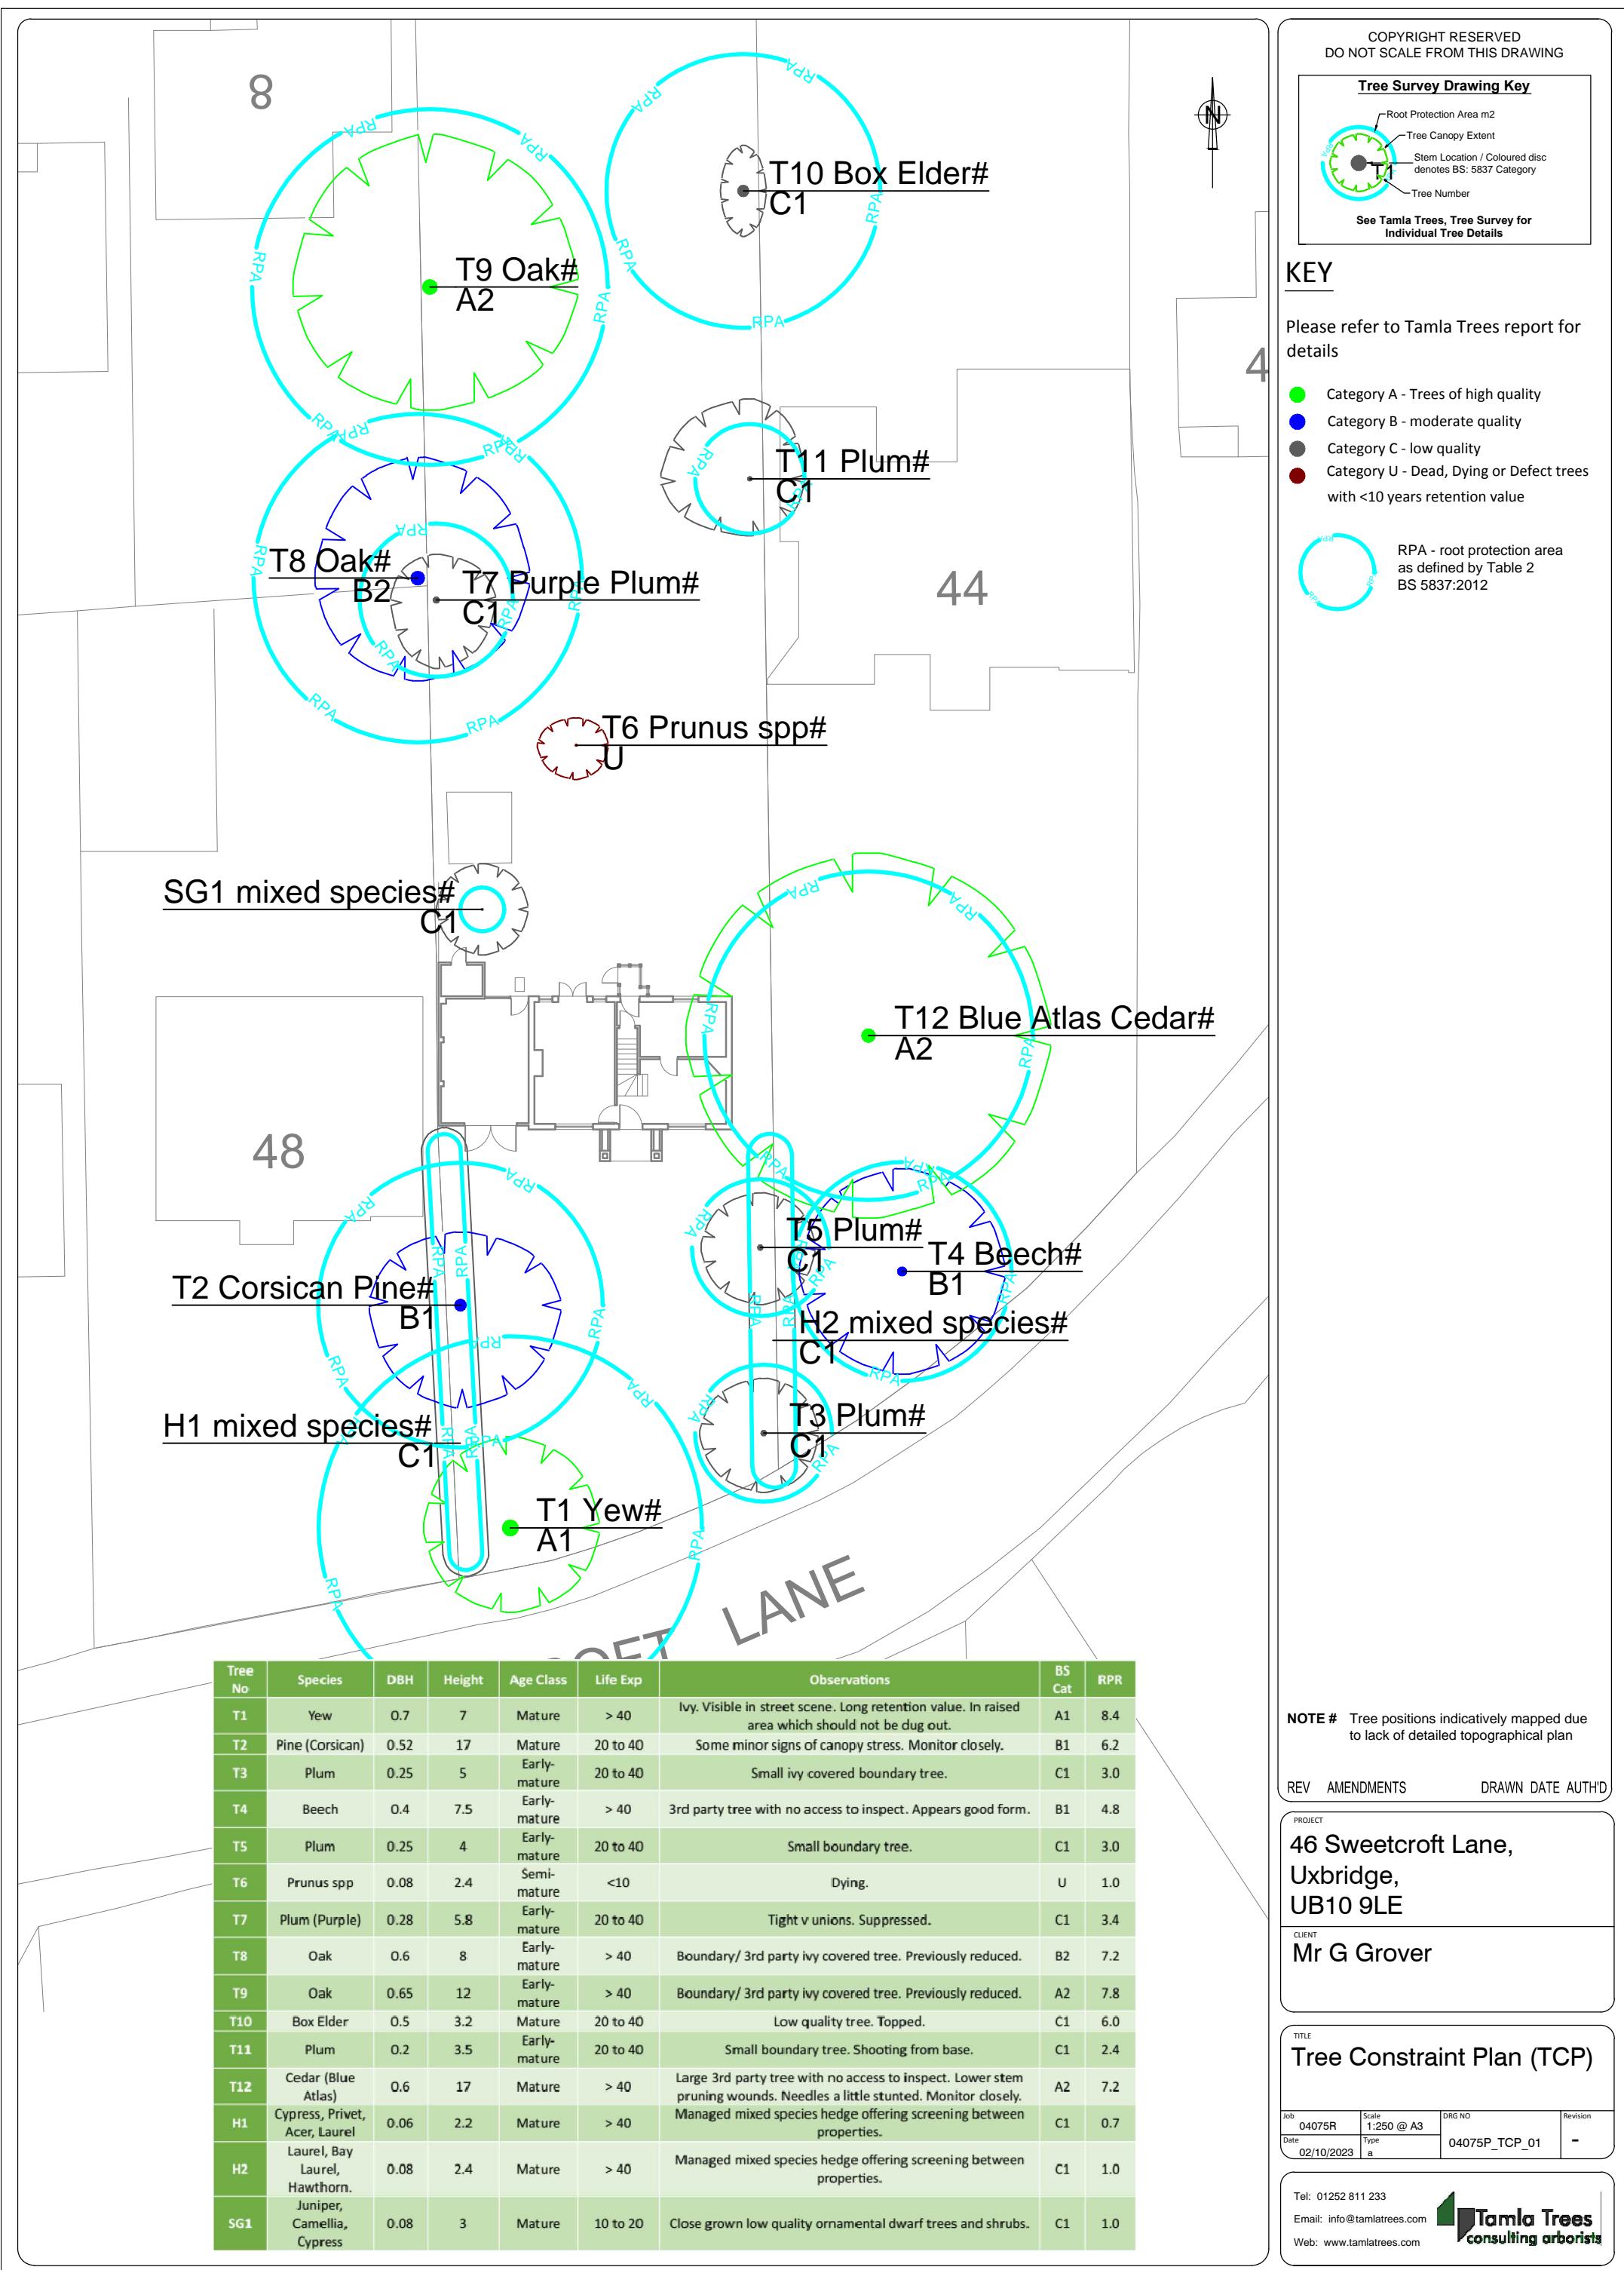
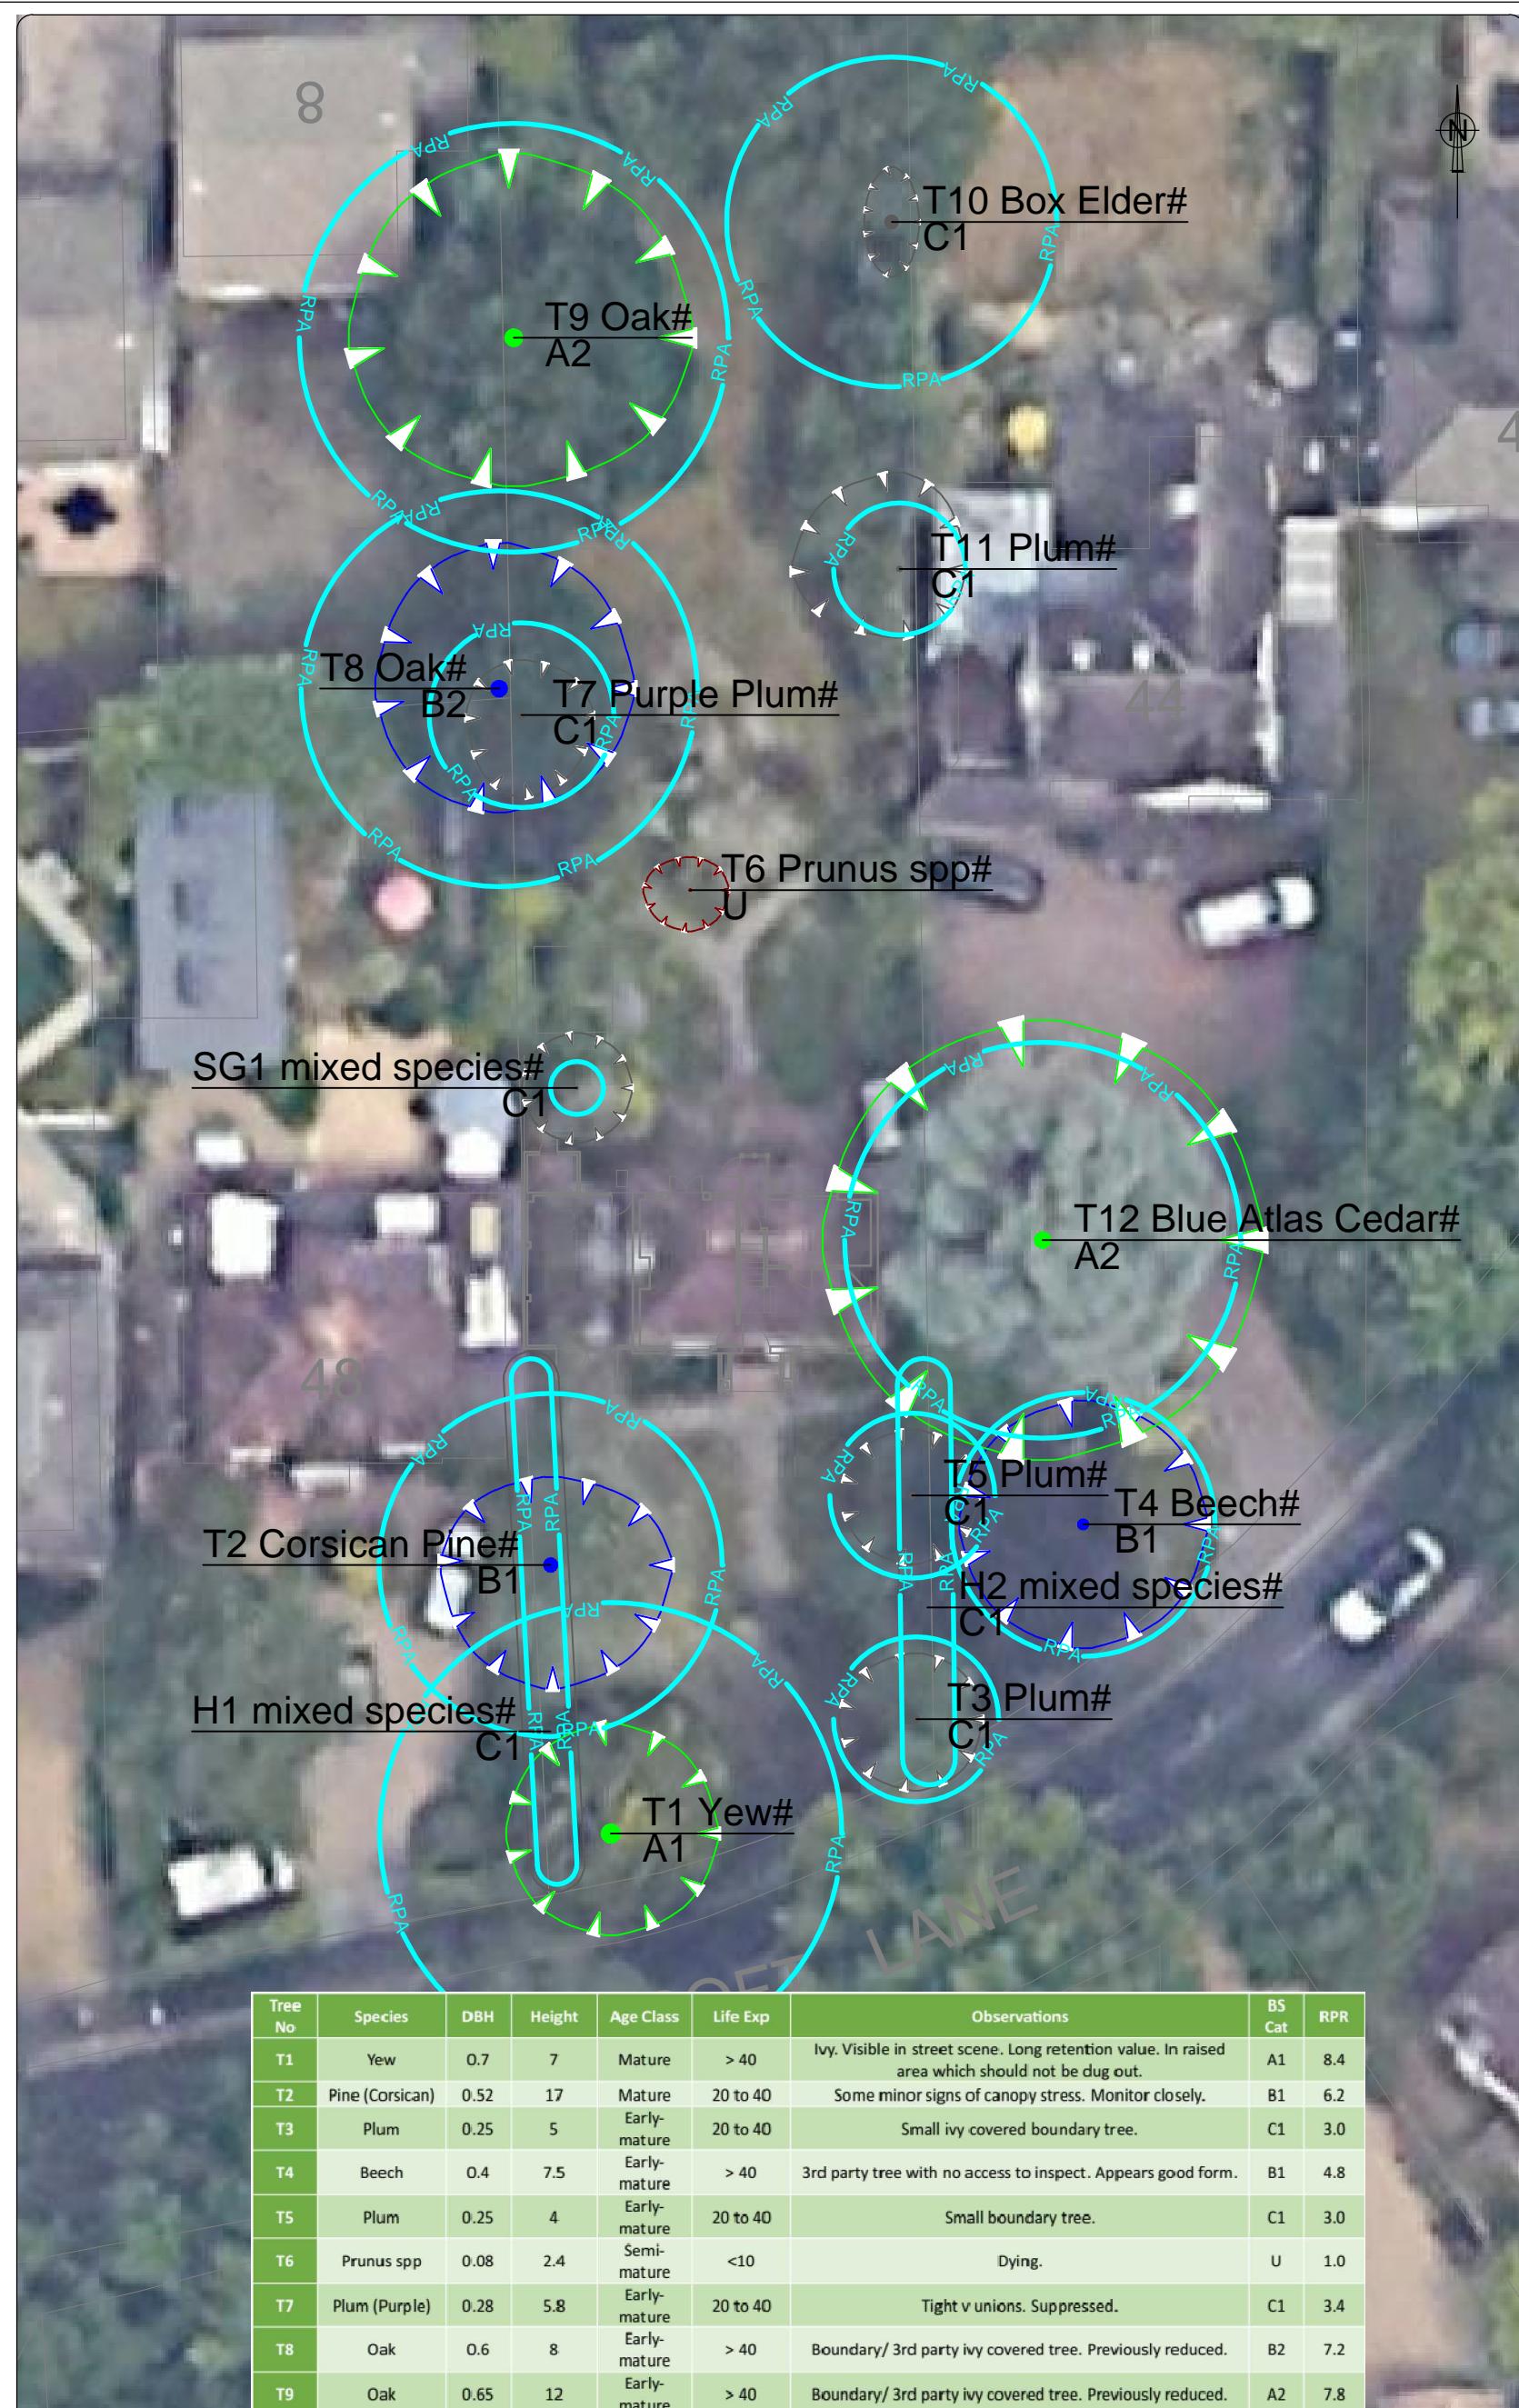
Appendix 5 - Tree Constraints Plan

Tree No	Species	DBH	Height	Age Class	Life Exp	Observations	BS Cat	RPR
T1	Yew	0.7	7	Mature	> 40	Ivy. Visible in street scene. Long retention value. In raised area which should not be dug out.	A1	8.4
T2	Pine (Corsican)	0.52	17	Mature	20 to 40	Some minor signs of canopy stress. Monitor closely.	B1	6.2
T3	Plum	0.25	5	Early-mature	20 to 40	Small ivy covered boundary tree.	C1	3.0
T4	Beech	0.4	7.5	Early-mature	> 40	3rd party tree with no access to inspect. Appears good form.	B1	4.8
T5	Plum	0.25	4	Early-mature	20 to 40	Small boundary tree.	C1	3.0
T6	Prunus spp	0.08	2.4	Semi-mature	<10	Dying.	U	1.0
T7	Plum (Purple)	0.28	5.8	Early-mature	20 to 40	Tight v unions. Suppressed.	C1	3.4
T8	Oak	0.6	8	Early-mature	> 40	Boundary/ 3rd party ivy covered tree. Previously reduced.	B2	7.2
T9	Oak	0.65	12	Early-mature	> 40	Boundary/ 3rd party ivy covered tree. Previously reduced.	A2	7.8
T10	Box Elder	0.5	3.2	Mature	20 to 40	Low quality tree. Topped.	C1	6.0

T11	Plum	0.2	3.5	Early-mature	20 to 40	Small boundary tree. Shooting from base.	C1	2.4
T12	Cedar (Blue Atlas)	0.6	17	Mature	> 40	Large 3rd party tree with no access to inspect. Lower stem pruning wounds. Needles a little stunted. Monitor closely.	A2	7.2
H1	Cypress, Privet, Acer, Laurel	0.06	2.2	Mature	> 40	Managed mixed species hedge offering screening between properties.	C1	0.7
H2	Laurel, Bay Laurel, Hawthorn.	0.08	2.4	Mature	> 40	Managed mixed species hedge offering screening between properties.	C1	1.0
SG1	Juniper, Camellia, Cypress	0.08	3	Mature	10 to 20	Close grown low quality ornamental dwarf trees and shrubs.	C1	1.0

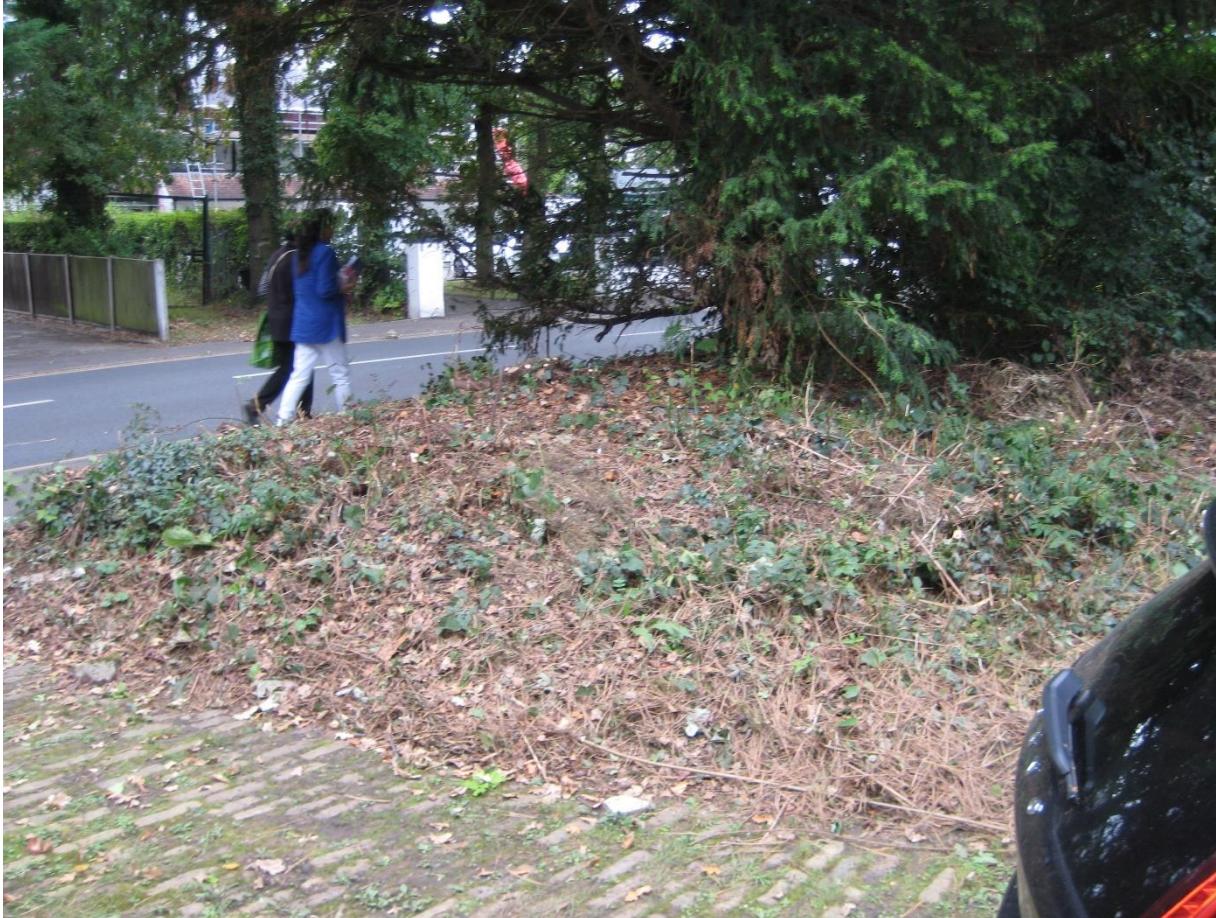
Image 1 – Looking towards T1 – the mounding in this area must not be removed.

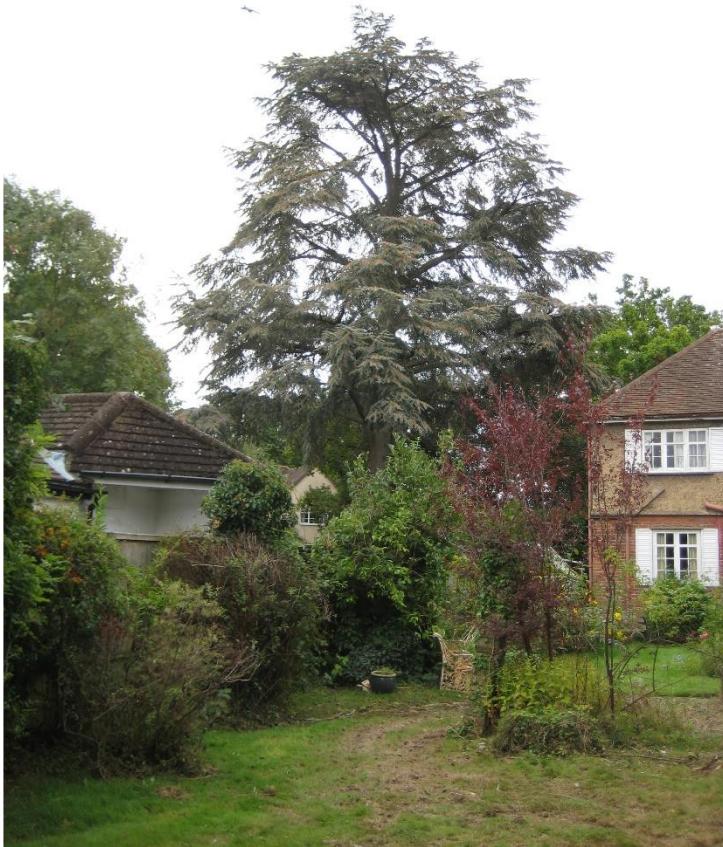
- 1.4 The proposed extension works encroach into the Root Protection Area (RPA) of T12 but at a peripheral distance and level where we would not envisage any issues in terms of the health or stability of this tree. This view is enhanced further by its location in a generally open soft landscaped front garden. A system of robust herras fencing will be used to protect the RPA of retained trees and supplemented with temporary ground protection where indicated.

Image 2 – T12 (Cedar) viewed from the rear with the property visible (right)

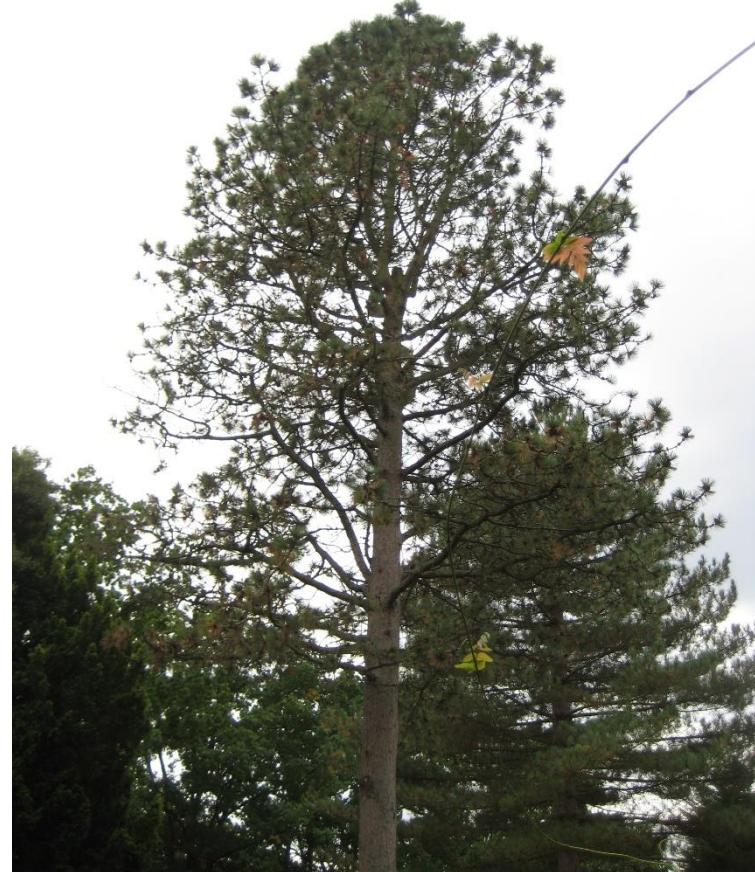
- 1.3 In terms of the development works the main constraint trees are T1 (Yew) and T2 (Corsican Pine) to the front which could come under pressure from any new services or changes to the front garden area (extended parking for example). T12 (Cedar) is a 3rd party tree where the Root Protection Area (RPA) extends into the area of the extended property.

Image 3 – T2 (Corsican Pine) Oct 2023 – Monitor this tree closely
