On behalf of:  
Hyde Park Construction Ltd

Date:  
April 2022

Earth & Marine Environmental Consultants Ltd (EAME) were instructed by Hyde Park Construction Ltd (the “Client”) to undertake a Phase I Contaminated Land Assessment of Haydon House, 296 Joel Street, Pinner, HA5 2PY (the “Site”). The report is required to support the proposed redevelopment of the Site and associated planning permission requirements.

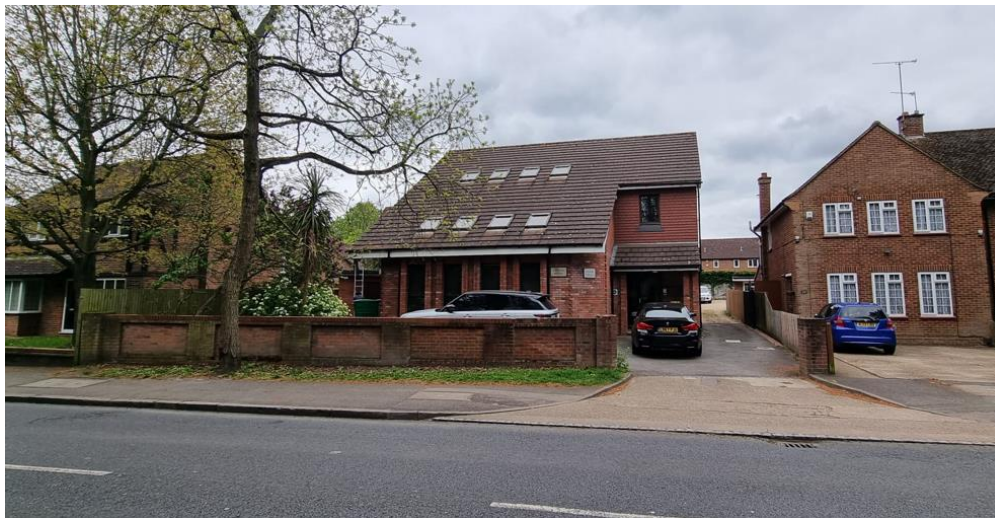
**Photograph 2-1:** *View of Site from Joel Street*

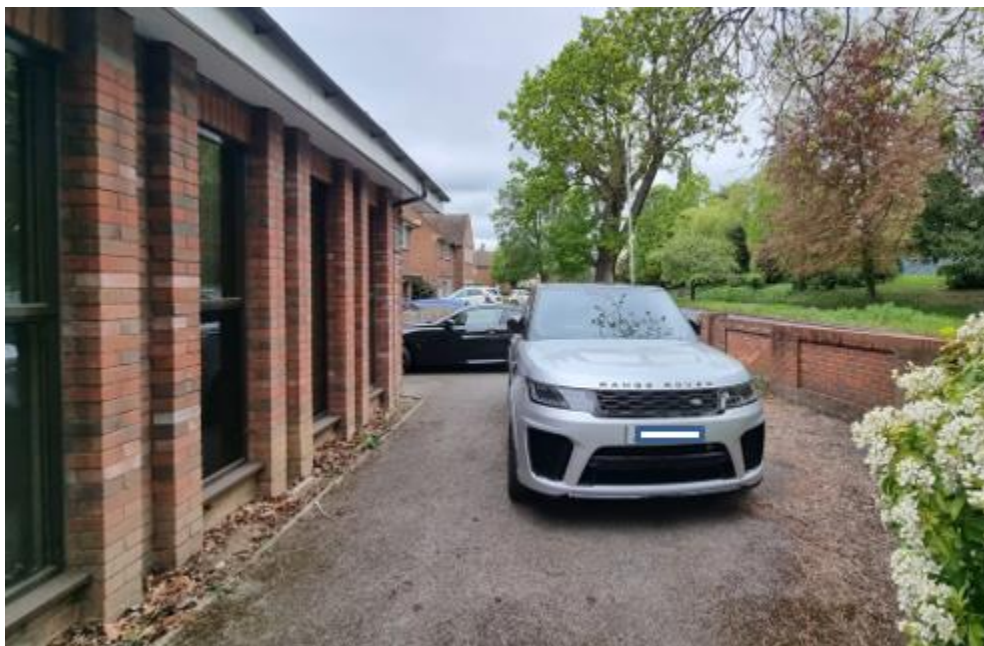
**Photograph 2-2:** *Front of building*

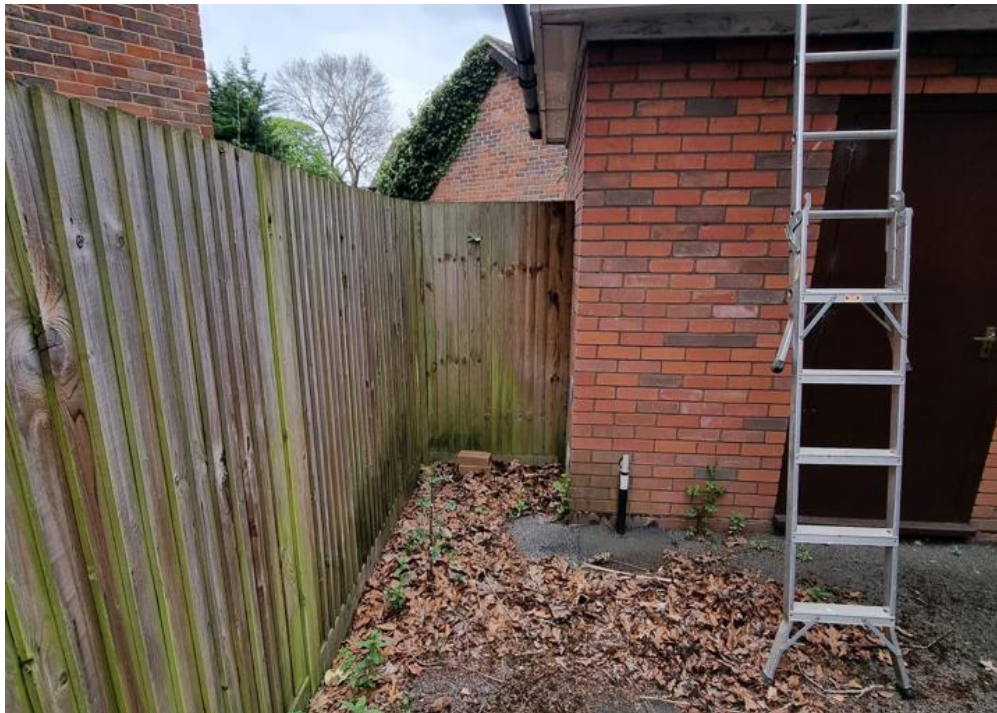
**Photograph 2-3:** *Southern side of the main building*

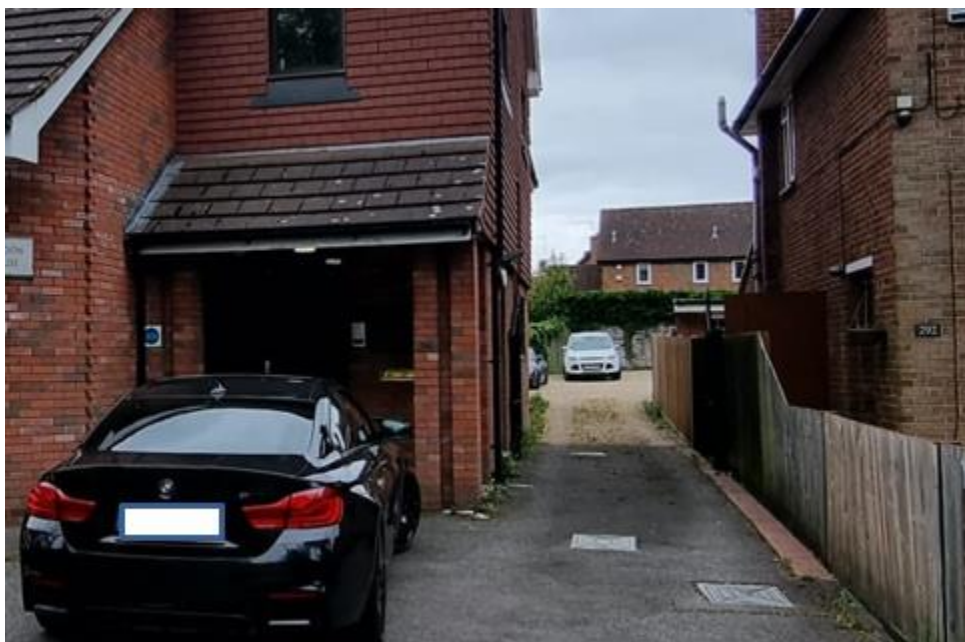
**Photograph 2-4:** *Northern side of the main building (with drainage covers)*

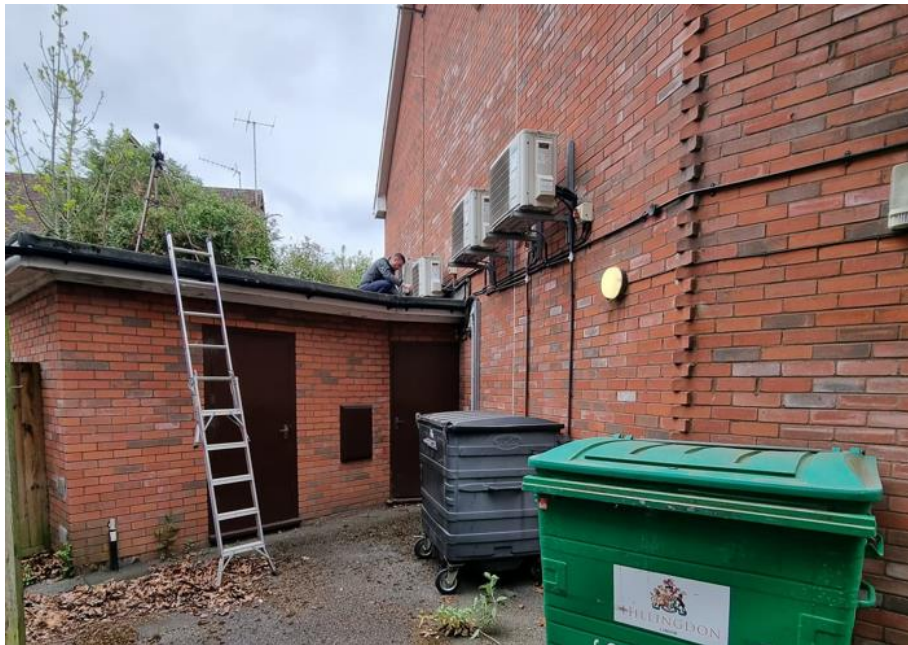
for small air-conditioning systems). From the end of 2009, the use of virgin HCFCs to service and maintain existing refrigeration and air-conditioning equipment (RAC) was banned in all EU Member States. Since 1st January 2010 it has been illegal to use virgin HCFCs to service RAC equipment. Only reclaimed and recycled HCFCs may be used. From 1st January 2015, it was illegal to use any HCFCs to service RAC equipment *i.e.* recycled or reclaimed HCFC may no longer be used. There are four small air conditioning units located at the rear of the property (**Photograph 2-5**).

**Photograph 2-5:** *Air conditioning units*

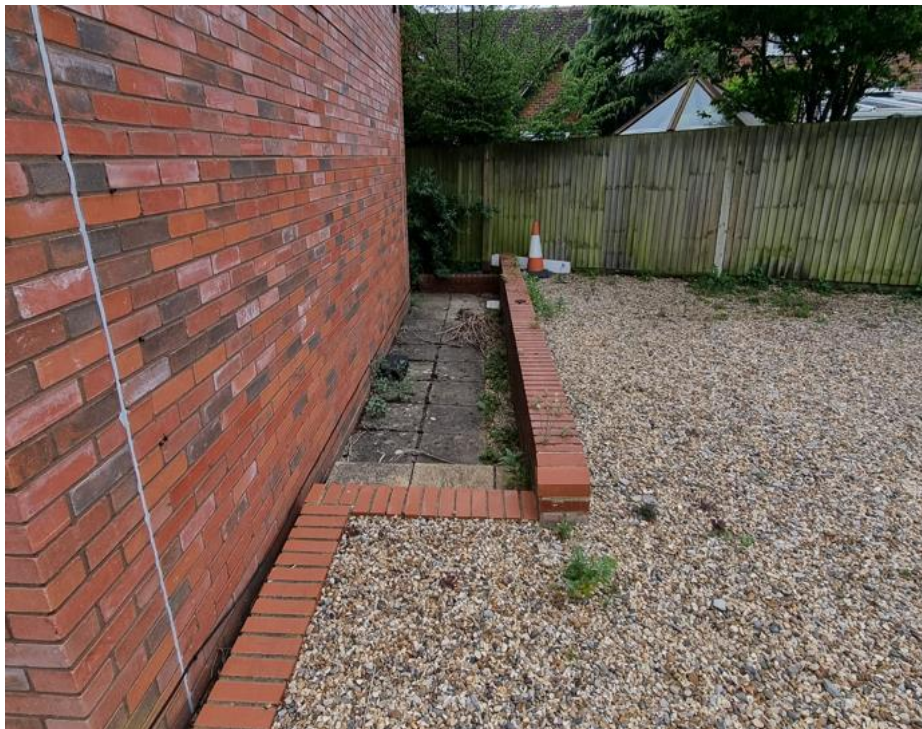
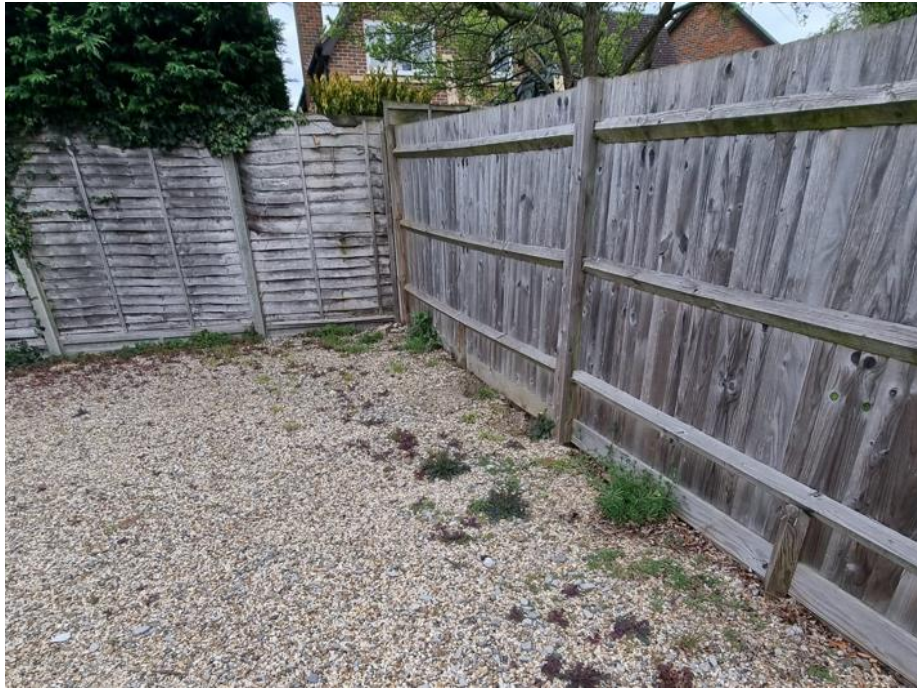
No visual evidence of uncontrolled releases to ground were observed. This included the gravelled car park at the rear of the property (**Photograph 2-6** and **Photograph 2-7**).

**Photograph 2-6:** *Rear of site (gravelled car parking area)*

**Photograph 2-7:** *Rear of site (gravelled car parking area)*

It is recommended that a watching brief is applied to the excavation and relaying of the existing car park (during the construction phase) in case hydrocarbon impacted ground is uncovered (although there is no visible evidence to suggest that this is the case).
