# BS5837 Arboricultural Impact Assessment & Method Statement

94 Vine Lane, Hillingdon, Hillingdon, Uxbridge, UB10 0BE

Job Reference: 04056R

## September 2023

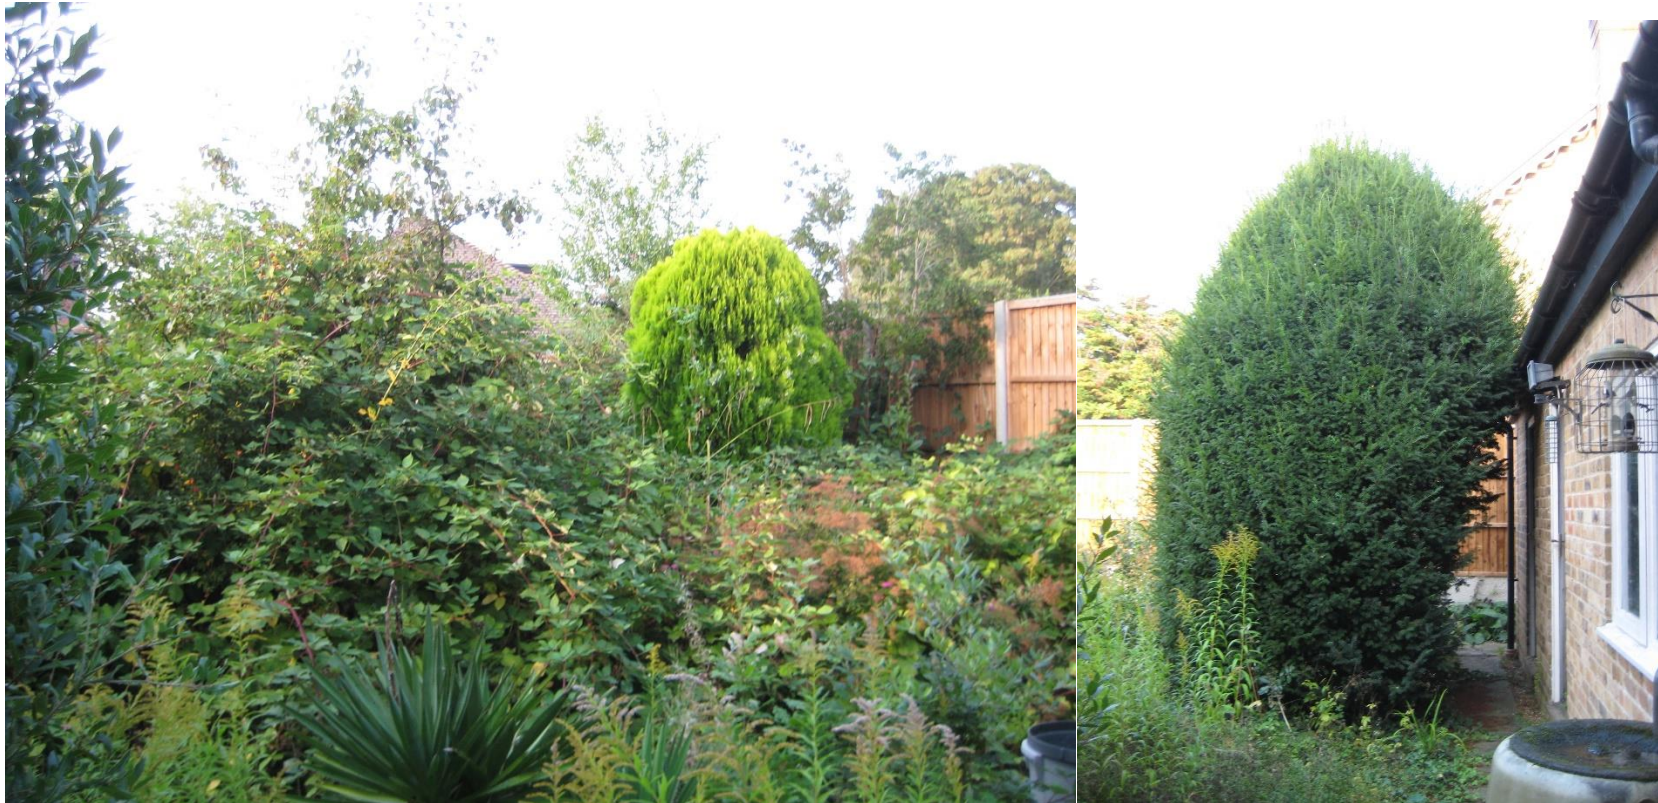
**Fig 7 - T4 & TG1 – Trees of small size in an overgrown garden (left) and T3 (Yew) right – these trees will be removed.**

- 5.3.1 T2 (Bay Laurel), T3 (Yew), T4 (Apple) and TG1 (Cypress, Arbutus and Birch) will be removed to facilitate the works and allow landscaping of what is a very overgrown rear garden area.

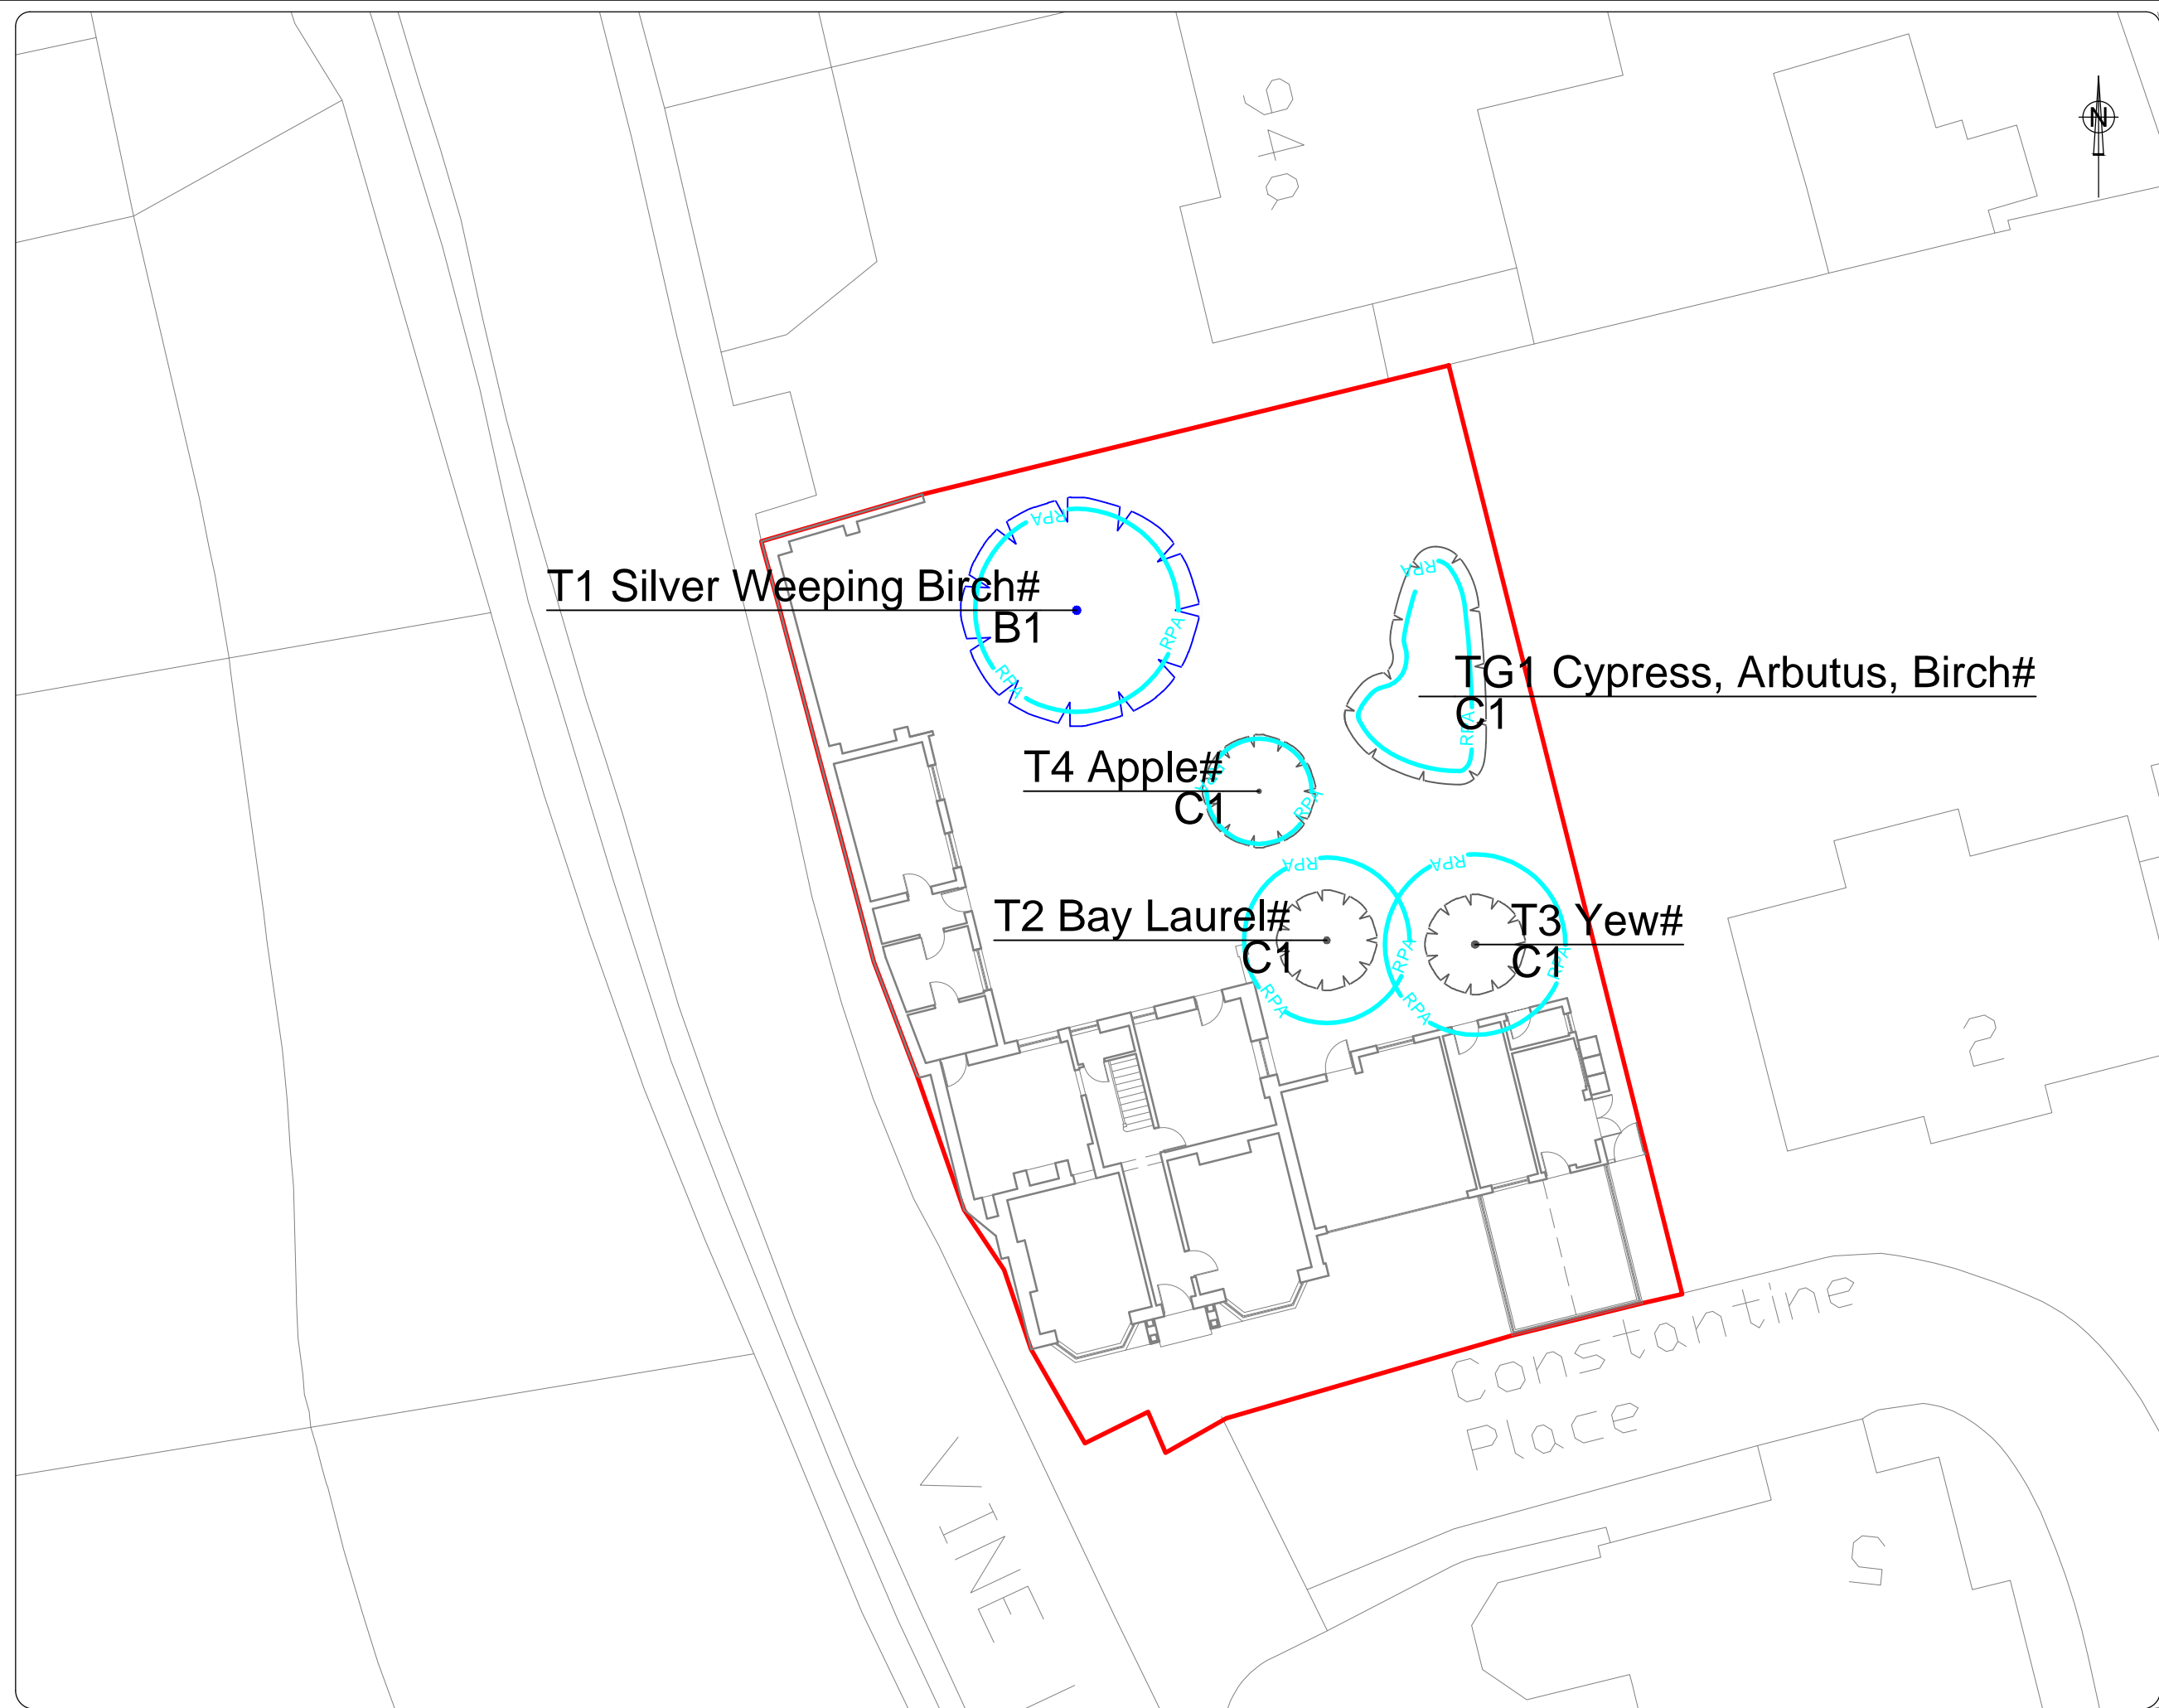
Job <b>04056R</b>	Scale <b>1:200 @ A3</b>	DRG NO <b>04056P_TCP_01</b>	Revision <b>-</b>
Date <b>11/09/2023</b>	Type <b>a</b>

Tree No.	Species	DBH (m)	No of Stems	Ht (m)	Crown Spread				BS Cat	Age Class	Life Expect	Cr Ht (m)	Observation	Recommendations	RPR (m)
					N	E	S	W							
T1	Birch (Silver Weeping)	0.27	1	4.2	3.6	3.9	3.7	3.7	B1	Mature	20 to 40	0.4	Ivy covered but good foliage cover. Not without character. Best left unpruned in area of mulched ground.	No works/ mulch below canopy.	3.2
T2	Laurel (Bay)	0.22	1	4.6	1.6	1.6	1.6	1.6	C1	Semi-mature	20 to 40	0.2	Shrub/ tree. Minimal amenity.	Remove	2.6
T3	Yew	0.24	M/S	4.2	1.6	1.6	1.6	1.6	C1	Semi-mature	20 to 40	0.2	Managed by repeat pruning. Minimal amenity.	Remove	2.9
T4	Apple	0.14	1	3.6	1.8	1.8	1.8	1.8	C1	Semi-mature	20 to 40	0.5	No access, overgrown with Brambles.	Remove	1.7
TG1	Cypress, Arbutus (tbc), Birch	0.08	M/S	3.5	1.4	1.4	1.4	1.4	C1	Mature	20 to 40	0.5	Close grown. No access given undergrowth.	Remove	1

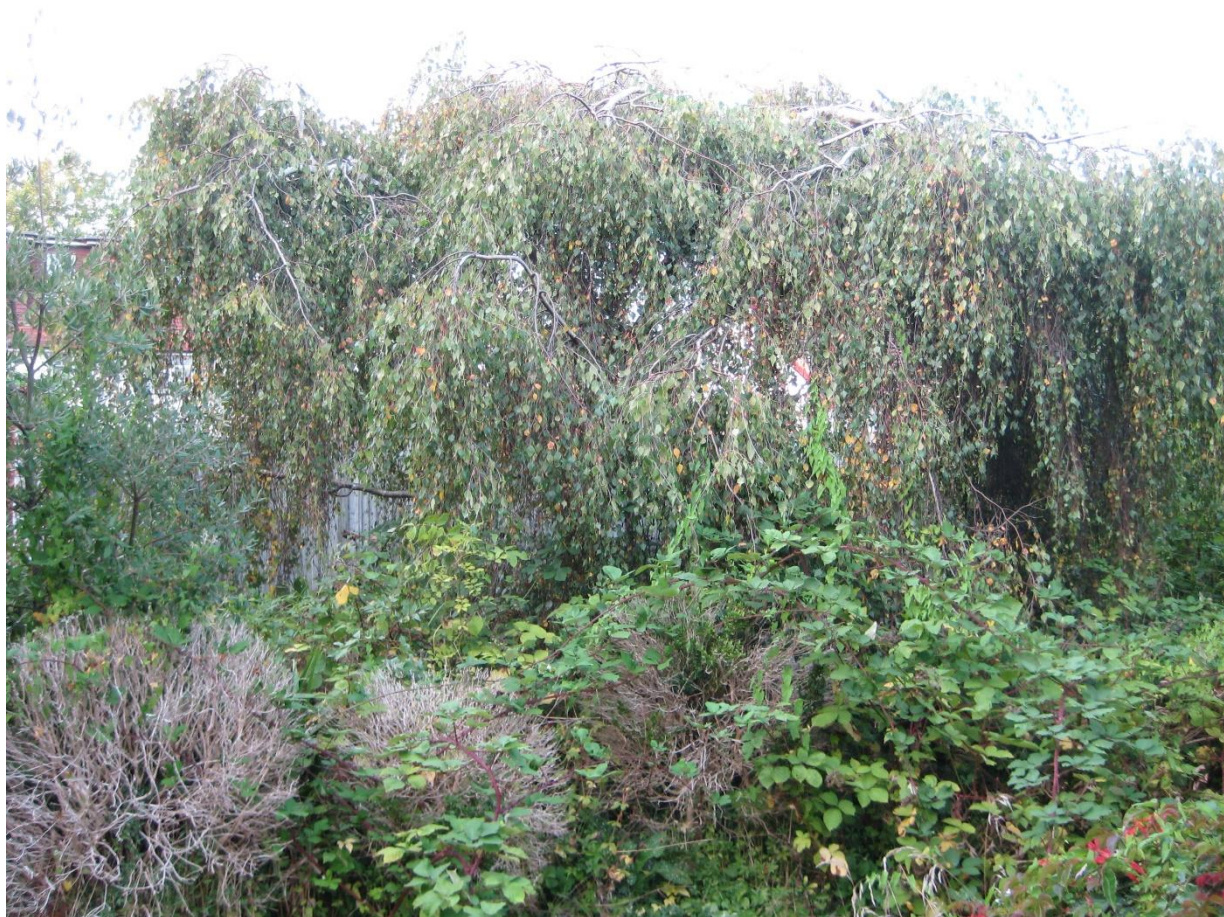
**Image 1** – Looking towards T1 – careful undergrowth removal (by hand) and mulching below canopy recommended.

- 5.7.2 We encourage the use of composted bark mulch below tree canopies where possible to aid water retention and increase soil microbial activity. This is particularly relevant to mature retained trees. This is recommended for T1 (Weeping Silver Birch) to the rear of the site.
