**Arboricultural Implications
Assessment and method statement
for a proposed development
at
Land rear of 4-6 Copperfield Avenue
Hillingdon
UB8 3NU**

Client: Sandhu Property Developments Ltd
First Floor, UNIT 8
Central Business Centre
Great Central Way
London
NW10 0UR

Prepared by
Simon Hawkins Dip Arb L6 (ABC) N.D Arbor M. Arbor. A.

Date
17/08/2022

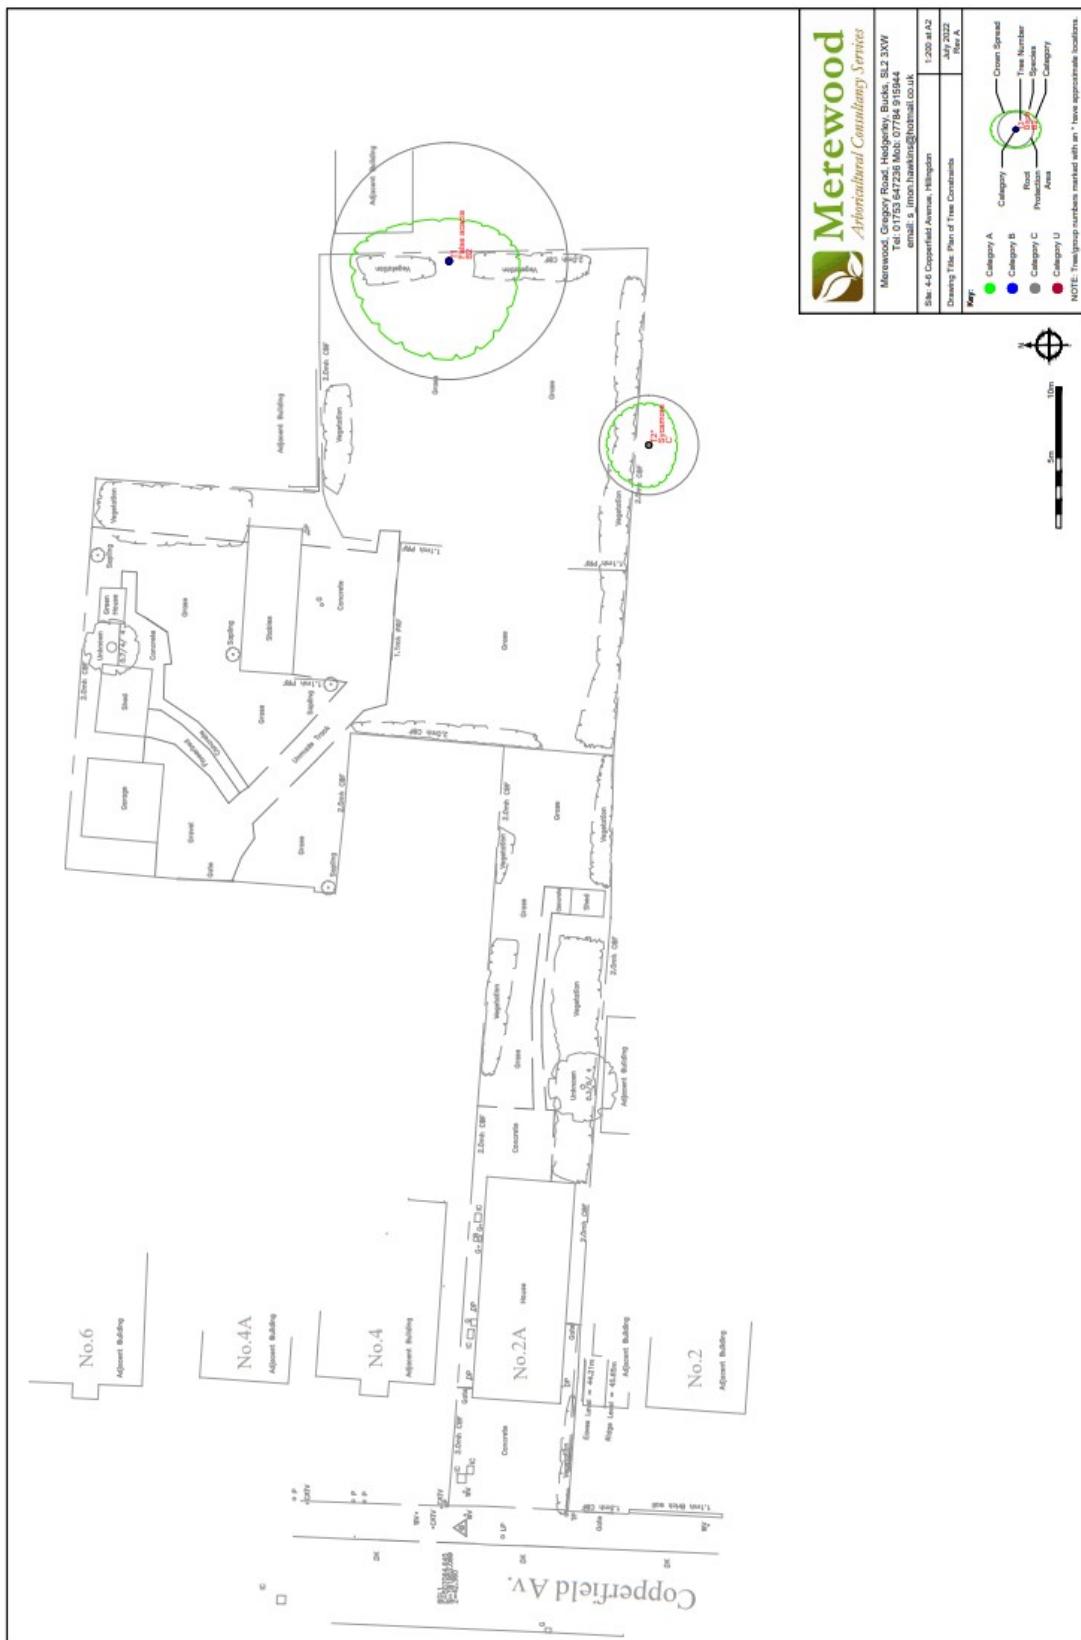
Plan of Tree Constraints

- 3.5.2 The excavations for the new building will encroach onto the root protection area of the neighbouring false acacia tree (T1). The extent of the incursion here amounts to 24m² out of a total RPA of 221m², or 11%. Of this, the actual building amounts to 10.5m² or just 4.5% of the RPA.

- 3.5.4 There is some incursion by the proposed parking spaces onto the RPA of the sycamore (T2). However it is considered that this tree is of such low value that there is no justification in requiring special measures to be taken to further minimise the impact of construction.

Tree no	Species	Height	Stem diameter	Crown spread				Physiological condition	Structural condition	Age	Observations/ Management recommendations	Life expectancy	Category
				North	South	East	West						
T1	False acacia	15	700	7	5	3	7	F	F	M	Fungal fruit body on north side of stem. Further investigation recommended	20 - 40	B2
T2	Sycamore	10	3 x 170	3	2	3	3	F	F	M/A		40+	C

- 3.5.3 The remaining incursion arising from the patio can be addressed by using a cellular confinement product to avoid any excavations, thereby protecting the roots in this area. The patio can be constructed as a dry joint patio, allowing rainwater to continue to pass through the slabs to the roots below.
