LIDL: HILLINGDON, FREEZELAND WAY, UXBRIDGE

Tree Survey Report and Arboricultural Impact Assessment

JSL5163_770
Tree Survey Report and
Arboricultural Impact
Assessment
B
24 March 2025

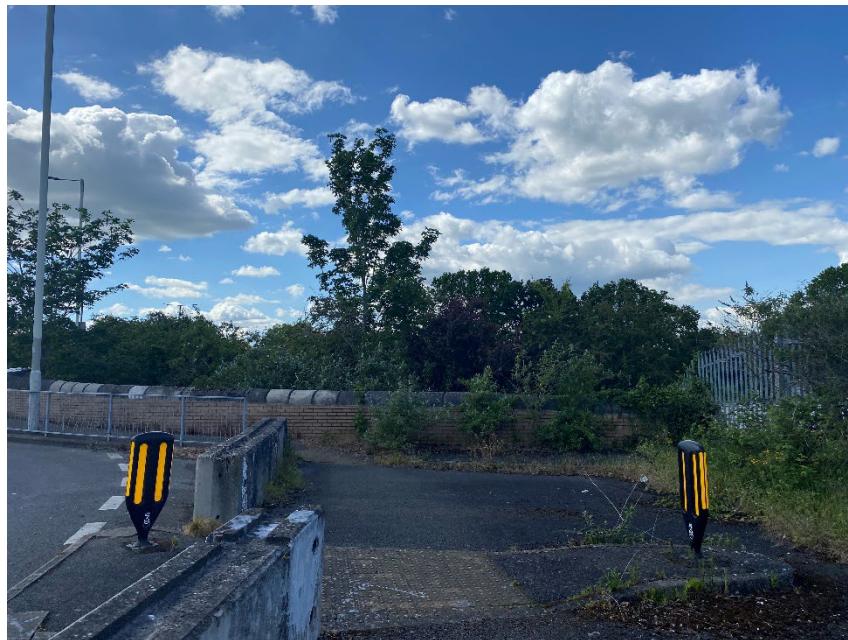
A view across the existing access point from Freezeland Way looking northwest. T1(left) T2(centre)

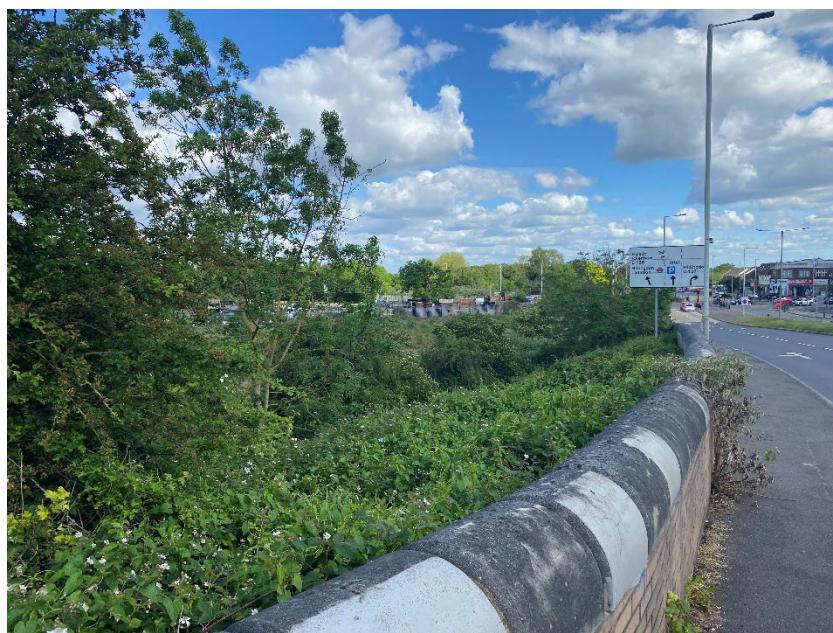
A view across site Scrub Area 11 looking southeast.T5 & T4 to the left.

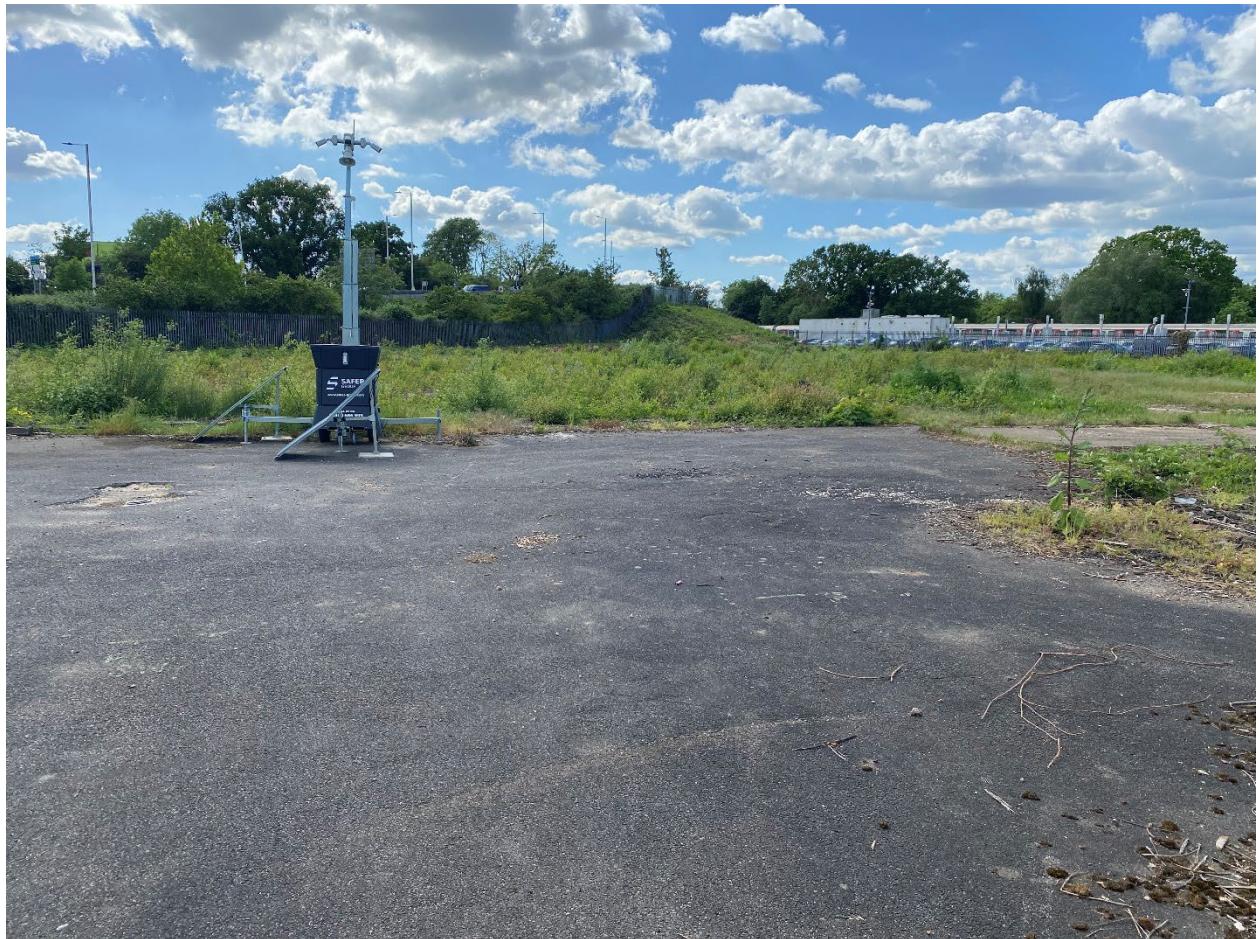
View looking northwest into the site. Taken from the eastern boundary. The proposed access point is located in the distance on the higher ground in the centre of the photo.
