Arboricultural Report

In accordance with BS 5837:2012

For 18 St Catherines Road
Ruislip
HA4 7RU

June 2021

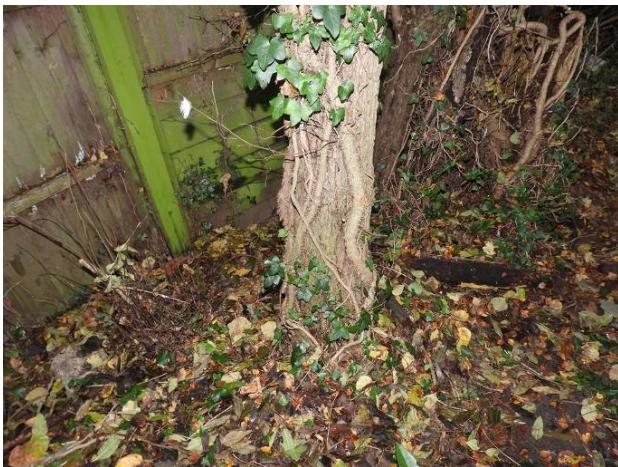
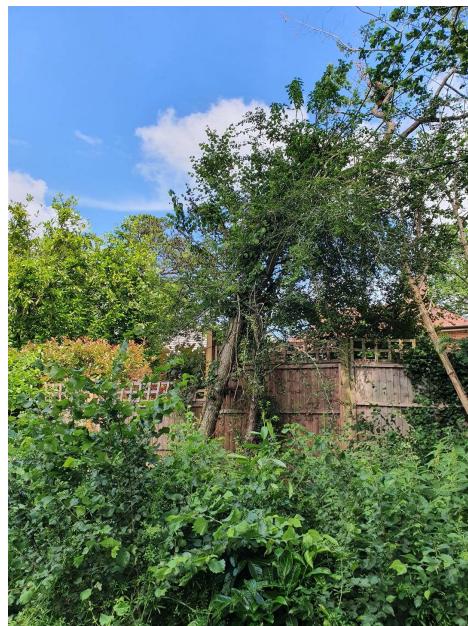
Tree	152
Location	North west of site
Species	Elm
Number stems	1
DBH (cm)	18.5
Height (m)	11
Spread (m)	6
Age	Early mature
Condition	Poor
Observations	Asymmetric crown, in decline
BS 5837 category	U
RPA radius (m)	2.22

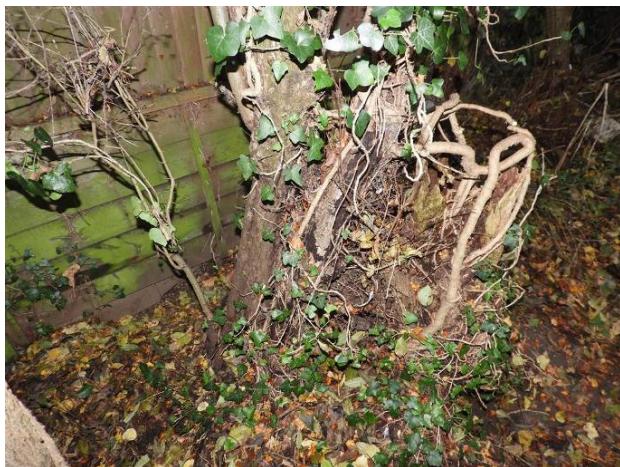
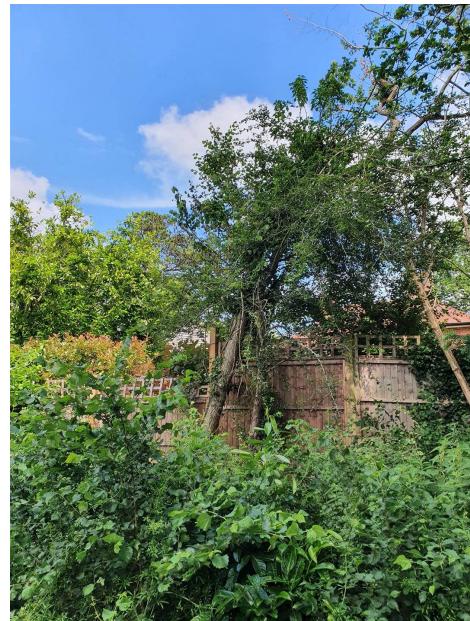
Tree	153
Location	North Western boundary
Species	Hawthorn
Number stems	2
DBH (cm)	10/4
Height (m)	6
Spread (m)	4
Age	Young
Condition	Poor
Observations	Young regrowth from decayed stool – hollow in ground
BS 5837 category	U
RPA radius (m)	1.08

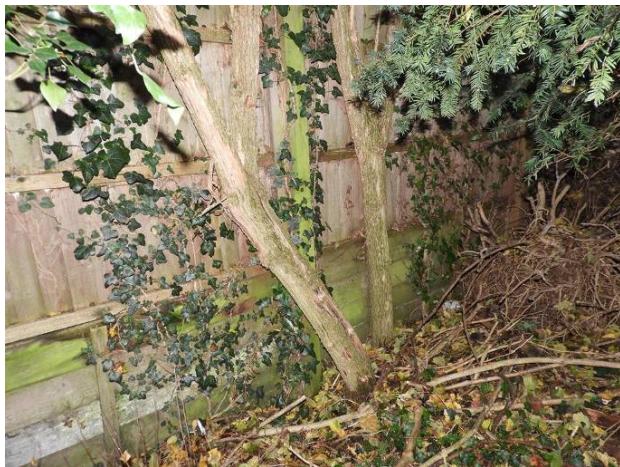
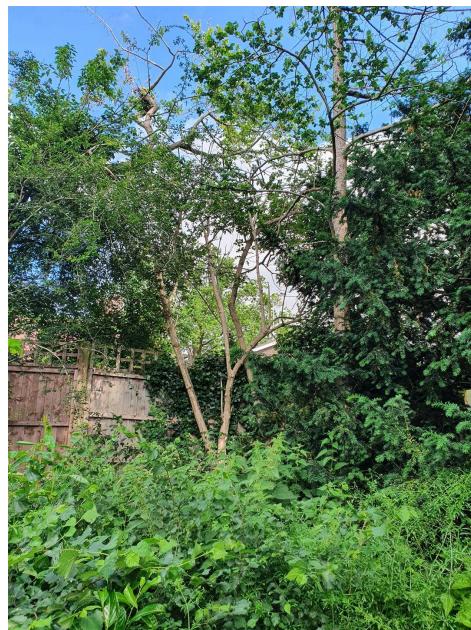
Tree	155
Location	Against north western Boundary fence
Species	Elder
Number stems	1
DBH (cm)	12.5
Height (m)	7
Spread (m)	5
Age	Early mature
Condition	Poor
Observations	Moribund, against fence
BS 5837 category	U
RPA radius (m)	1.50

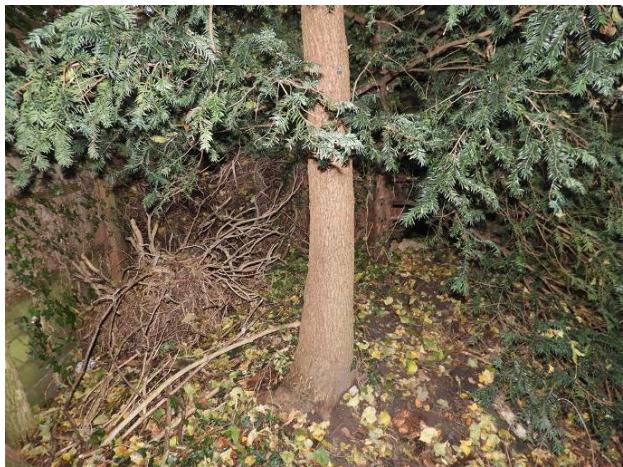
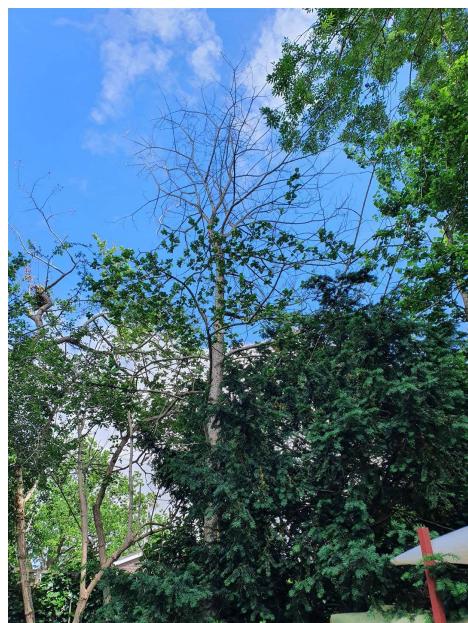
Tree	156
Location	North east corner of site
Species	Elm
Number stems	1
DBH (cm)	17
Height (m)	12.0
Spread (m)	5.0
Age	Early mature
Condition	Good
Observations	Dead
BS 5837 category	U
RPA radius (m)	2.04

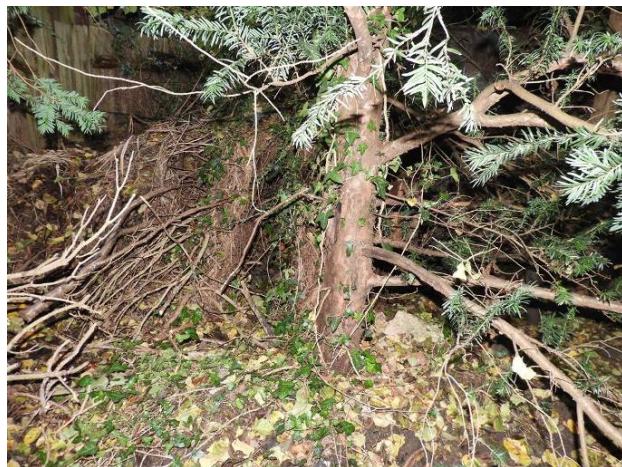
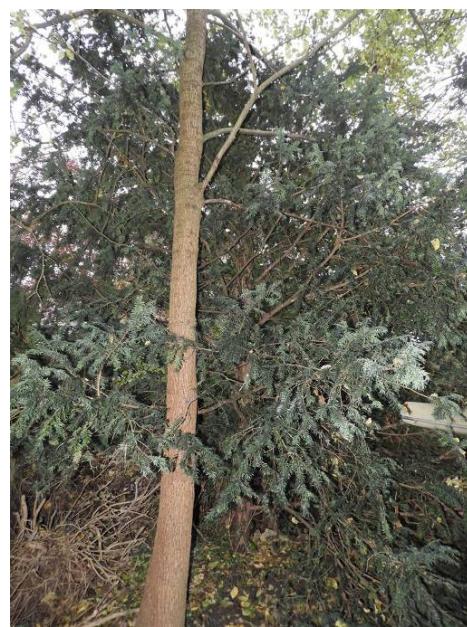
Tree	157
Location	North east corner of site
Species	Yew
Number stems	1
DBH (cm)	13
Height (m)	6.0
Spread (m)	5.0
Age	Early mature
Condition	Good
Observations	Balanced with many laterals from near base
BS 5837 category	U
RPA radius (m)	1.56

4.3 Whilst T157 the Yew is in good condition, it has been classified as U since its DBH is below 15cm. The remaining trees are of poor quality or are Elms which are likely to be infected with Dutch Elm disease within the next 10 years.

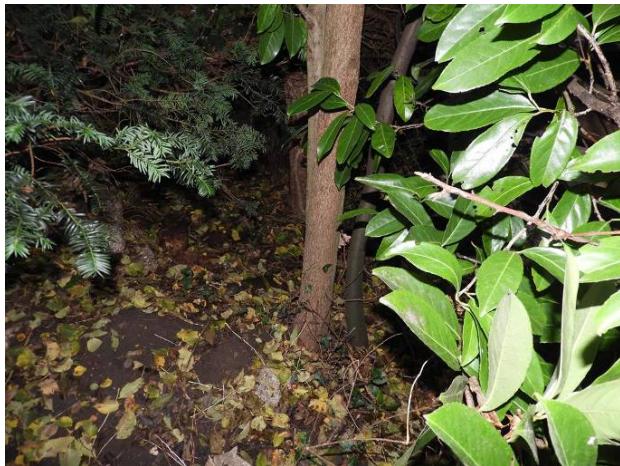
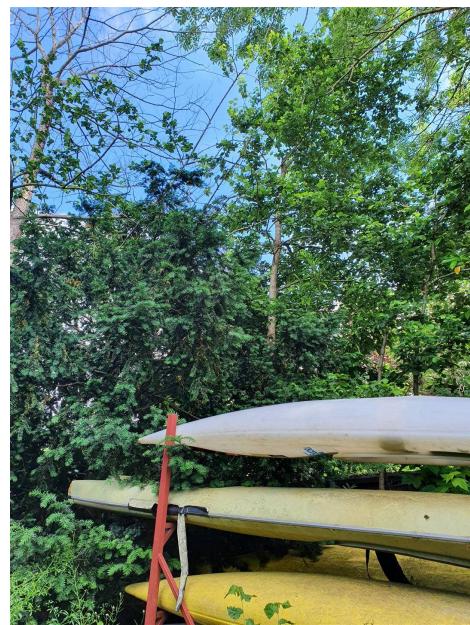
Tree	158
Location	Eastern boundary
Species	Elm
Number stems	1
DBH (cm)	10
Height (m)	10
Spread (m)	3
Age	Young
Condition	Fair
Observations	Etiolated, in decline
BS 5837 category	U
RPA radius (m)	1.20

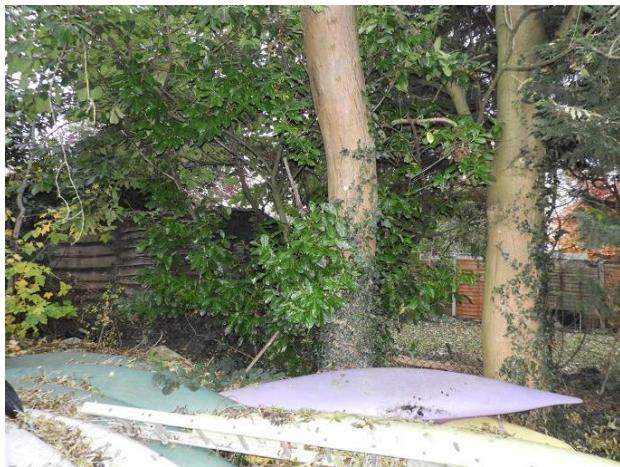
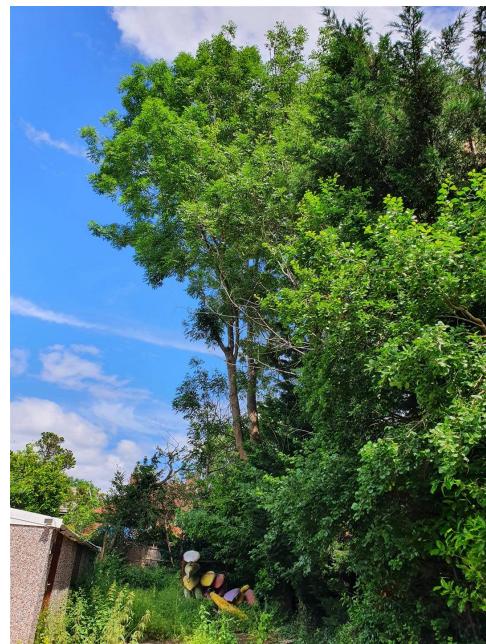
Tree	159
Location	Eastern boundary
Species	Ash
Number stems	1
DBH (cm)	45
Height (m)	22.0
Spread (m)	14.5
Age	Semi mature
Condition	Fair
Observations	Forks @ 4m, co-dominant leaders
BS 5837 category	B
RPA radius (m)	5.40

4.4 The two most significant trees on this boundary are T159 and T160, both semi mature Ash. The trees are of similar dimensions and age and should be considered as a pair. Whilst both trees have been given a B classification, neither is considered to be suitable for retention given their proximity to the proposed new building and the potential targets once the building is in use. It is likely that the proposed new footprint will impinge on the Root protection areas of both trees, though the southernmost RPA could be

amended due to the proximity to the existing roadway. Both trees fork at 4 and 6 metres respectively and the southernmost has a tight fork. Reducing these trees as a pair may be a possibility; however the pollard regrowth will be a potential hazard within 20 years.

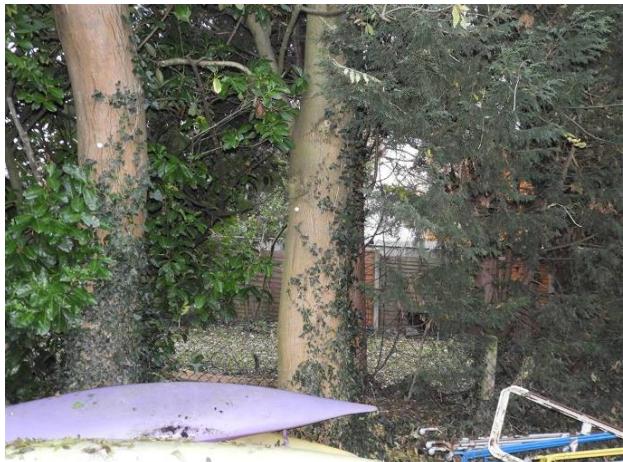
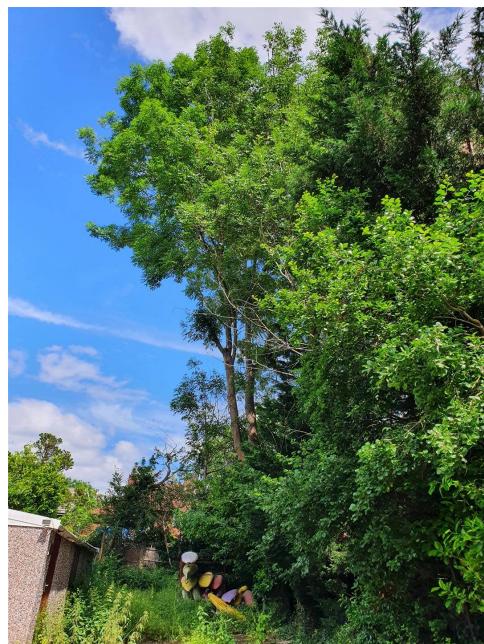
Tree	160
Location	Eastern boundary
Species	Ash
Number stems	1
DBH (cm)	49
Height (m)	22.0
Spread (m)	14.0
Age	Semi mature
Condition	Fair
Observations	Tight fork @ 6m, co-dominant leaders
BS 5837 category	B
RPA radius (m)	5.88

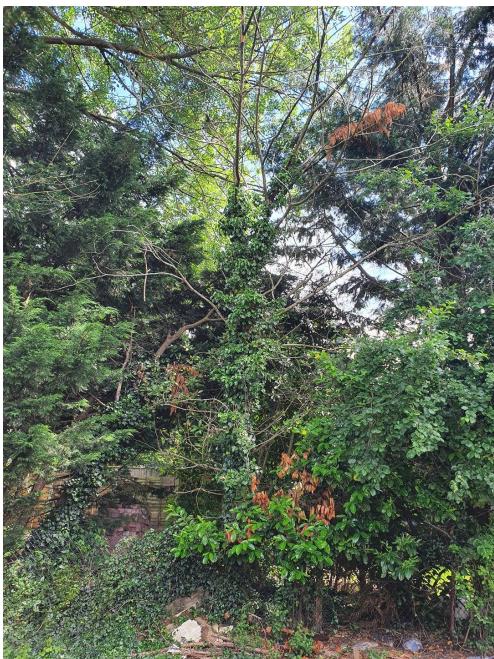
Tree	161
Location	Eastern boundary, adjacent to fence
Species	Elm
Number stems	1
DBH (cm)	20
Height (m)	11.0
Spread (m)	7.0
Age	Early mature
Condition	Poor
Observations	Dead
BS 5837 category	U
RPA radius (m)	2.40

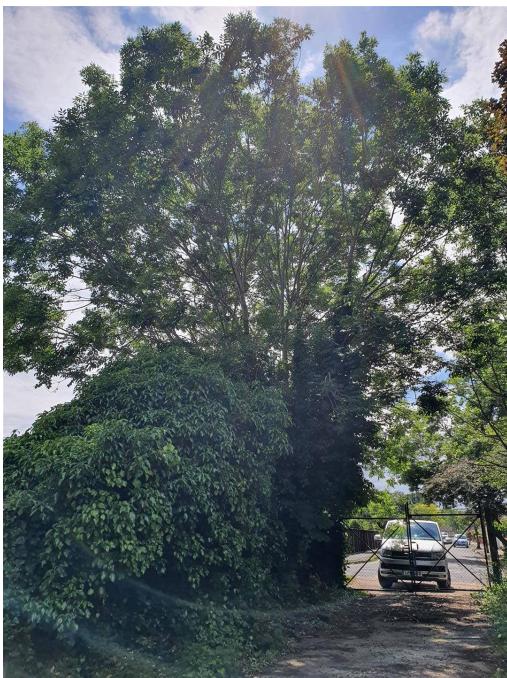
Tree	162
Location	Eastern boundary
Species	Ash
Number stems	3 becoming 6
DBH (cm)	30 / 30 / 24
Height (m)	13.0
Spread (m)	11.0
Age	Early mature
Condition	Fair
Observations	On boundary, three stems forking @ 1m
BS 5837 category	C
RPA radius (m)	4.87

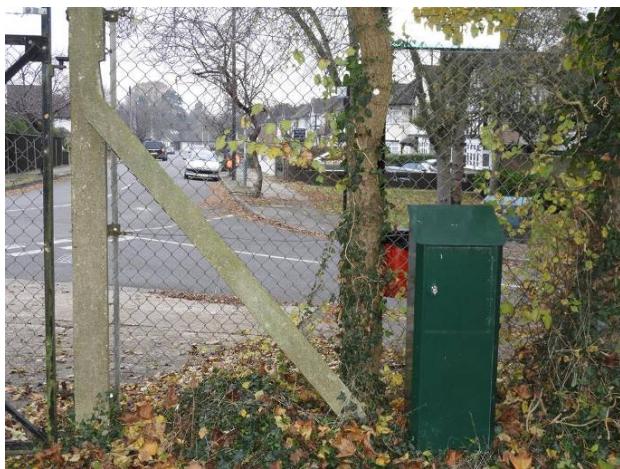
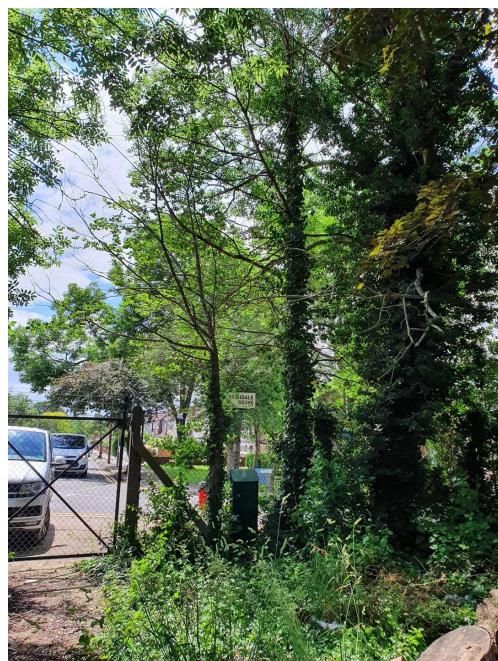
Tree	163
Location	Southern boundary
Species	Elm
Number stems	1
DBH (cm)	14
Height (m)	7
Spread (m)	4
Age	Early mature
Condition	Poor
Observations	Moribund
BS 5837 category	U
RPA radius (m)	1.68

4.5 The trees on this boundary provide some screening for the site from the road, which is desirable to maintain and improve. However, T163 and T164 are Elms, which are moribund due to Dutch Elm Disease.

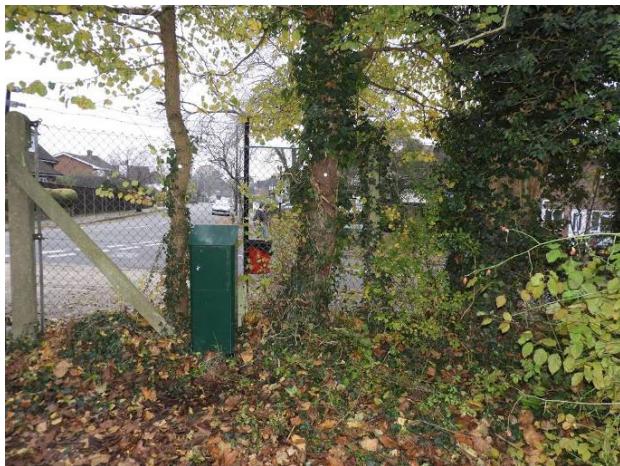
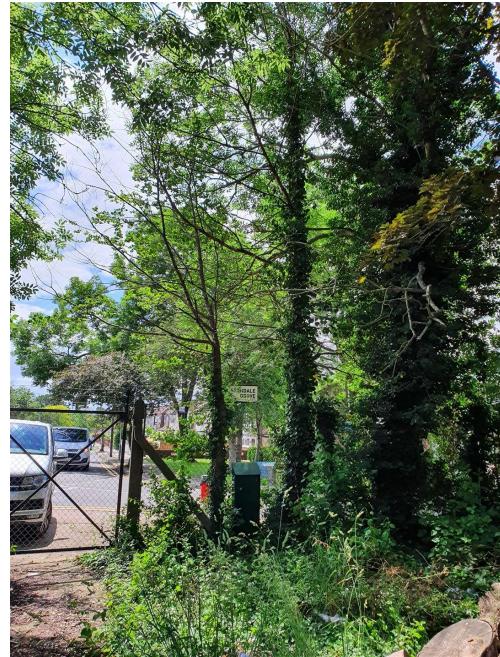
Tree	164
Location	Southern boundary
Species	Elm
Number stems	1
DBH (cm)	22
Height (m)	12.5
Spread (m)	6
Age	Early mature
Condition	Poor
Observations	Moribund
BS 5837 category	U
RPA radius (m)	2.64

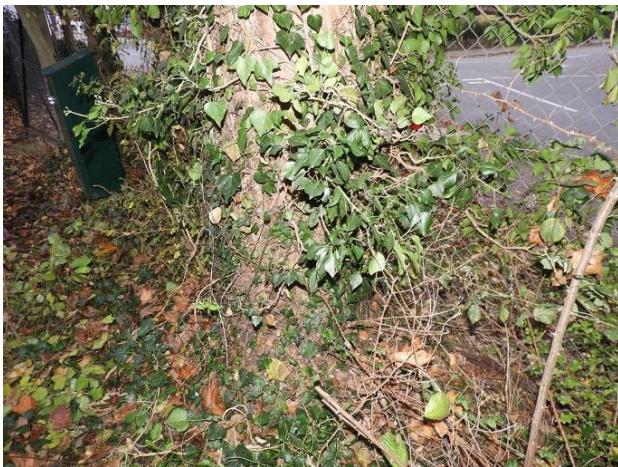
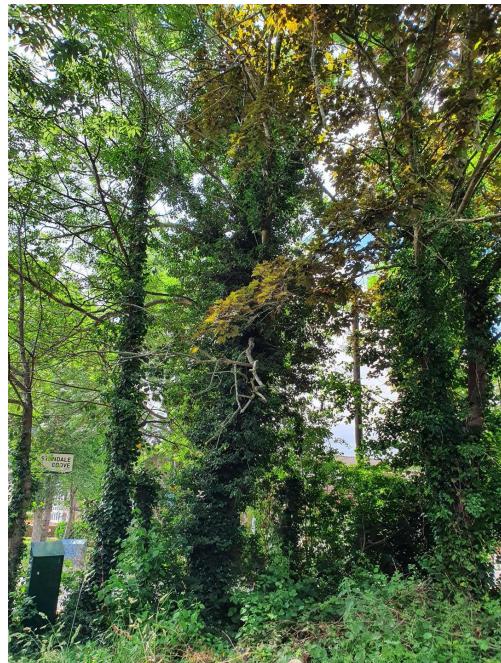
Tree	165
Location	Southern boundary
Species	Ash
Number stems	1
DBH (cm)	35
Height (m)	14.5
Spread (m)	10
Age	Semi mature
Condition	Fair
Observations	Against fence with some wire included.
BS 5837 category	B
RPA radius (m)	4.20

T165 is an Ash and T166 a Norway Maple, both with B classifications. It is intended to retain both these trees and to protect the root protection areas as detailed in section 4.7 of this report. The RPA for these trees is partially below an existing concrete path and permeable concrete parking grid, as such they have grown with these in place.

Parking and the storage of materials will be prohibited in the root protection areas of these trees if the path and parking grid are removed.

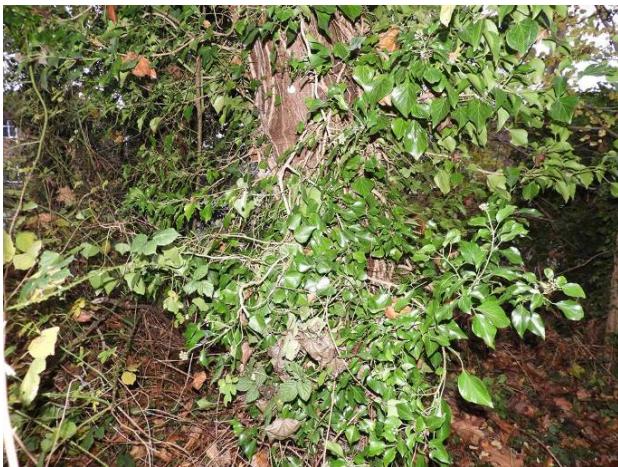
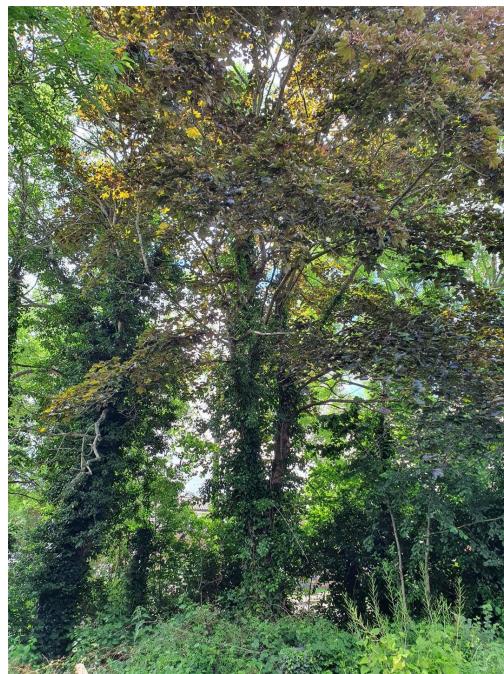
Tree	166
Location	South west corner
Species	Norway Maple
Number stems	1
DBH (cm)	41
Height (m)	14.5
Spread (m)	10
Age	Semi mature
Condition	Fair
Observations	Heavy Ivy obscuring inspection. Asymmetric crown with bias to north due to T165
BS 5837 category	B
RPA radius (m)	4.92

The hut access ramp partially encroaches the RPA of T166, however it is within the tolerances given for RPA offset in BS5837.

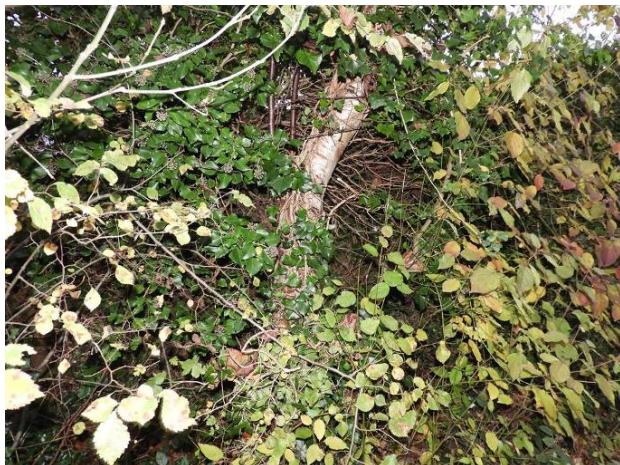
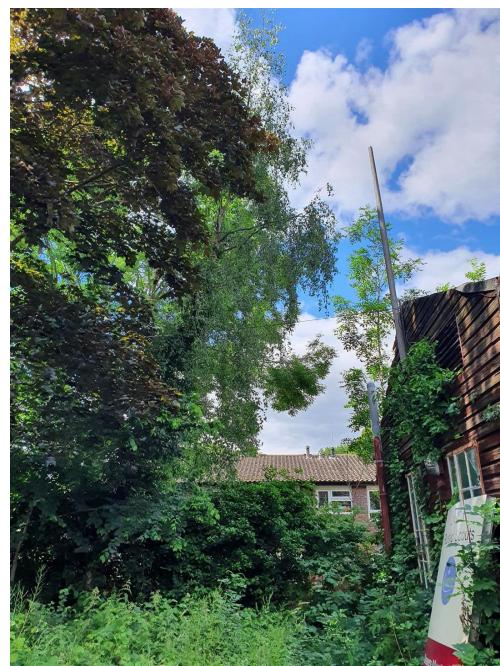
Tree	167
Location	South west corner
Species	Birch
Number stems	1
DBH (cm)	15
Height (m)	11.5
Spread (m)	4
Age	Early mature
Condition	Poor
Observations	Etiolated with significant lean to NNE due to T166
BS 5837 category	U
RPA radius (m)	1.80

T167 is a poor quality Birch with a significant lean as it is suppressed by T166. It is proposed to fell this tree.
