**B.S. 5837 Arboricultural Report
Implications Assessment
at
10 Tanworth Close
Northwood
HA6 2GF**

**Client: Rajesh Shah
64 Copsewood Way
Northwood
HA6 2TZ**

Date
13/04/2023

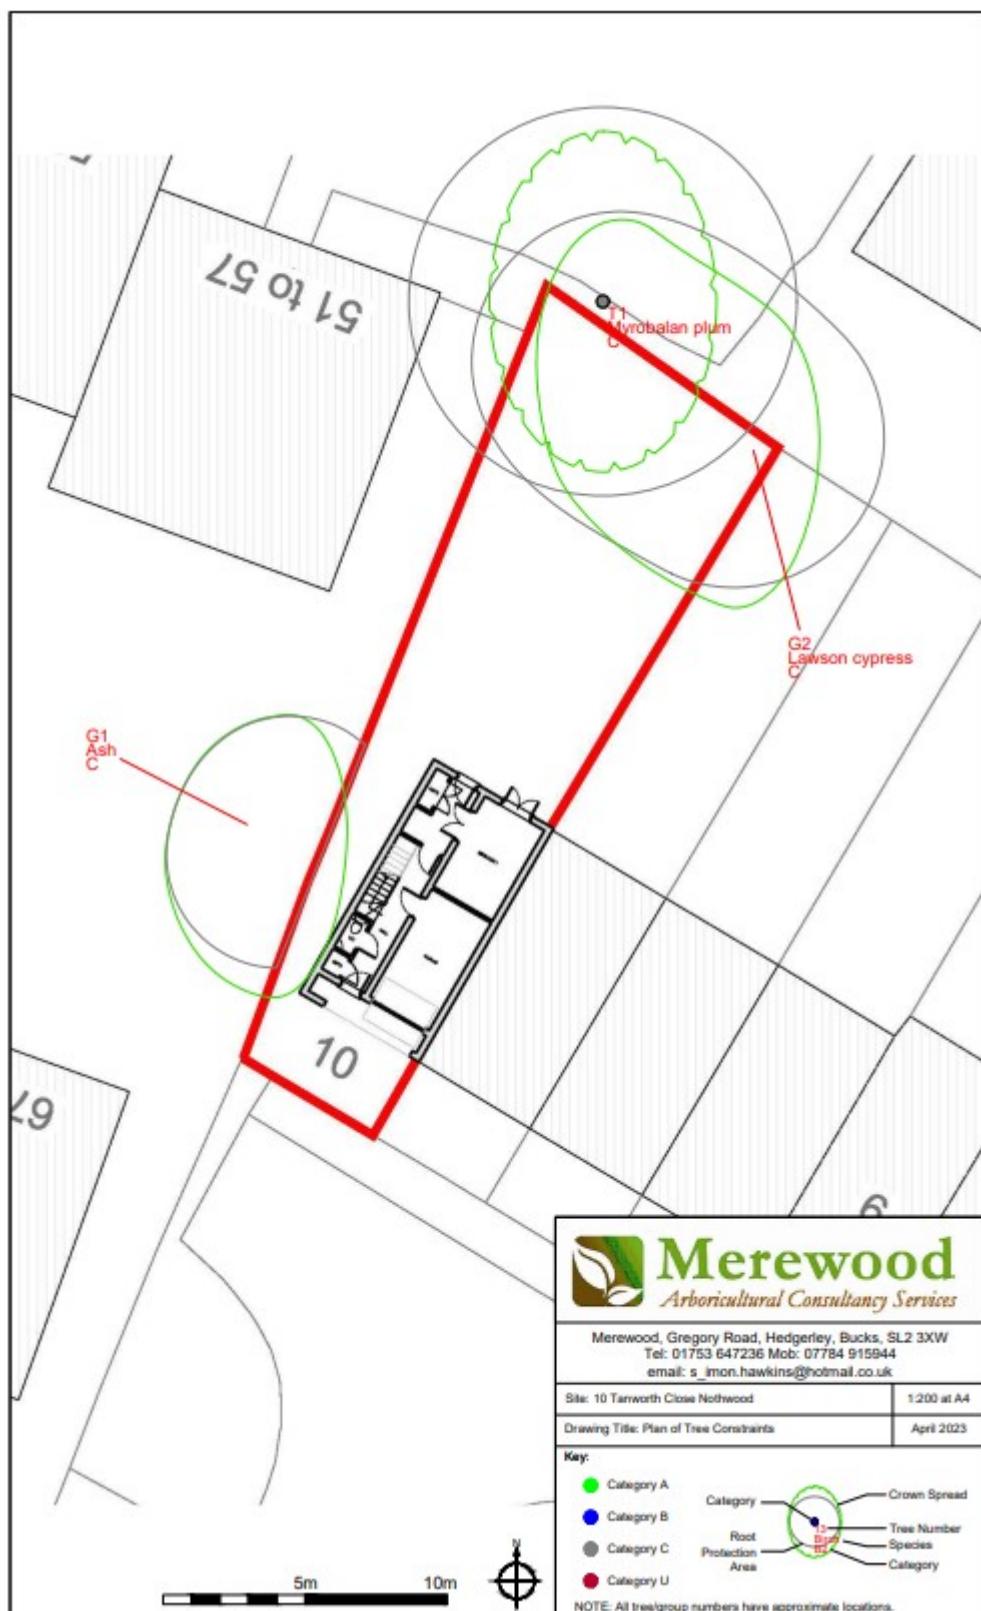
Plan of Tree Constraints

- 3.1.3 The ash tree group (G1) includes young trees that may become affected by Chalara dieback of ash (*Hymenoscyphus fraxineus*) in time. The roots of this young group are unlikely to have developed very far (at the present time) beyond the boundary wall due to the restriction of the foundation, although there is a chance this could change over time. It is not an ideal species to have growing so close to a structure such as the boundary wall.

- 3.1.4 The cypress group (G2) is becoming overgrown and unmanageable. Although some pruning and reduction work has taken place in the past, regular pruning has not been kept up and as a result the hedge has become leggy, with branches now failing and the shape and structure of the hedge becoming lost. This is in contrast to the remainder of the hedge on adjacent properties where maintenance has been more regularly carried out.

- 3.1.5 Where cypress hedging does become overgrown and shapeless, pruning will no longer provide a satisfactory solution and the recommendation is to remove the plants and to replace them with a more suitable species.
