**10 Tanworth Close
HA6 2GF
Leyland Cypress Removal Argument**

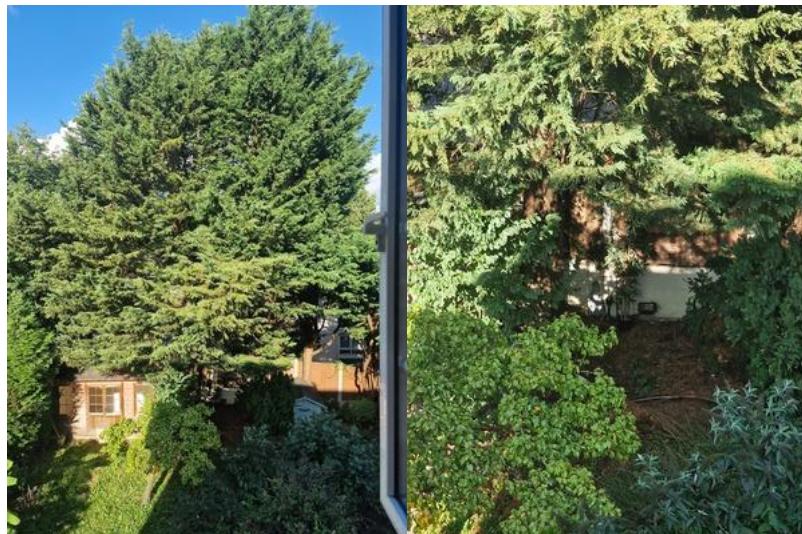
Regrowth has been huge with all top sections vulnerable to wind damage. Sideways growth has also been huge with many overlong side branches very prone to collapse especially from wind or snow damage. Many sections appear to have already failed and more likely to follow.

Exhibit 1: Excessive Overgrown and unmanageable.

Our objective is to remove both trees from rear garden location by dismantling in sections and into available space. Stumps to be cut as low as location allows.

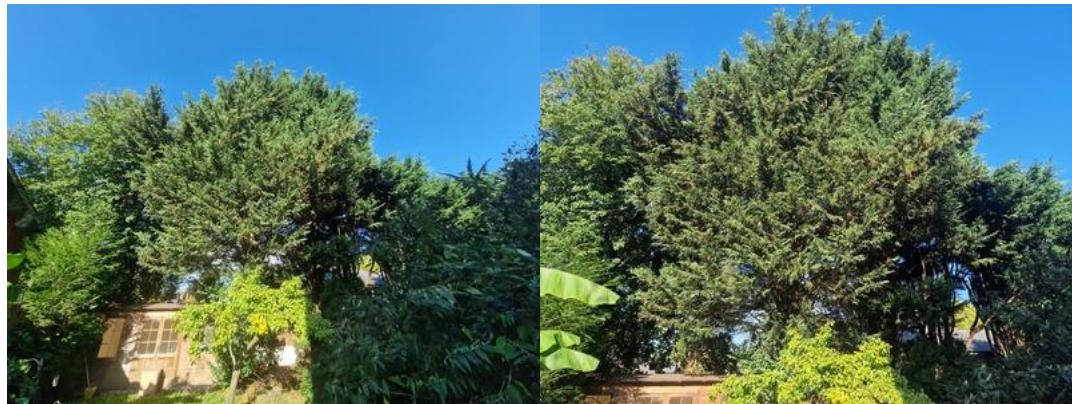
These trees have become so overgrown that I do not believe any pruning will leave a safe or valuable asset to this location. Sideways growth is so overgrown that it needs to be cut back beyond the foliage on the ends of the branches, and by doing this all screening is lost, and no regeneration can be expected. The arboriculturist report seems to support this assessment.

Exhibit 2: Excessive sideways growth

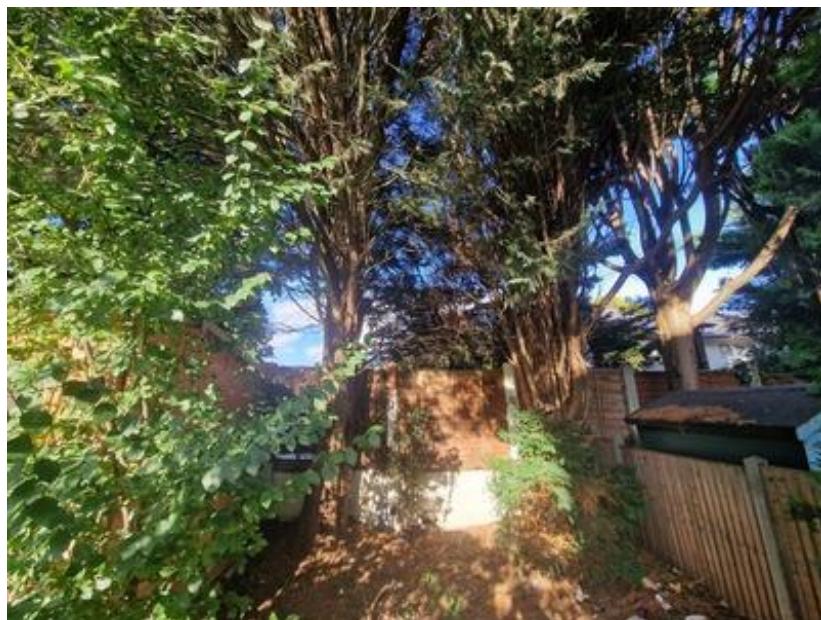
Exhibit 3: Many branches have fallen and continue to fall

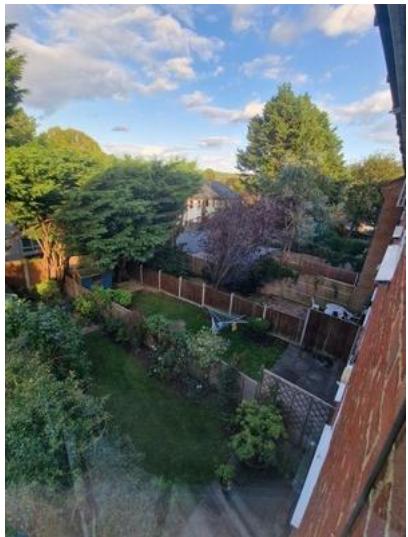
Exhibit 4 – Neighbouring properties have had their overgrown trees removed

6, 5 and 4 Tanworth Close have had their Leyland Cypress trees removed.
