# BS5837 Arboricultural Impact Assessment & Method Statement

102 Vine Lane, Uxbridge, UB10 0BE

Client: **Mr G Grover**

Job Reference: 04091R

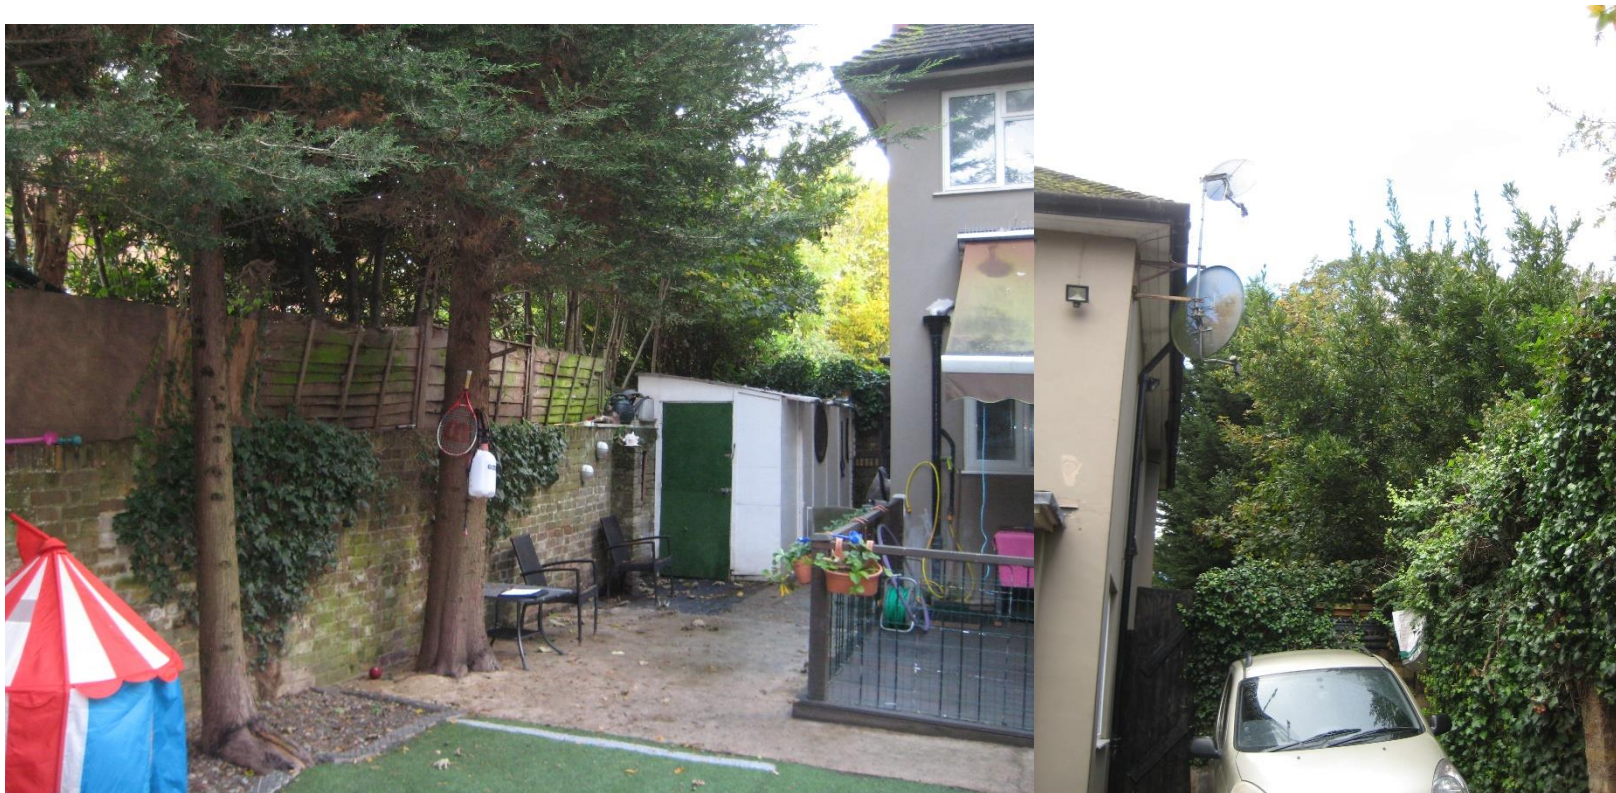
**Fig 7 – Example of trees to be removed from TG3 (left) and the existing overhang from TG2 (right)**

- 5.3.1 It is proposed to remove the first 3 trees in TG3 closest to the existing property. The remaining trees within TG3 can then be pruned to good form/shape to establish a longer-term management regime. The overhang of TG2 into the site will be 'faced off' to address this and again establish repeat pruning management positions.

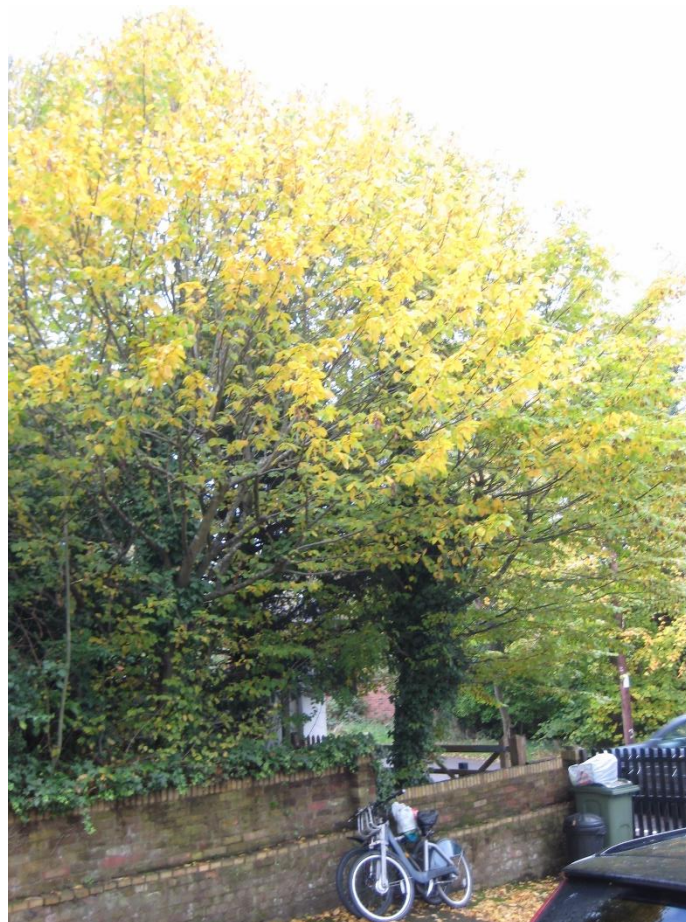
**Image 1 – TG2 (Hornbeam x 2)**

| Tree No | Species | DBH | Height | Age Class | Life exp | Observations | BS Cat | RPR |
|---|---|---|---|---|---|---|---|---|
| TG2 | Self-set Sycamore & Sweet Bay x2 | 0.25 | 6.5 | Early-mature | 20 to 40 | Close grown 3rd party trees beyond boundary wall. | C1 | 3 |

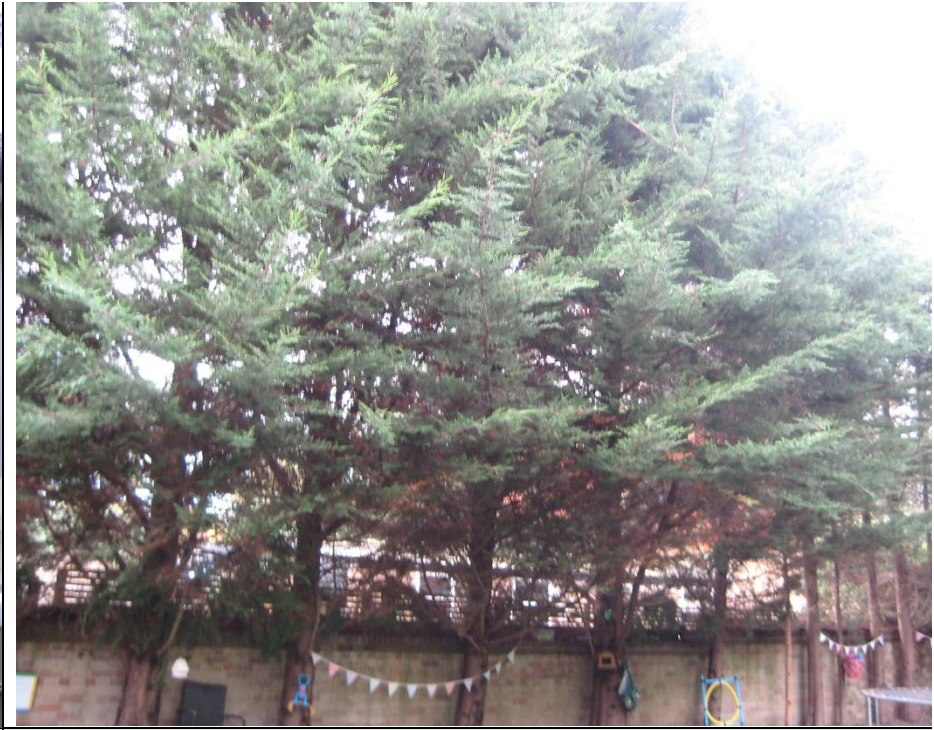
**Image 3 –TG3**

| Tree No | Species | DBH | Height | Age Class | Life exp | Observations | BS Cat | RPR |
|---|---|---|---|---|---|---|---|---|
| TG3 | Cypress | 0.33 | 8 | Mature | 20 to 40 | Close grown screening group which surrounds rear garden. Not regularly pruned to shape. | C1 | 3.9 |
