BS5837 Arboricultural Impact Assessment & Method Statement

102 Vine Lane, Uxbridge, UB10 0BE

Job Reference: **04091R**

Consultant: **Keiron Hart (BSc Hons, C.Env, F.Arbor.A, MICFor, MEWI, AARC, APAEWE)**

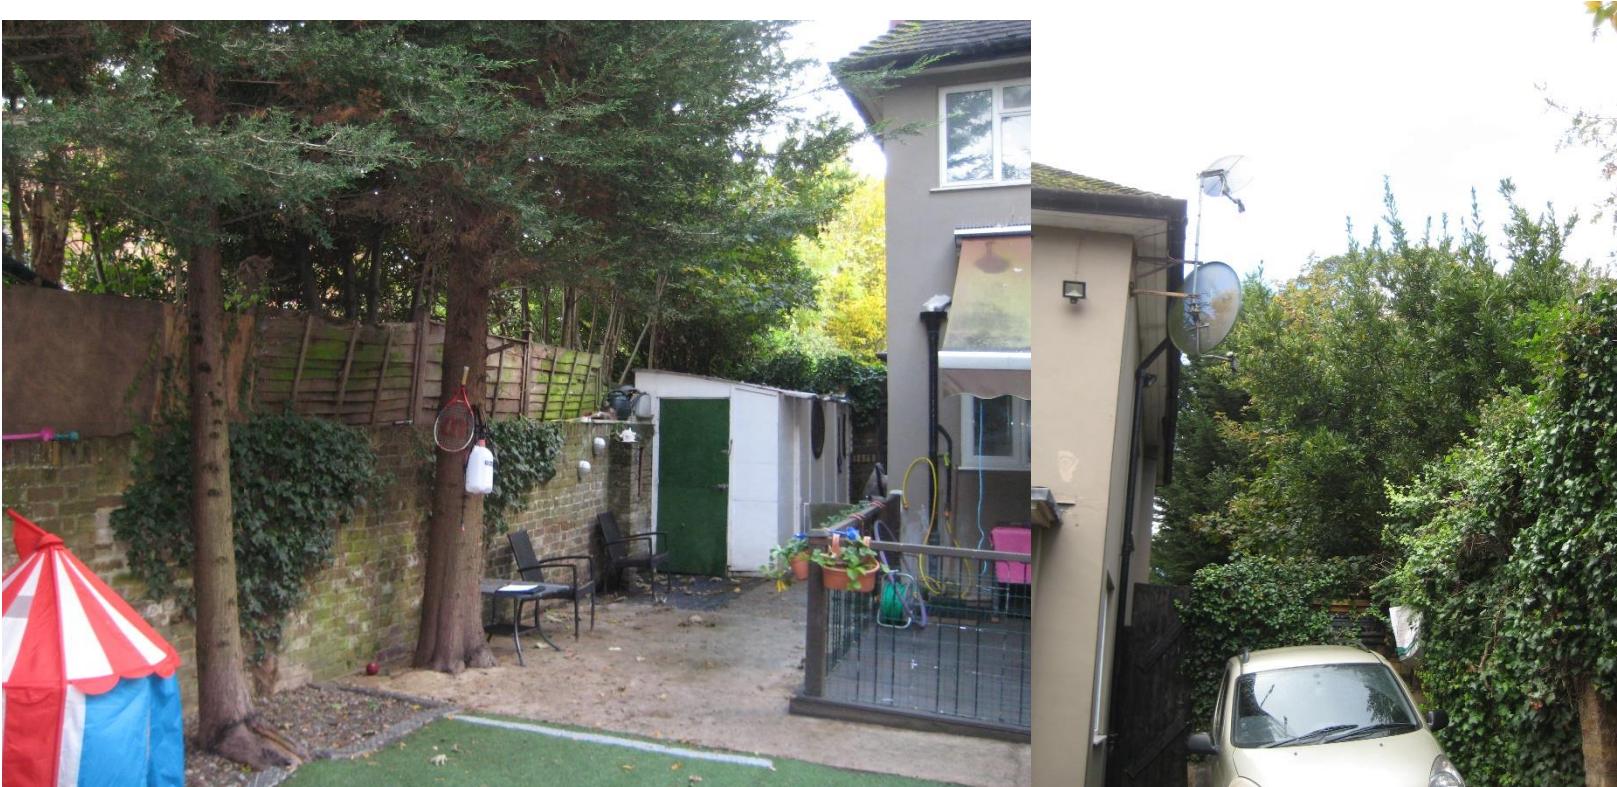
5.3.1 It is proposed to remove the first 3 trees in TG3 closest to the existing property. The remaining trees within TG3 can then be pruned to good form/shape to establish a longer-term management regime. The overhang of TG2 into the site will be 'faced off' to address this and again establish repeat pruning management positions.

Fig 7 – Example of trees to be removed from TG3 (left) and the existing overhang from TG2 (right)

- TG2 & TG3 will require ongoing pruning management but this situation arises whether the property is redeveloped or not.
- **Note:** This is an indicative assessment. All and any future works should be undertaken in accordance with BS3998 (Tree Works) and we recommend the use of Arboricultural Association approved contractors.⁵

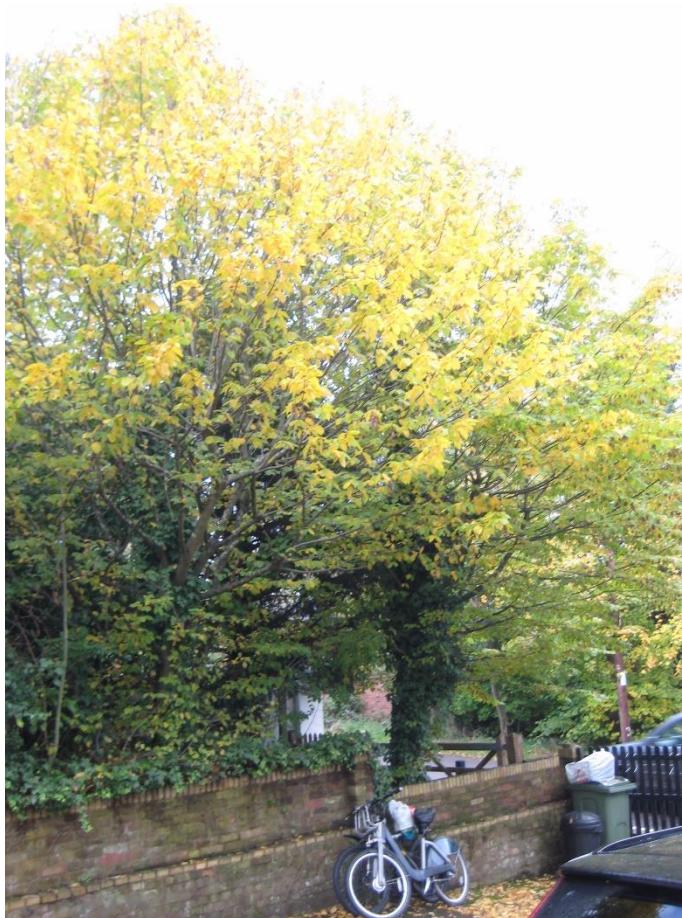
Image 1 – TG2 (Hornbeam x 2)

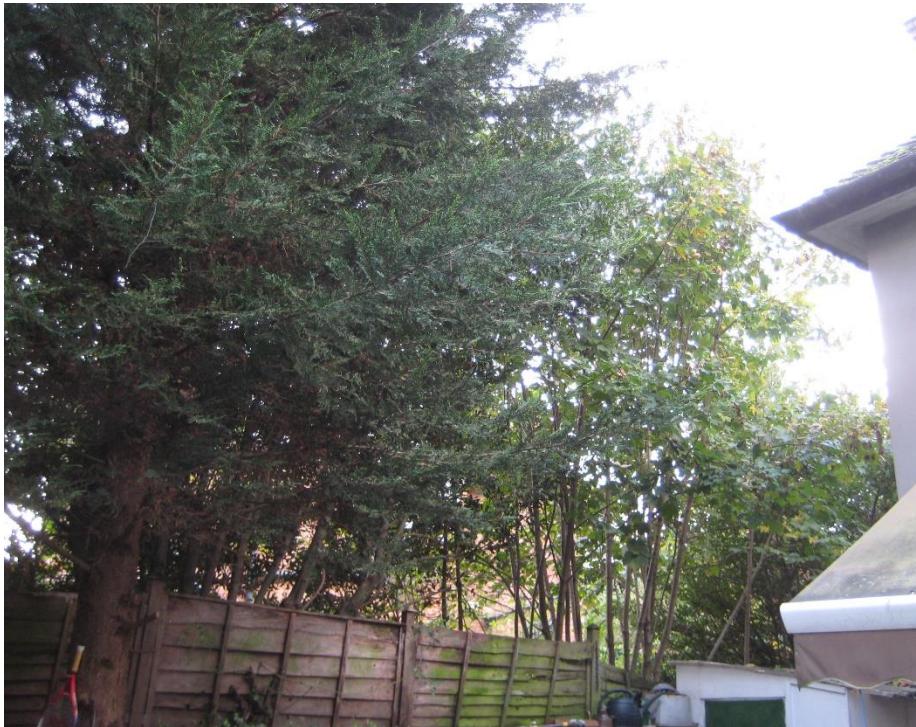
Image 2 – TG3 & TG2 from rear

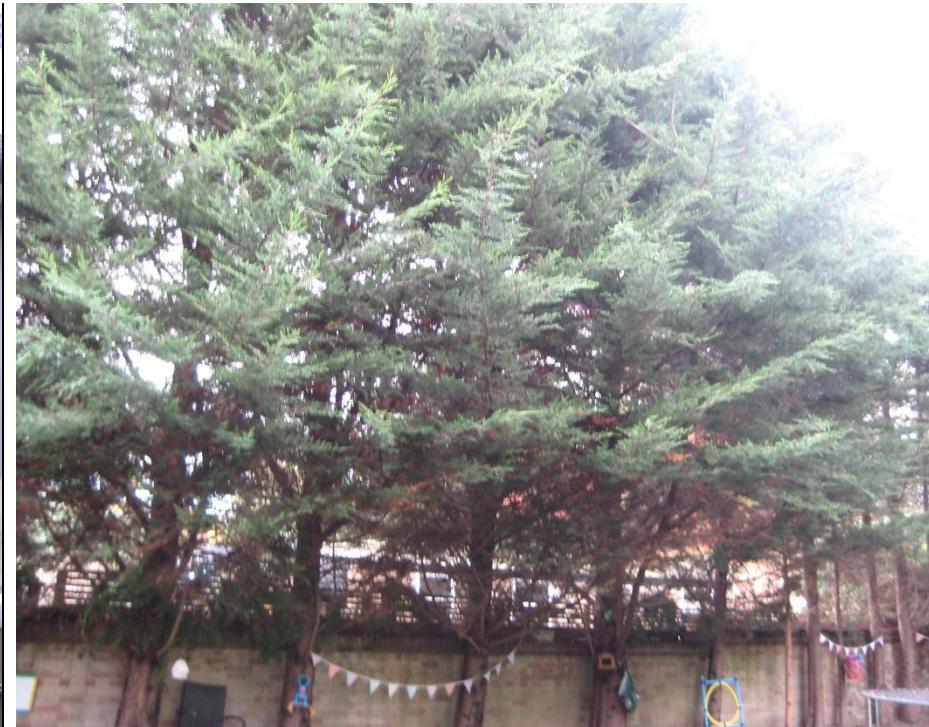
Image 3 –TG3
