## **Arboricultural Report** incorporating:

Garages at Southbourne  
Gardens, Ruislip, London,  
HA4 9SW

Alastair Durkin BSc (Hons) MArborA

Reference: AIA/003/2017/Rev1  
Dated: 28th October 2017

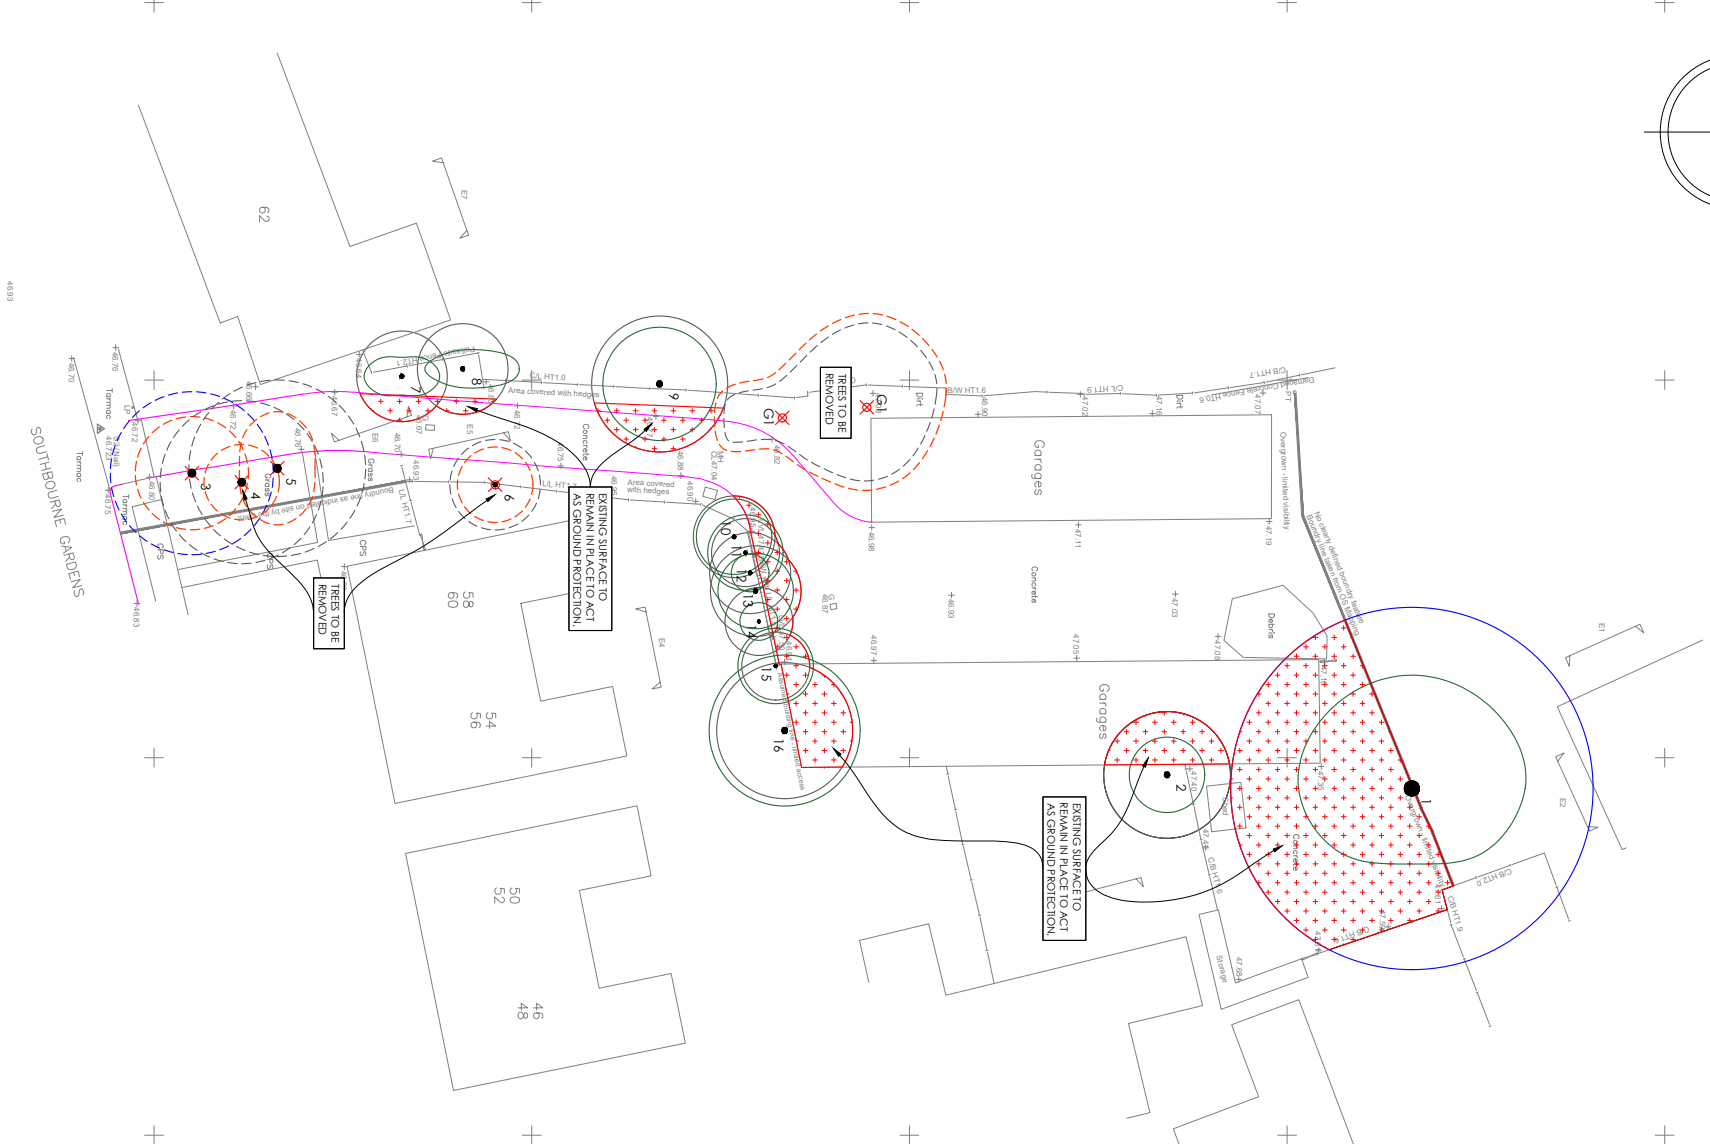
EXISTING SITE PLAN  
INDICATING PROPOSED  
TREE REMOVALS

- 9.2 Of the trees surveyed a total of 4 trees are to be removed including the offsite T6 (Lawson cypress) with the landowner's permission (Table 2). This tree is not a high value specimen and is already outgrowing its location, causing light loss to main habitable rooms of the neighbouring dwellings. Its retention is also incompatible with the access width necessary to serve the development. Similarly the retention of T3, T4 and T5 cannot be achieved whilst gaining the access width necessary to serve the development. All of the trees to be removed fall within the 'C' BS5837 category. Although T3, T4 and T5 are visible from Southbourne Gardens they are not of high quality and have little overall landscape value, or long-term retention potential.

- 9.3 G1 is a group of Portuguese laurel shrubs/trees growing very close to the western boundary. Visually this group is of moderate quality, but its retention cannot be achieved whilst providing the necessary parking for the proposal, and allowing for the necessary working area around the footprint of the main construction area.

| Tree works proposed | Tree ID |
|---|---|
| Trees to be removed to facilitate construction | T3, T4, T5, T6, G1 |

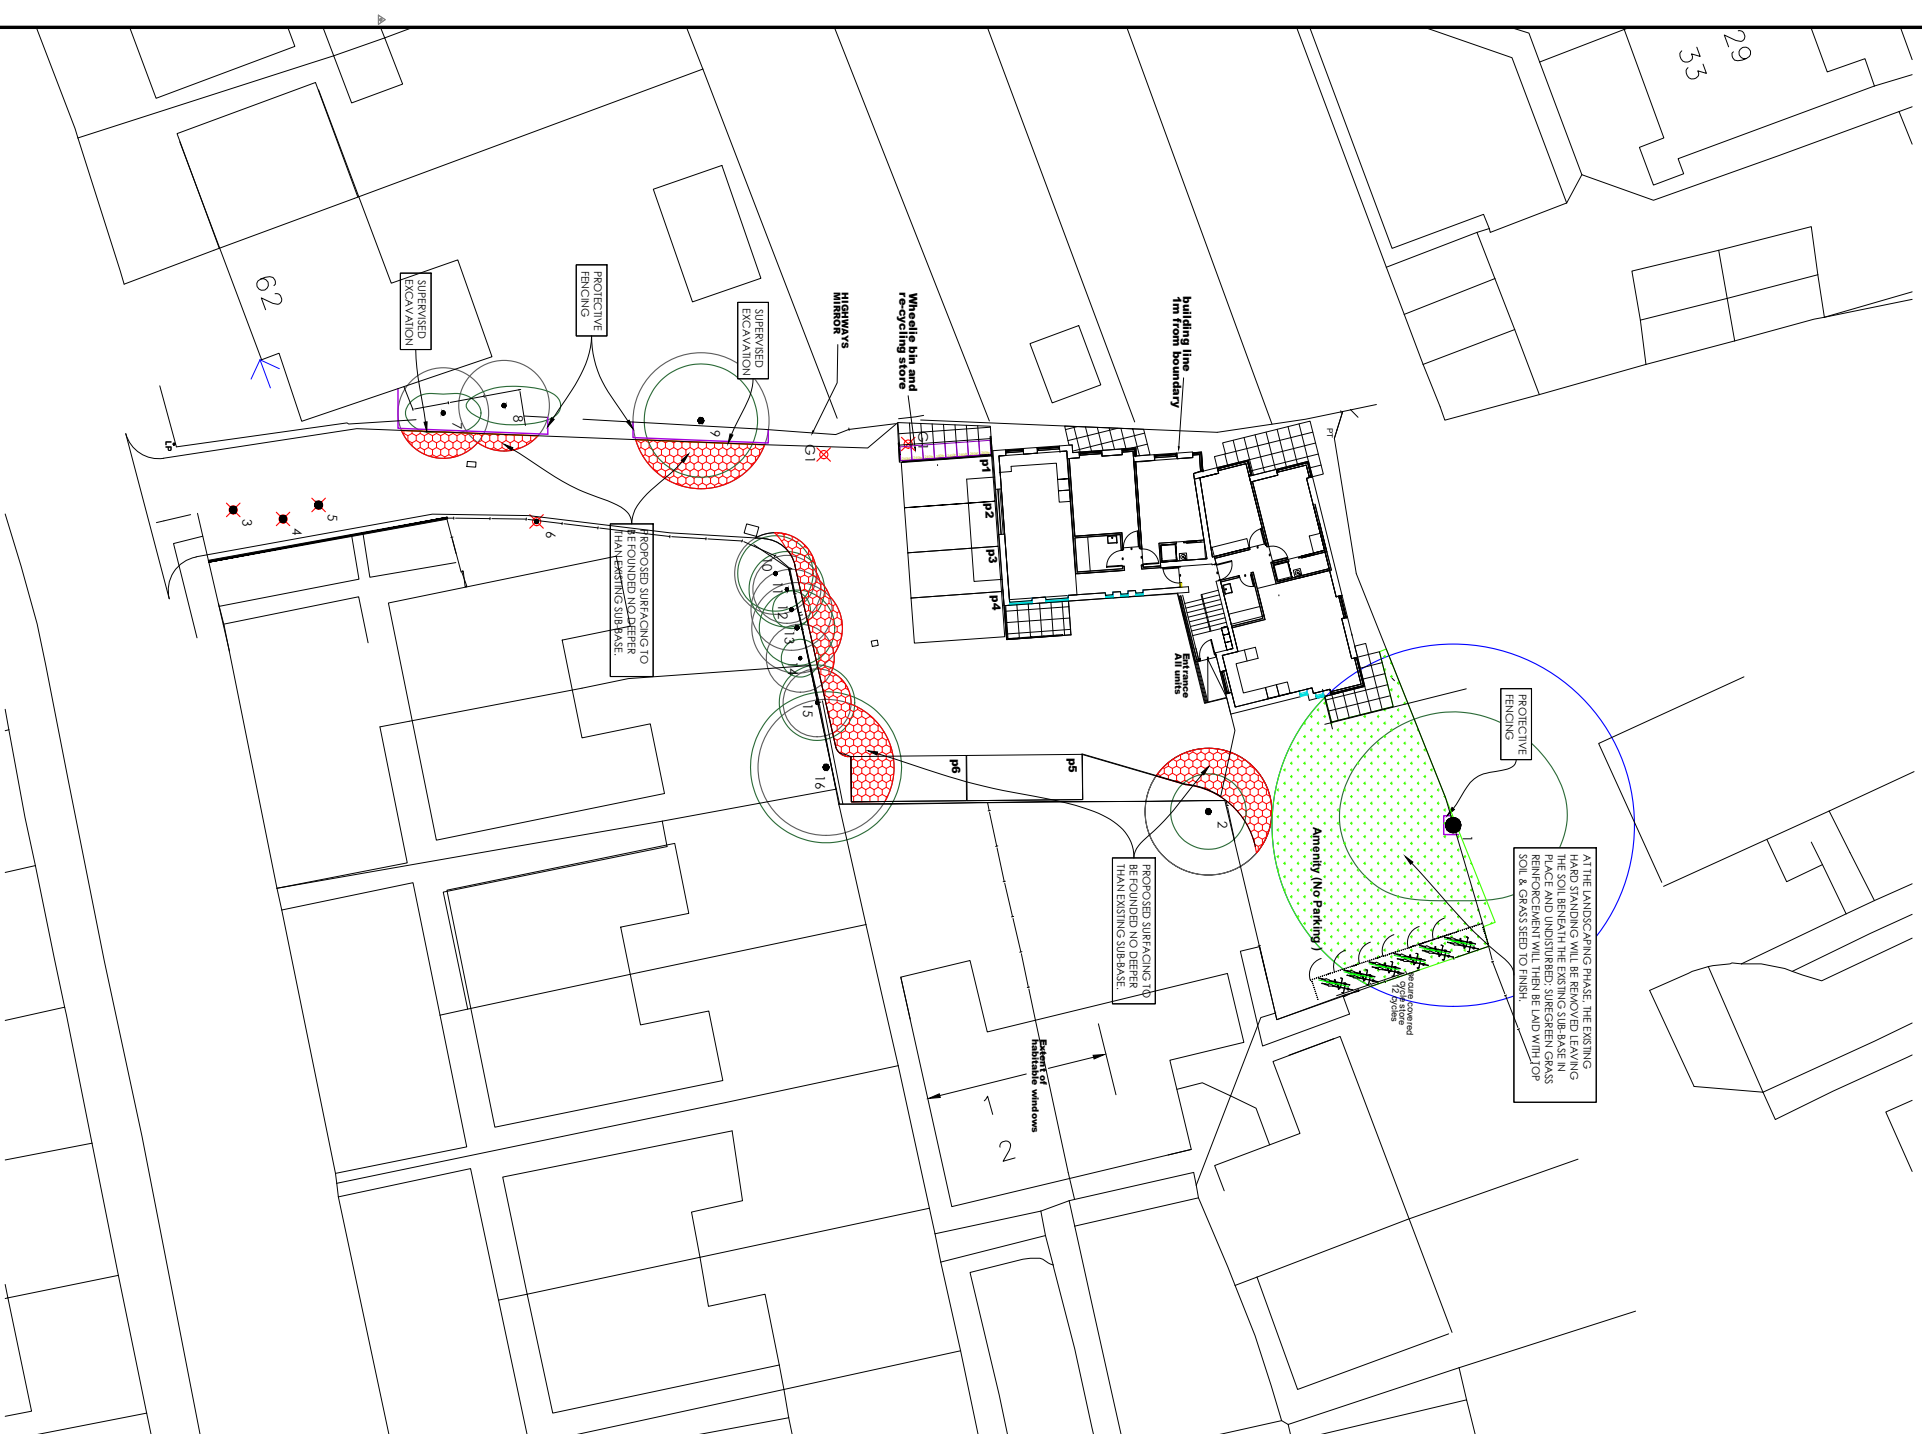
PROPOSED SITE PLAN  
INDICATING PROPOSED  
TREE PROTECTION

- 11.1 Redevelopment of the site will require works within the RPA of T7-T16.
- 11.2 In respect of T10-T16 only replacement of the existing hard standing surface will be undertaken. No disturbance of the sub base is necessary. As such it is highly unlikely that significant roots will be harmed, in the unlikely event that they are present at all, due to the inhospitable rooting environment associated with hard standing areas. During the main development phase the hard standing will act as effective ground protection for the trees.

- 11.3 Some works may be necessary within the RPA of T9, an offsite *prunus sp.* tree. However, the rooting of this tree is already heavily restricted by the existing access road and it is unlikely that major roots have proliferated in the area affected. Furthermore the ample room available within the garden for roots to proliferate means that should roots need to be removed then the tree is likely to be able to adapt within in a short timeframe. In any case as the tree is BS 5837 'C' category and not of high landscape value it is not considered reasonable for technical measures such as no dig surfacing to be put in place in order to protect the RPA.

- 16.4 In this case the formation of a CEZ will be achieved by using a combination of fencing and ground protection utilising the existing hard surface around T1 and T10-T16. An example of the protective fencing design is given at Appendix C and will be utilised as indicated on the TPP.

- 17.1 The location of protective fencing to be installed on site is detailed within the TPP (Appendix B).
- 17.2 Alternative specification**
- 17.3 Protective fencing shall consist of a 2.m high welded mesh panels on rubber or concrete feet, joined together with a minimum of two anti-tamper couplers with one metre separation, installed so that they can only be removed from inside the fence. The panels are to be supported on the inner side by stabilizer struts and attached to a base plate secured with ground pins in accordance with *figure 3* of BS 5837. 'Tree Protection Area – Keep Out!' signs shall then be fixed to every forth panel (Appendix E).
