ARBORICULTURAL IMPACT ASSESSMENT SURVEY & REPORT

Former MSD Facility, Breakspear Road South,
Ickenham

Report Reference: BG22.113.6

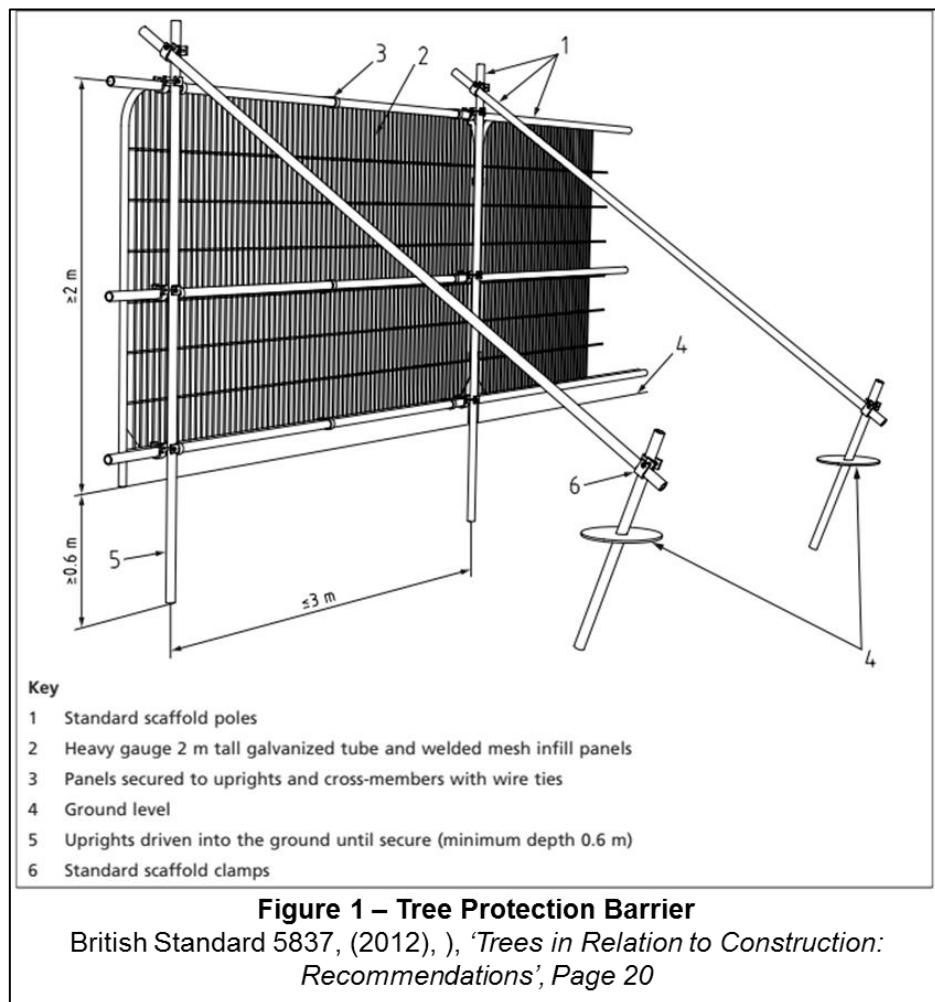
Figure 1 – Tree Protection Barrier
 British Standard 5837, (2012), 'Trees in Relation to Construction: Recommendations', Page 20

- 1.1. In order to avoid damage to their roots, retained trees should be protected using protective barriers as detailed in British Standard 5837:2012 'Trees in Relation to Design, Demolition and Construction – Recommendations' and as illustrated in Figures 1 and 3. Such barriers will be erected around the RPA or as shown in the Tree Protection Plan prior to the commencement of the demolition/construction activity; it must remain in situ and intact until completion. The area within these barriers will be considered sacrosanct throughout the works, with no work permitted within them; any exceptions to this will be detailed in the site specific Arboricultural Impact Assessment. All-weather notices should be attached to the tree protection barriers with words such as 'Construction Exclusion Zone – No Access' or 'Tree Protection Area – Keep Out'.
