Arboricultural Impact Assessment

Garages off Green Walk

Ruislip

09th April 2018

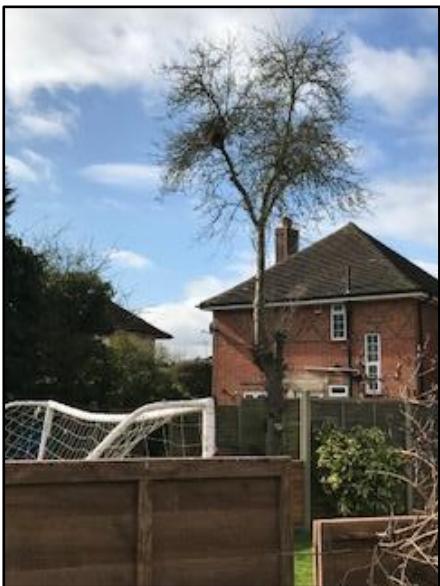
- 3.10 There was one category U tree on site, T1, and one category U group on site, G2.
- 3.11 T1 was a mature apple tree *Malus domesticus* in the rear garden of 23 Windmill Way.
- 3.12 T1 had been subject to unsympathetic past management with a large co-dominant stem having been removed leaving the crown unbalanced and the tree drawn up. Several decay pockets were present where large limbs had been removed and there was evidence of die back in the crown.
- 3.13 As a result of T1's poor form and evidence of decline it is recommended that this tree is removed on arboricultural grounds.

Photograph 1: T1, apple.

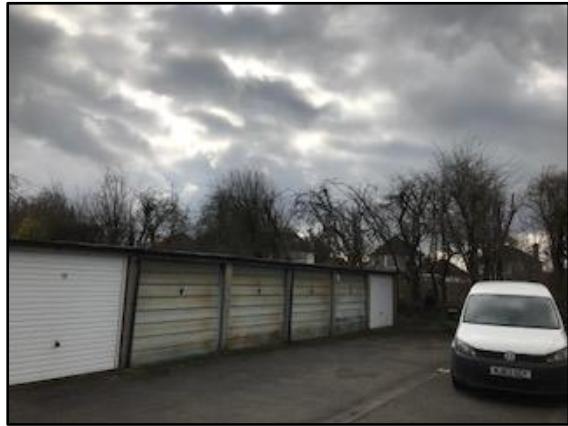
- 3.5 There was one category C group on site, G1.
- 3.6 G1 was a group of hawthorns *Crataegus monogyna* rooted on the boundary line between the garages off Green Walk and the rear gardens of the properties on Pembroke Road.

- 3.7 G1 appeared to be a lapsed hedge line. It had been subject to unsympathetic past management and the existing growing environment was inhospitable as a result of vehicular activity and littering. In some areas parts of the tree's root plates were visibly damaged.

- 3.8 There was also an established climbing plant growing in the crowns of the trees in the west part of this group. The climber has heavily suppressed growth in these areas of G1.

Photograph 2: G1, lapsed hawthorn hedge line.

- 3.9 Due to the lapsed management of the hedge line and the damage being caused to G1 it is considered the group does not have a useful life expectancy. This group should be removed and replaced on completion of the development with species more fitting to the character of the Conservation Area (Appendix 5).

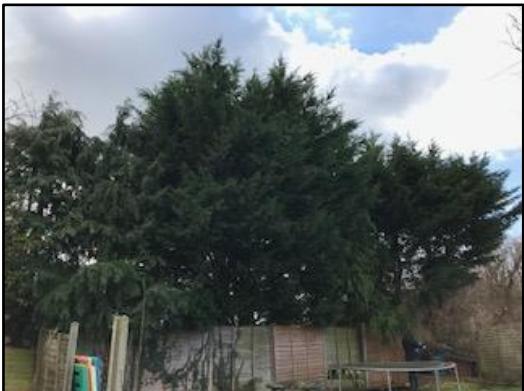
- 3.14 G2 was a hedge line of mixed coniferous species including Leyland cypress *Cupressus × leylandii* and Lawson cypress *Chamaecyparis lawsoniana*. G2 was rooted on the boundary of 23 and 25 Windmill Way.
- 3.15 G2 was subject to unsympathetic past management, some of the larger trees had been 'topped'. As a result of this whilst G2 provides some screening value its amenity value as a whole is considered to be low.
- 3.16 There was also an established climbing plant growing in the crowns of the trees in the east part of this group. The climber has heavily suppressed growth in these areas of G1.
- 3.17 Due to G2's poor condition and its lack of amenity value it is considered this group should be removed and replaced on completion of the development with species more fitting to the character of the Conservation Area.

Photograph 3:
G2, Leyland cypress *Cupressus x leylandii* and
Lawson cypress *Chamaecyparis lawsoniana*

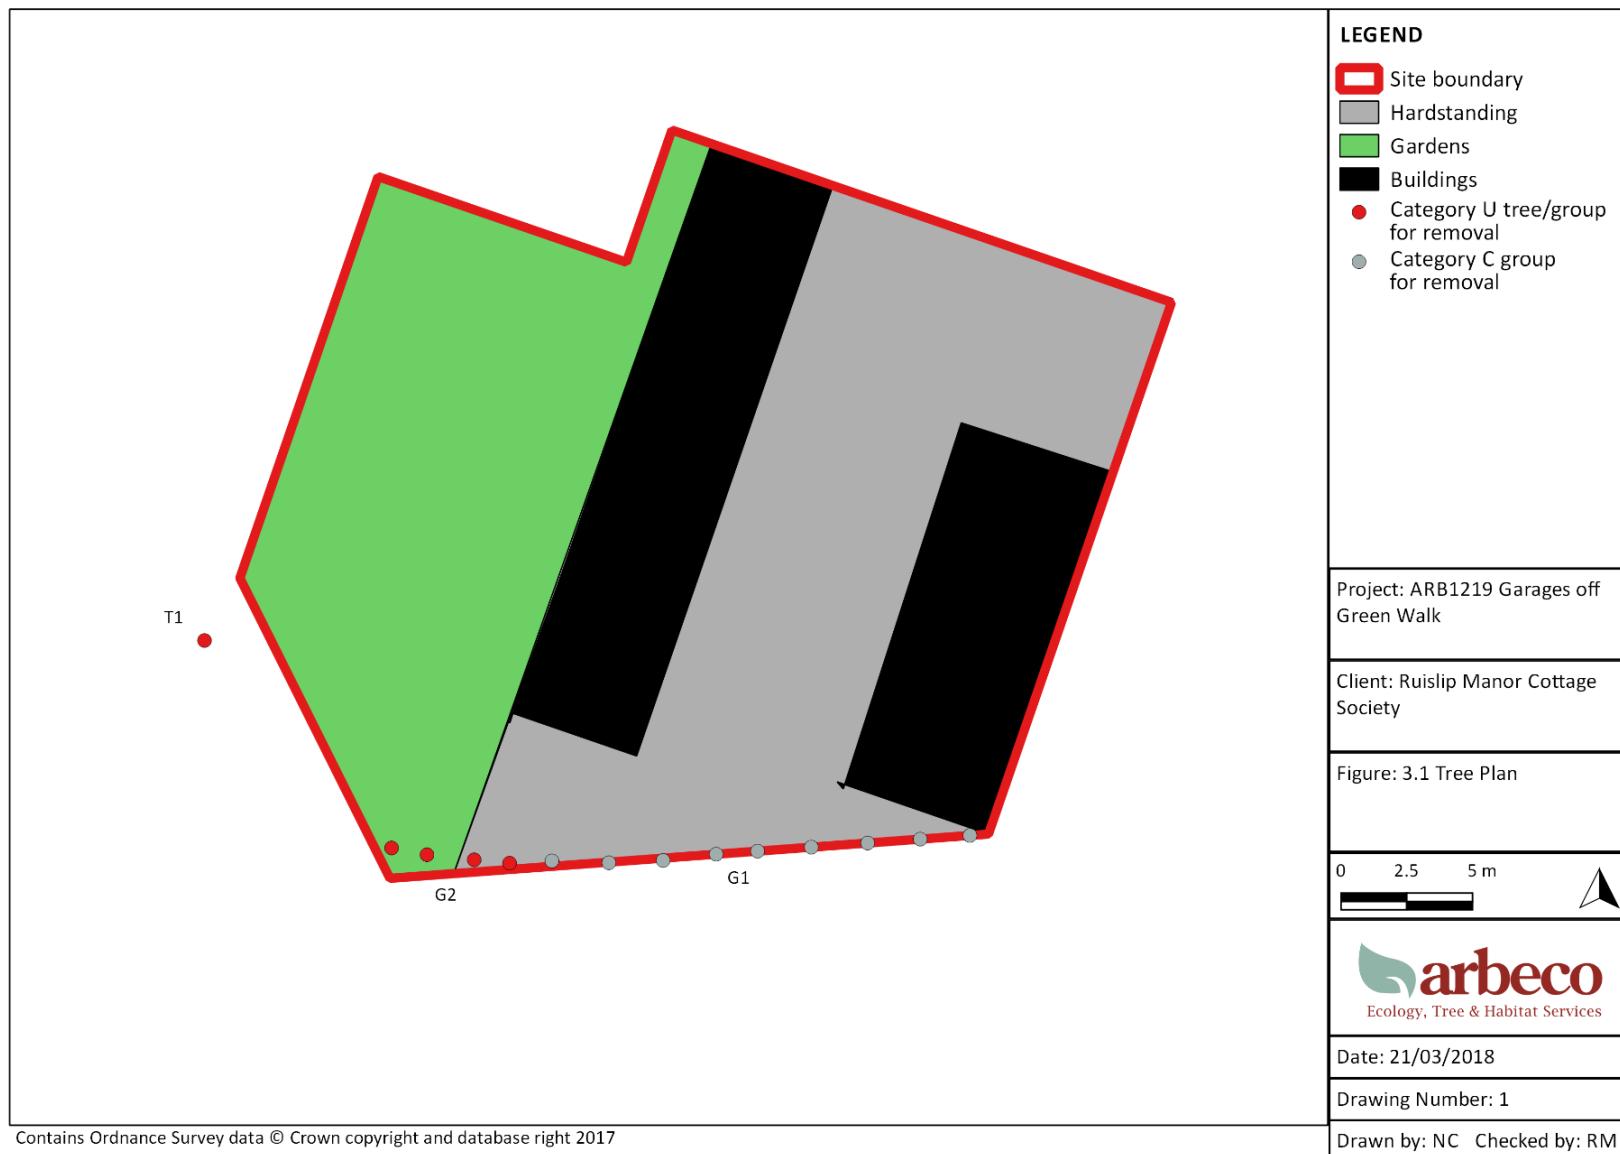
Figure 3.1: Tree Plan

- 2.12 The results of the Arboricultural Survey were used to evaluate the direct and indirect effects of the proposed design on the existing trees and identify appropriate mitigation measures.
- 2.13 The locations of the recorded trees were digitised in the Tree Plan (Figure 3.1) showing their approximate locations and BS5837 quality assessment categories.
