ARBORICULTURAL IMPACT ASSESSMENT

**SITE: Corner of Fore Street and High Road, Eastcote,
Pinner HA5 2ET**

CLIENT: Watervale Property Ltd

17th January 2023 EAS-062v3

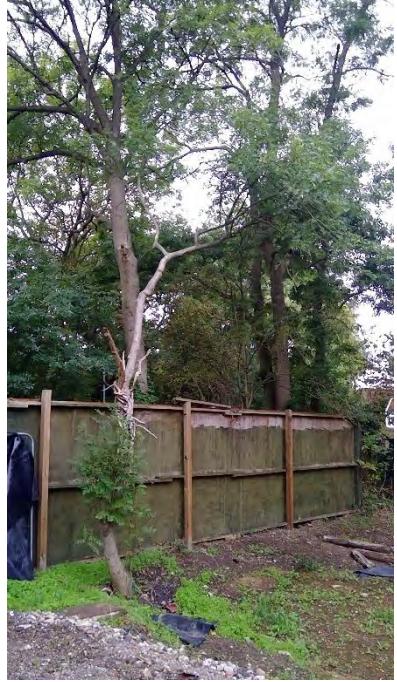
T1 - Ash (Common)	T3 - Ash (Common)

Tree No	Species	Ht (m)	DBH (mm)	No of Stems	BS Cat	Observation	Recommendations
T1	Ash (Common)	9	180	1	U	Poor form (asymmetric canopy), shape and condition. Sparse lower crown showing signs of stress with major deadwood. Ivy cut.	Fell to ground level and treat.
T2	Ash (Common)	13	390	2	U	Poor form (asymmetric canopy), shape and condition. Sparse crown showing signs of stress with major deadwood. Infected with Ash dieback disease. Basal trunk wounding.	Fell to ground level and treat.
T3	Ash (Common)	7	170	1	U	Poor form (asymmetric canopy), shape and condition. Sparse lower crown showing signs of stress with major deadwood. Wood nailed to tree. Too close to service manhole.	Fell to ground level and treat.
T4	Ash (Common)	9	180	1	U	Poor form, shape and condition. Self-set pioneer tree. Asymmetric form. Moderate deadwood infected with Ash dieback disease. Large basal wound with associated decay.	Fell to ground level and treat.

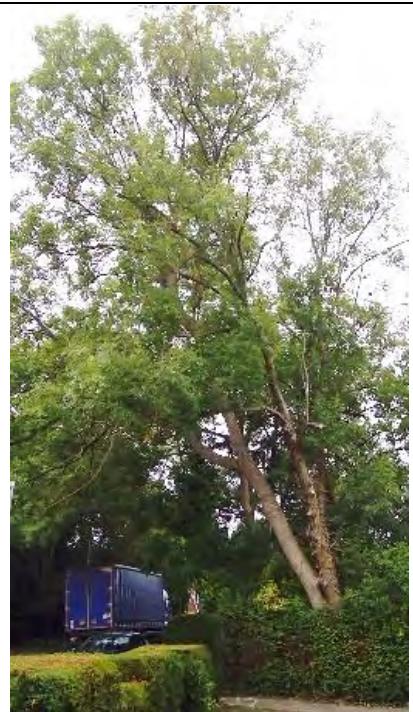
T5 - Ash (Common)

Tree No	Species	Ht (m)	DBH (mm)	BS Cat	Age Class	Observation	Recommendations
T5	Ash (Common)	18	720	C2	Mature	Poor asymmetric canopy shape and condition. Major crown deadwood. Infected with Ash dieback. Leans heavily over highway. BT wires in crown. Codominant tree with severe included basal and trunk unions. In dense vegetation unable to fully inspect.	Crown reduce and reshape by 4m to West to balance crown over highway. Remove major deadwood. Sever Ivy at 2m from ground level and remove section. Re-inspect. Insert flexible restraint system between co-dominant stems.
T6	Oak (English)	13	550	B2	Mature	Good form, shape and condition. Dense crown, moderate dead wood. History previous limb failure. Debris piled within rooting zone with dense vegetation unable to fully inspect.	Remove major dead wood. Remove basal vegetation and re-inspect root crown.
T7	Oak (English)	13	990	C2	Mature	Poor suppressed asymmetric form, shape and condition. Growing as one crown with adjacent Oak. Dense low crown over highway. Moderate dead wood. Trunk epicormic growth. Debris piled within rooting zone. Within dense vegetation. Ivy clad trunk unable to fully inspect.	Remove major dead wood. Cut back over highway by 2m. Crown lift over footpath by 4m. Prune trunk epicormic growth to 4m. Remove basal vegetation. Sever Ivy at 2m from ground level and remove section. Re-inspect.

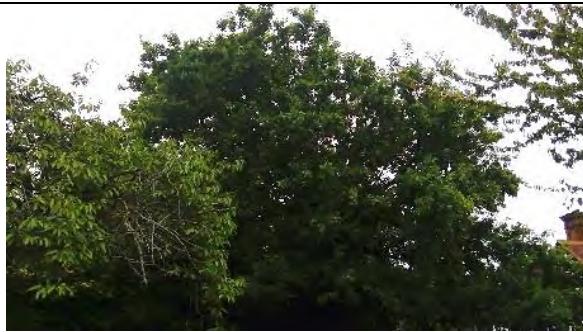
T6 - Oak (English)

T6	Oak (English)	13	6	6	7	6	550	1	137	7	123	B2	Mature	20-39	Good form, shape and condition. Dense crown, moderate dead wood. History previous limb failure. Debris piled within rooting zone with dense vegetation unable to fully inspect.	Remove major dead wood. Remove basal vegetation and re-inspect root crown.

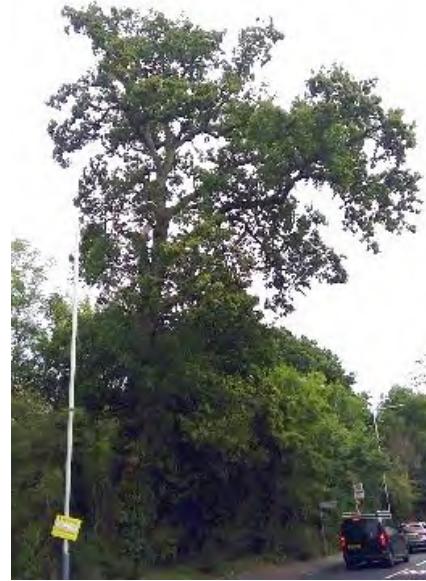
T8 - Oak (English)

T8	Oak (English)	24	1100	C2	Mature	Poor asymmetric form, shape and condition. Sparse upper crown showing signs of stress with crown retrenchment and major deadwood. Tree adjacent to and overhangs highway. Tree subject to previous history of limb failures. Ivy clad crown and stem, unable to fully inspect. Trunk epicormic growth	Sever Ivy at 2m from ground level and remove section. Re-inspect. Remove dead wood. Remove epicormic growth to a height of 6m.

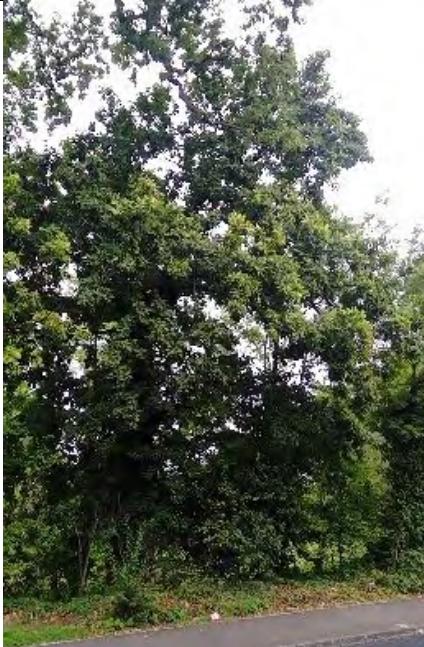
T9 - Oak (English)

Tree No	Species	Ht (m)	DBH (mm)	BS Cat	Age Class	Observation	Recommendations
T9	Oak (English)	13	680	B2	Mature	Average suppressed form, shape and condition. Dense crown, moderate dead wood, overhangs highway. Basal and Trunk epicormic growth. Ivy clad crown and stem, unable to fully inspect.	Remove dead wood. Remove basal vegetation and re-inspect root crown. Sever Ivy at 2m from ground level and remove section. Prune epicormic growth to 4m. Crown lift to 6m over highway
TG2	Mixed species group; Blackthorn, Hawthorn, Holly, Ash seedlings, Cherry	9	200	C2	Early Mature	Average form, shape and condition boundary mixed species group. No significant recent crown management. Dense crowns, minor dead wood. Multiple-stemmed. Ash infected with Ash dieback.	Sever Ivy at 2m from ground level and remove section. Re-inspect. Crown lift to 6m over public footpath highway. Fell Ash seedlings.
T10	Ash (Common)	16	1100	U	Mature	Poor form, shape and condition. Old Multiple-stemmed highway boundary tree with included unions with all previous stems pollarded. Epicormic trunk regeneration. Ivy clad stump.	Re-pollard all regenerated stems. Fell stump closer to ground level and treat to prevent regrowth.

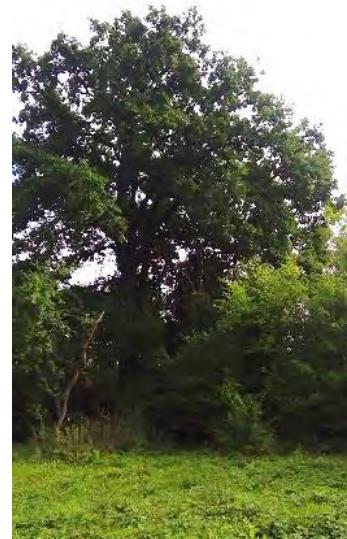
T13 - Oak (English)

Tree No	Species	Ht (m)	DBH (mm)	BS Cat	Age Class	Observation	Recommendations
T13	Oak (English)	30	1240	A1	Mature	Good form, shape and condition. Dense crown and moderate deadwood. Tree subject to previous history of limb failures. Ivy clad crown and stem, unable to fully inspect. Trunk epicormic growth.	Sever Ivy at 2m from ground level and remove section. Re-inspect. Remove dead wood. Remove epicormic growth to a height of 6m.
T24	Cherry	13	420	C2	Mature	Poor form, shape and condition. Thinning crown, moderate dead wood. Still suffering effects of Summer heat stress. Ivy clad crown and stem, unable to fully inspect.	Remove dead wood. Sever Ivy at 2m from ground level and remove section. Re-inspect.
T25	Ash (Common)	11	600	C2	Mature	Average form, shape and condition low pollard on stream bank. No significant recent crown management. Thinning low crown. Moderate dead wood. Infected with Ash dieback. Ivy clad crown and stem, unable to fully inspect.	Remove dead wood. Sever Ivy at 2m from ground level and remove section. Re-inspect. Crown lift to 4m over site.

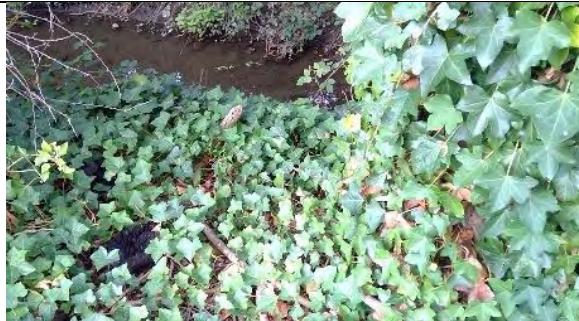
<p>T15 - Ash (Common) – Innonotus bracket on ground</p>	<p>T16 - Oak (English)</p>

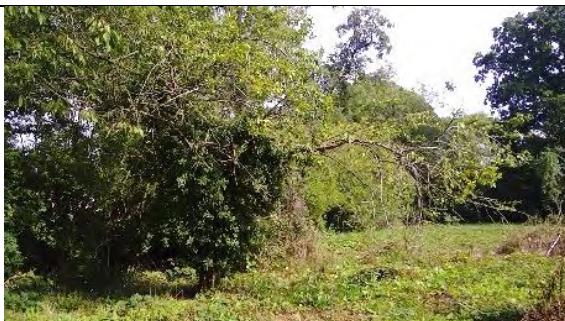
T23 - Pissard Plum

T23	Pissard Plum	6	2	2	5	3	200	1	18	2	27	U	Early Mature	<10	Poor suppressed asymmetric canopy. Poor condition. Sparse crown showing signs of stress with upper crown retrenchment and major deadwood.	Fell to ground level and treat.

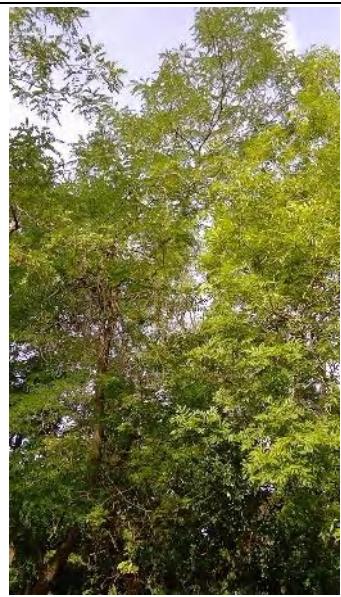
T26 - False Acacia

T26	False Acacia	14	250	C2	Early Mature	Poor form, shape and condition. No significant recent crown management. Sparse crown. Moderate dead wood. Large basal trunk wound with associated decay. Wire around trunk. Sucker from parent tree.	Remove dead wood.
T28	False Acacia	15	410	C2	Mature	Poor leaning form, shape and condition. No significant recent crown management. Dense crown, moderate dead wood. Sucker from parent tree overhanging stream.	Remove dead wood.
T29	Oak (English)	22	770	C1	Mature	Average condition. Asymmetric canopy. Thinning crown. Major dead wood. Tree subject to previous history of limb failures. Ivy clad crown and stem, unable to fully inspect.	Remove dead wood. Sever Ivy at 2m from ground level and remove section. Re-inspect.
TG4	Mixed species group; Hazel, Blackthorn, Hawthorn, Holly, Ash seedlings,	10	200	C2	Early Mature	Poor form, shape and condition boundary mixed species group. Sparse crowns. Moderate dead wood. Multiple-stemmed coppice. Some dead standing Elm and Ash. Ash infected with Ash dieback.	Sever Ivy at 2m from ground level and remove section. Re-inspect. Fell dead Ash and Elm trees. Re-coppice Hazel.

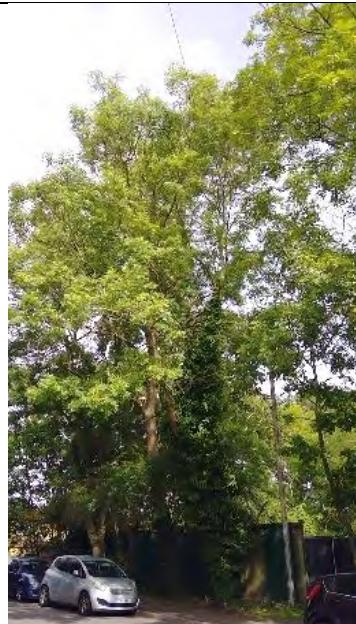
T33 - Ash (Common)

T33	Ash (Common)	20	550	C2	Mature	Asymmetric canopy over highway. Poor condition. Thinning low crown. Major deadwood. Infected with Ash dieback. Lifted over highway. Ivy clad crown and stem, unable to fully inspect.	Remove dead wood overhanging the Highway. Sever Ivy at 2m from ground level and remove section. Re-inspect. Crown lift to 6m.

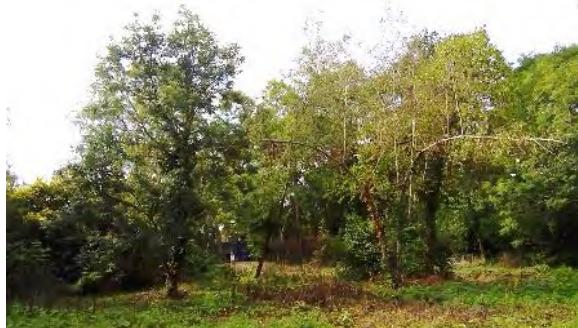
TG1 - Mixed species group; Hawthorn, Birch, Sweet Chestnut, Ash

TG1	Mixed species group; Hawthorn, Birch, Sweet Chestnut, Ash	9	250	m/s	C2	Poor form, shape and condition self sown trees. Sparse crowns showing signs of stress with crown retrenchment and major deadwood. X1 Dead standing tree.	Fell to ground level and treat.
T10	Ash (Common)	16	1100	m/s	U	Poor form, shape and condition. Old Multiple-stemmed highway boundary tree with included unions with all previous stems pollarded. Epicormic trunk regeneration. Ivy clad stump.	Re-pollard all regenerated stems. Fell stump closer to ground level and treat to prevent regrowth.
T14	Pissard Plum	8	170	1	U	Poor suppressed form (asymmetric canopy), shape and condition. Top snapped out of tree. Sparse crown. Moderate deadwood.	Fell to ground level and treat.
